Different kinds of bridges, DIFFERENT KINDS OF REPAIRS

Different technology and different products employed to restore two bridges over the River Duero: one in concrete and one in stone.

Bridges on the River Duero, located along the stretch between Peñafiel and Pesquera de Duero (Valladolid – Spain).

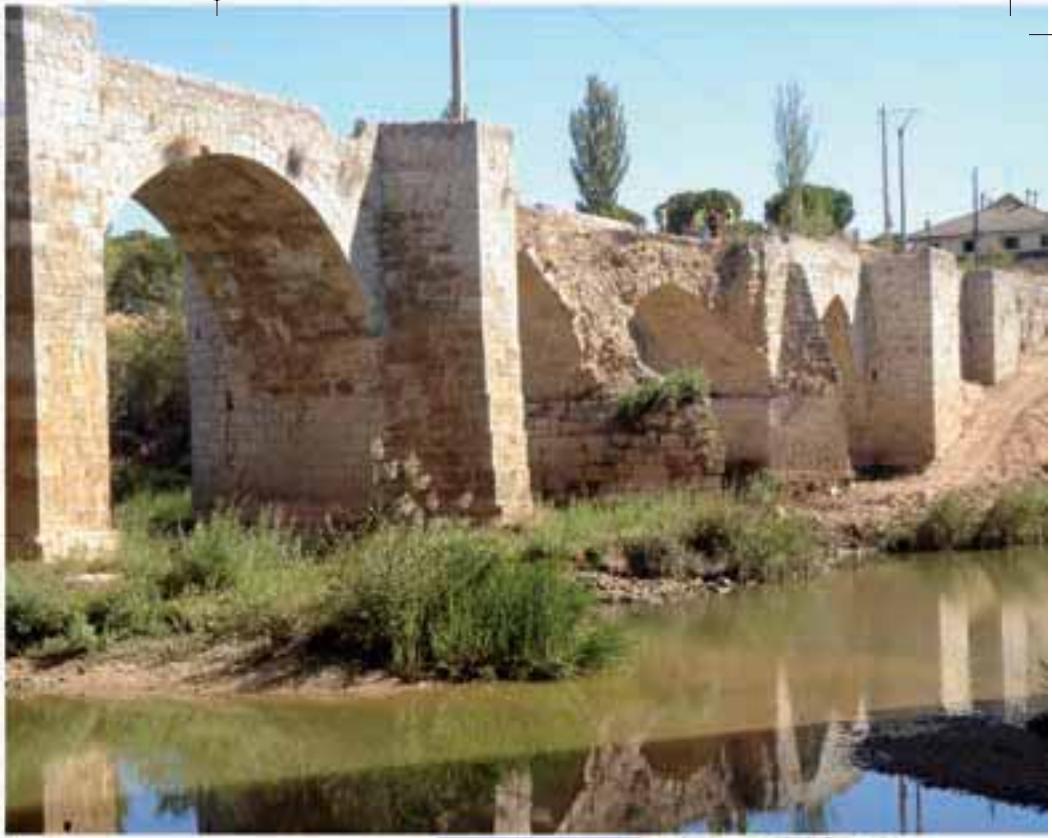
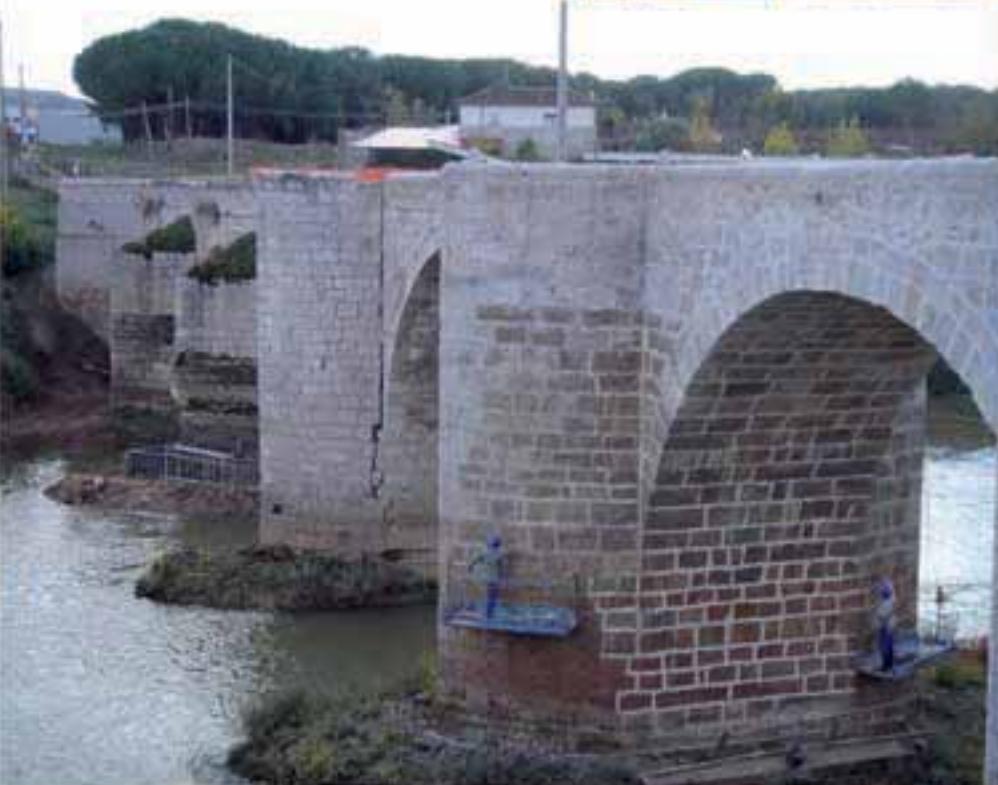
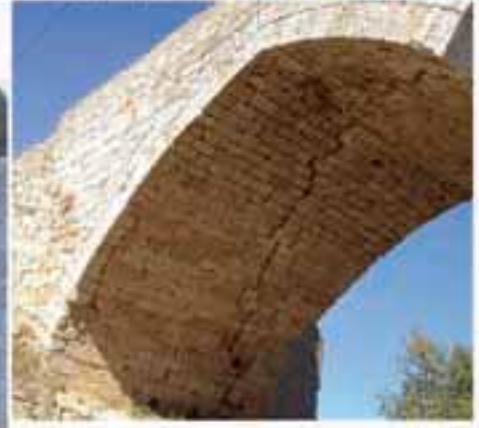
The stone bridge over the River Duero, which dates back to the VI century AD, is formed by seven arches and is reserved for pedestrians and light traffic only. Of the seven arches, the two central ones were completely ruined. A field analysis carried out by technicians from the Ibermapei Technical Service Department highlighted a series of

problems, which made the bridge dangerous for pedestrians. The main cause was that the structure had been left to its own devices over the years, and its conditions had gradually become worse and worse as time went by. Waste material had also collected over the years at the foot of the pillars which support the bridge, and weeds had grown in the joints causing the old mortar to crumble.

Further damage was also found by the technicians, with cracks in the columns which support the arches, no sealant between the stones in various portions of the masonry work and cracks in the vault of some of the arches, which had

provoked detachment of a number of blocks of stone.

*On this page:
view of the serious damage of the ancient stone bridge which, before the repair work, had been closed to traffic.*

The missing and damaged stones were then put back into place, and the joints between each row of stones were pointed using MAPE-ANTIQUÉ LC* cement-free hydraulic binder mixed with fine local sand. MAPE-ANTIQUÉ LC* is based on synthetic fibres and fine additives and features pozzolanic-activity. It is resistant to sulphates and is particularly suitable for renovation work on masonry subject to rising damp or else damaged by soluble

The operation required the rebuilding of the missing and damaged parts, repair of the cracks, consolidation of the arches and, lastly, pointing between the rows of stone blocks.

salts. The cracks in the vaults of the arches were repaired using MAPE-GROUT T40* thixotropic mortar and pointing was again carried out using MAPE-ANTIQUÉ LC* binder.

MAPE-ANTIQUÉ I* hydraulic binder was then injected to consolidate all of the arches, except the two central ones. MAPE-ANTIQUÉ I* is used to consolidate by injection and fill cavities, cracks and internal porosity in ancient stone and brick structures. The day before the binder was injected, the internal structure to be consolidated had to be thoroughly soaked with water, using the same holes which had been drilled ready for injecting the

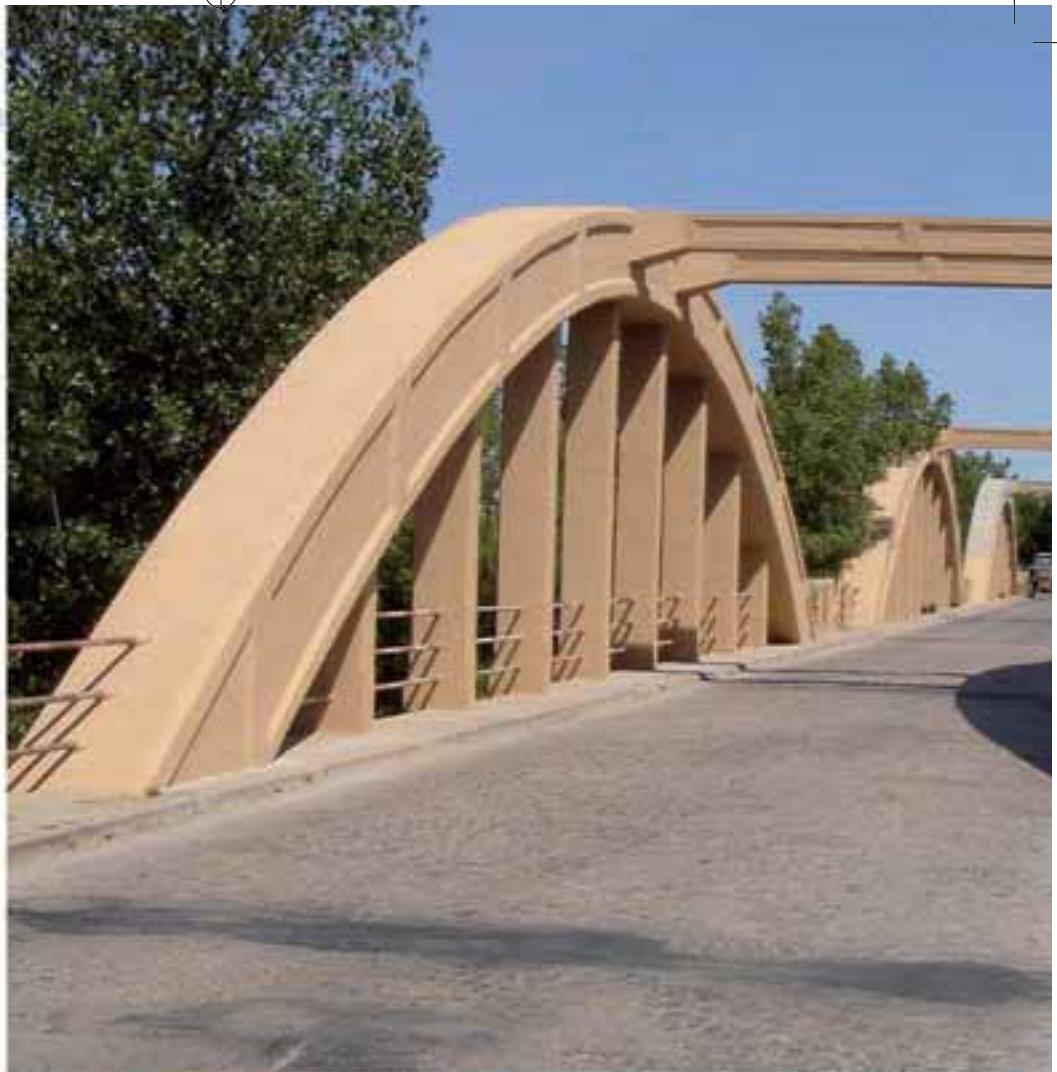
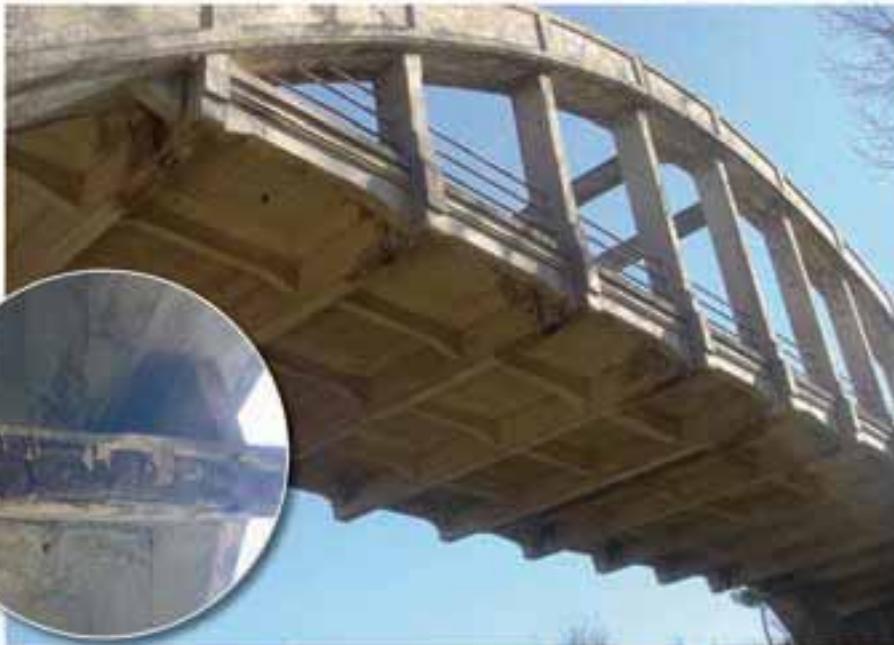
The concrete bridge is used by vehicles to cross the River Duero. It features large arches reinforced by a series of lateral pillars, while the roadway is supported by beams and there are iron parapets, for safety purpose, running along the sides. A careful technical analysis brought to light a series of problems which "plagued" the bridge. In some areas, the reinforcement rods were clearly visible and oxidised, due to detachment of portions of the con-

crete. The condition of the bridge was rather serious, especially in the lower pillars of the arches and in the beams beneath the roadway. Also, because gravel with an inadequate grain size had been used during the original construction work, there was poor cohesion of the concrete to the substrate. During the survey, the technicians also found that the surface of the roadway had insufficient drainage.

The increase in stresses due to an increase in road traffic, which had not been calculated during the design phase of the structure, and a lack of sufficient maintenance over the years had done the rest.

On the facing page, at the bottom: details of damage of the concrete bridge. Notice the exposed, rusty reinforcement rods which were treated with Mapefer.

The first step was to clean all the surfaces to be treated using a high-pressure water washer. The deteriorated portions of concrete, or those in danger of detachment, were removed mechanically and the reinforcement rods which were in a poor condition were exposed.

The reinforcement rods were brushed to remove all traces of rust and loose parts, and were then treated with MAPEFER* two-component anti-corrosion mortar based on polymers in water dispersion. Once the MAPEFER* had dried, the areas of the structure where the damaged concrete had been removed were repaired using MAPEGROUT T40* thixotropic mortar. The final step was to finish off the surfaces by smoothing them over with MONOFINISH* one-component, normal-setting cementitious mortar.

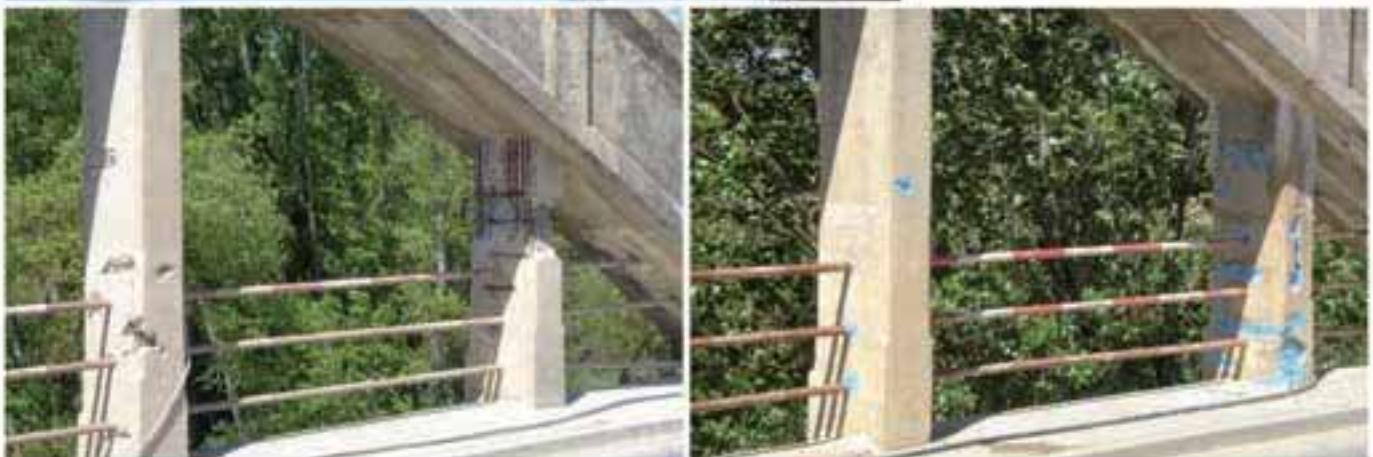
Below: after rebuilding the missing and removed portions, Elastocolor protective and decorative paint was applied on the entire surface of the bridge.

Once the repair work had been completed, the entire surface of the bridge was treated with ELASTOCOLOR PAINT* elastic paint. Apart from leaving the structure with an attractive, even coating, this paint waterproofs concrete surfaces and protects them against aggressive agents present in the atmosphere.

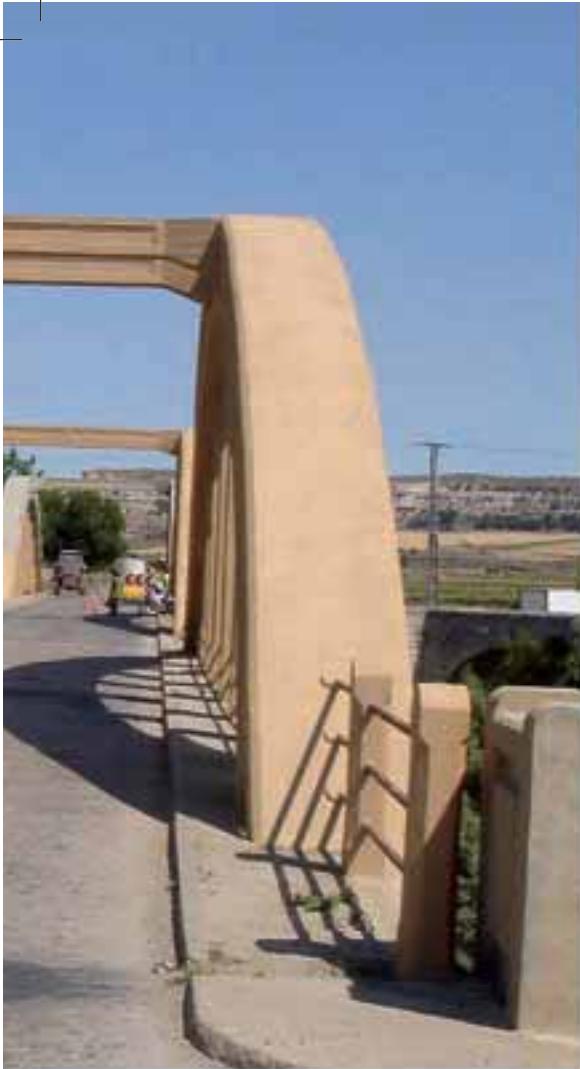
To the side: the bridge was reopened to traffic once the work was over.
