A LONGER LIFE FOR VIADUCTS

THE SAN SAVINO VIADUCT

THE ILDE VIADUCT

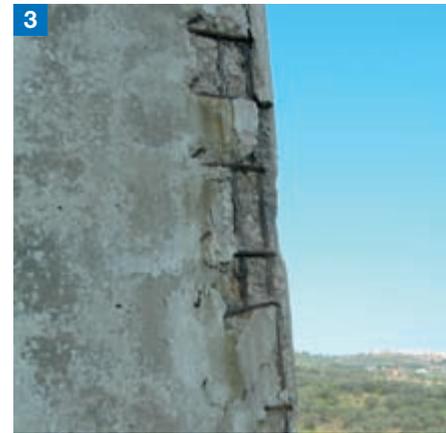
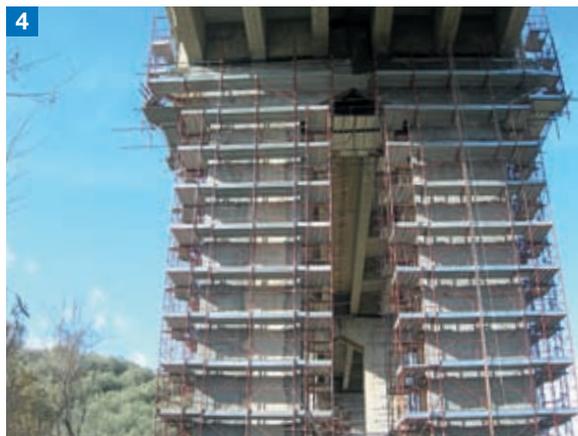
*Photos 2 and 3.
The bearing elements of the viaduct had problems of localised detached concrete, with the reinforcement rods exposed in some areas.*

The concrete used to make the piles had signs of localised scouring and was partially deteriorated.

The concrete cover was worn away by the rusty steel reinforcement, especially all around the corners and the bearing elements. After analysing the problems highlighted on the San Savino viaduct, repair operations were then carried out.

The first phase was to demolish the deteriorated surfaces by hydro-blasting, until all the deteriorated and carbonated concrete had been removed, including concrete in danger of becoming detached.

This operation completely exposed the reinforcement rods. Those which were particularly eroded or corroded were replaced.

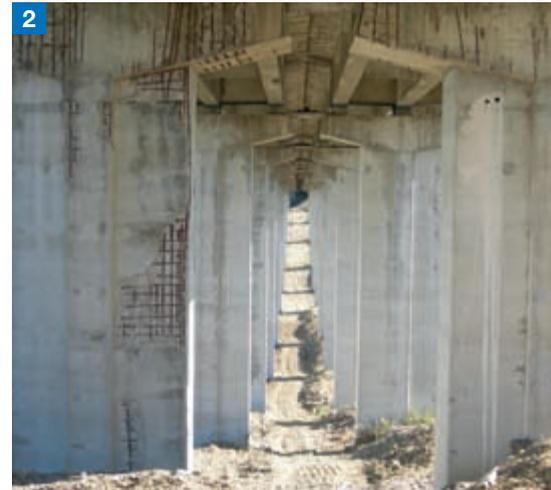
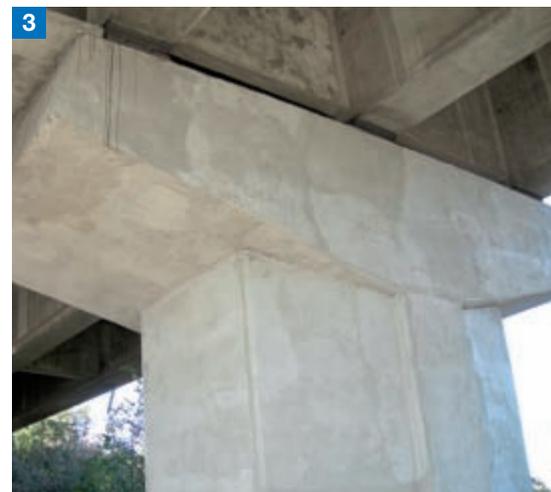
Photos 2 and 3.
Beams, piles and bearing elements of the viaduct had problems of localised detached concrete, with the reinforcement rods exposed in some areas. MAPEGROUT EASY FLOW GF mortar was used to rebuild areas where the concrete had been removed.

A number of areas in danger of concrete becoming detached from the root of some of the beams were found during the survey, which in some cases exposed the reinforcement rods.

riorated, and the reinforcement rods were exposed and oxidised.

The concrete used to make the piles had signs of localised scouring and was partially deteriorated, with parts of the concrete on the corners worn away exposing rusty steel reinforcement rods on the surfaces of the piles. With the repair work to the Ilde viaduct and to the San Savino viaduct carried out to the piles, edges abutments, pulvinoes, floor slabs and the head-pieces of the beams risen at a certain height, tubular scaffolding fixed at ground level was used.

As with the San Savino viaduct, the first operation was to demolish the deteriorated areas by hydro-blasting in order to remove all the concrete which was deteriorated, carbonated or in danger of detachment from the areas highlighted during the survey. Missing or particularly corroded reinforcement rods were replaced.

The deteriorated concrete was then rebuilt using MAPEGROUT EASY FLOW GF pre-packed, sulphate-resistant, mortar for repairing concrete structures. As before, the product was applied by spray and by hand in smaller areas, in various layers at a thickness of from 2 to 8 cm.
