## Repairing the Bamberger Railroad (Highway) Bridge

By Tom Lundgren, MAPEI CRS Representative

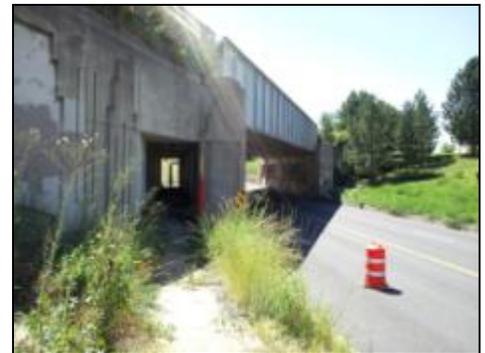
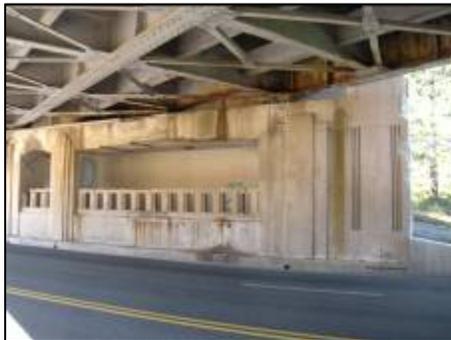
The Bamberger Bridge was constructed when bridges were designed to be aesthetic show pieces as well as functional structures. (Note the ornate stepped beams and the elaborate railing as evidence of the architectural values of the period.)

Over the years, the bridge had become structurally unsound due to water intrusion, freeze-thaw damage

and active corrosion cells in the concrete beams and columns.

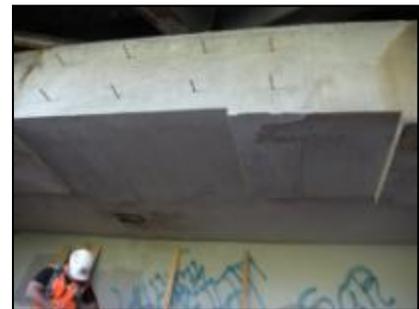
In all cases, when forms were stripped after three days of cure time, *Planitop* 15 had achieved 100% bond to the existing concrete structural elements and was effectively working homogeneously with the existing beam or column in carrying dynamic loads. It is important to note that the Gerber Construction crew and the UDOT inspector checked each repair for any defects and sounded them for hollow areas. There was not a single hollow area or honeycomb in the area filled by the 600 bags used in the repair.

While the *Planitop* 15 was curing, the Gerber crew took care of smaller repairs using *Planitop X* – a non-sag, fast-setting, ‘sculptable’ repair mortar.
