CONCRETE STRUCTURE RENOVATION  
IN THE SLAG DROP ZONE  
OF MITTAL STEEL PLANT IN CRACOW

DATE: 06-2011

INTERVENTION BY MAPEI: REPAIR AND STRENGTHENING WORKS OF CONCRETE STRUCTURE IN THE SLAG DROP ZONE (MITTAL STEEL)

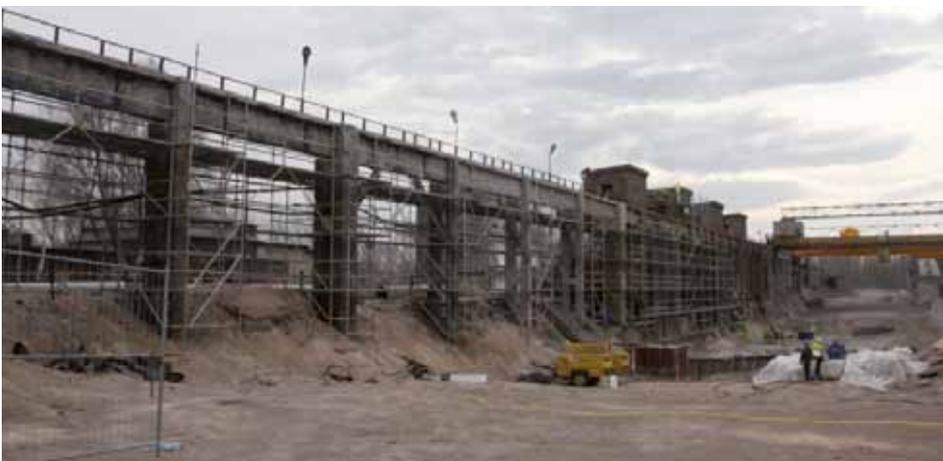
Photograph above represents the slaking slag process. During the slaking we have to face huge amounts of vapor and the installation's construction is therefore exposed to huge thermal shocks. It is based on concrete structure and developed with poles and crane beams and four commanding booths. During the use only temporary repairs of the construction elements were executed. Intensive exploitation, without extensive renovation led to construction's withdrawn from use in 2009, the decision was taken by the Bureau of Technical Inspection. The same year, the construction repair, renovation and protection works concept's elaboration was commenced. In the designing phase the Mapei Technical Assistance was asked to collaborate in the concrete structure renovation technology development. The first step was to execute an adequate inventory of damages and construction's technical condition. The construction was divided to two load zones, depending on the influence of temperatures fluctuation and on conditions in which it has to operate. In the zone I, the machines with permanent contact with vapor, released during the slaking found their place. The damages in this case were major.

The concrete structure in the slag drop zone.

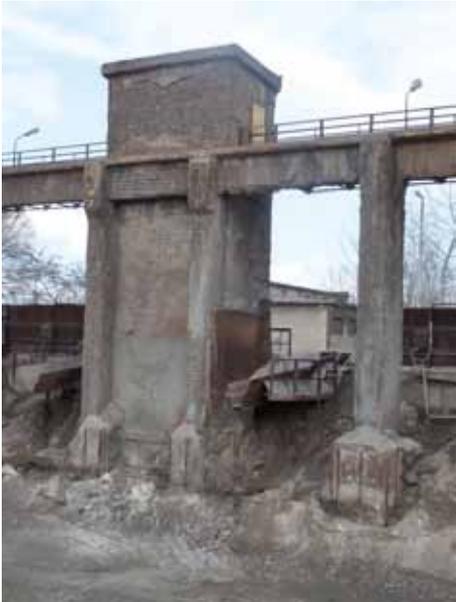
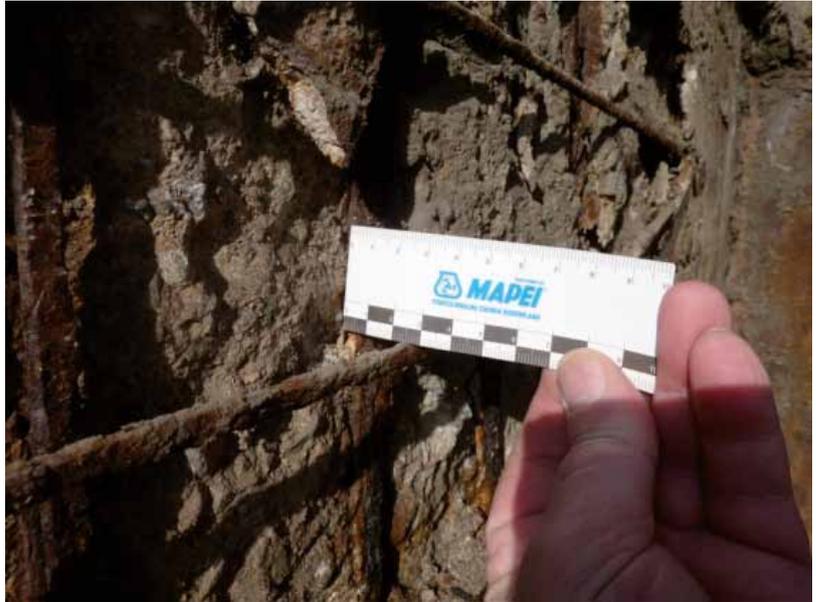
**Zone I.** Concrete degradation in the slaking slag construction installation.

Meanwhile, in zone I for larger construction cavities re-profilation, a repair mortar for spraying application (MAPEGROUT GUNITE) was suggested, whereas for local defects, similarly to zone I, a thixotropic repairing mortar (MAPEGROUT 430). Furthermore, in the direct fluctuate temperature and vapor impact zone, it was implied to create a reinforcing and protective layer from alkali-resistant fiberglass and protective mesh (MAPEGRID G220), immersed in a two-component cementitious and polymer base repair mortar (PLANITOP HDM). This technology was applied in the commanding booths and crane beams between them. This solution has for its scope raising the level of construction resistance and protection, in regards to the temperature variations during its use.

The alkali-resistant fiberglass mess immersed in the mineral mortar, thanks to its perfect adherence to the substrate, provokes the increase of resistance to brittle cracking, redistributes tensions, ensures durability and resistance to fluctuating temperatures.

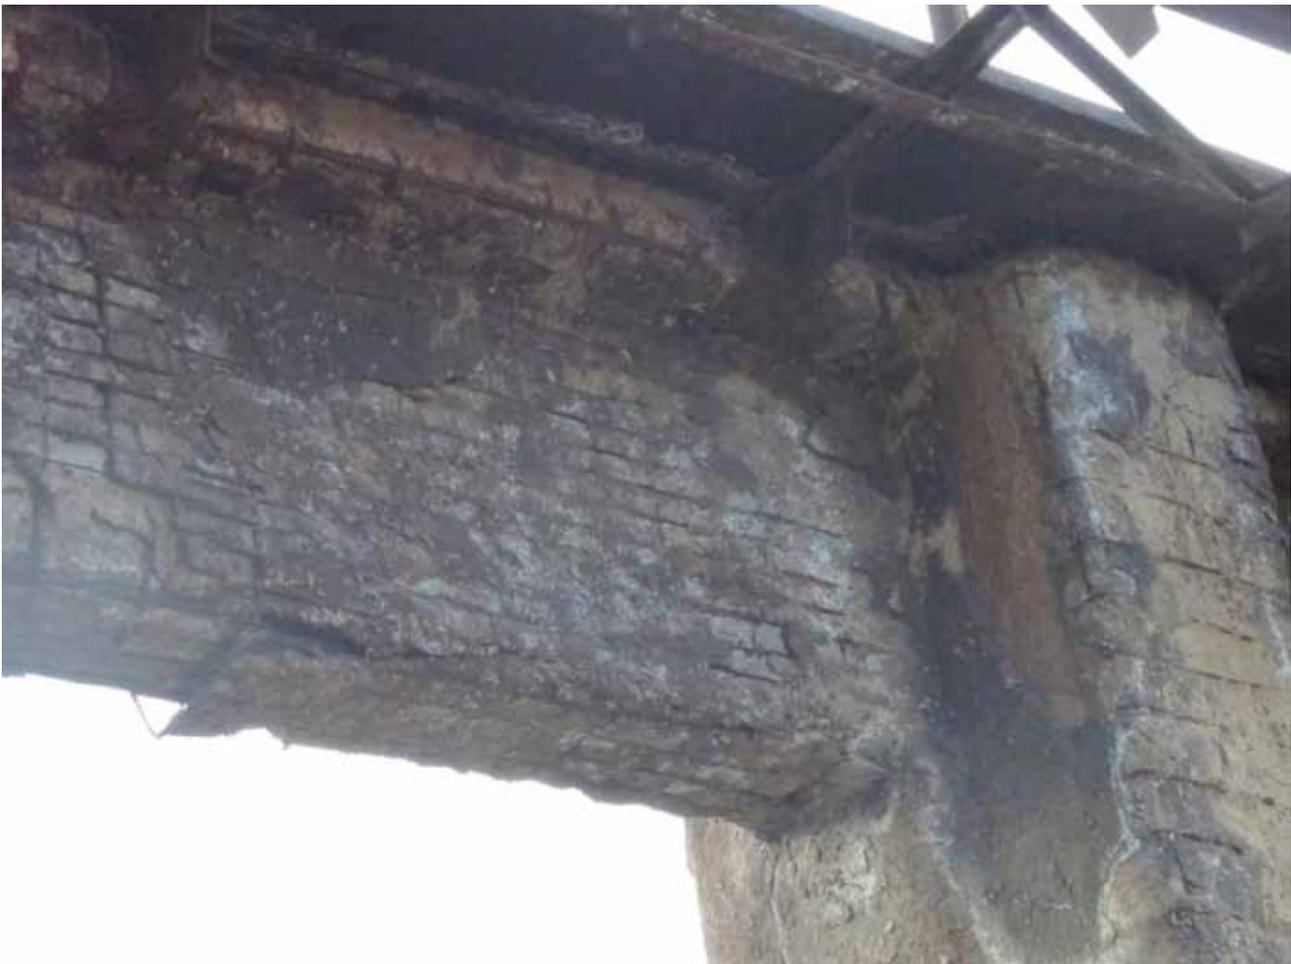
**Zone I.** Crane beams degradation.

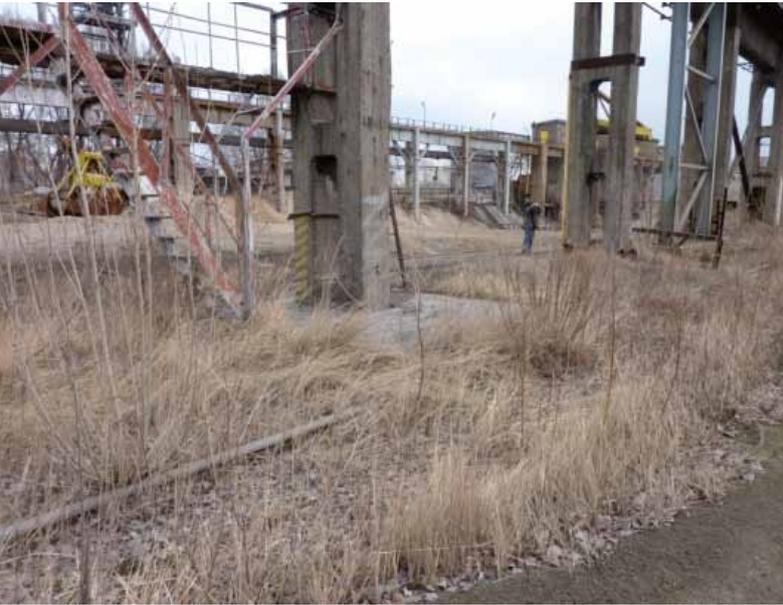
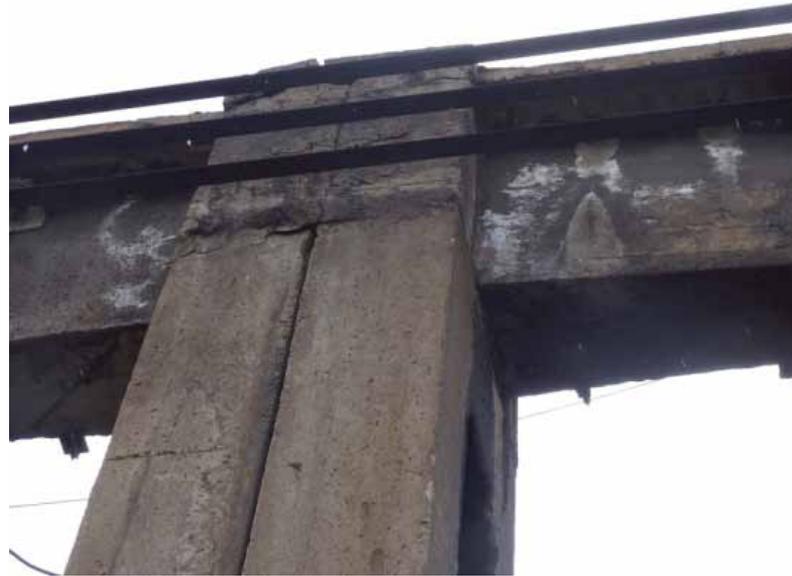
The zone II included beams and poles from the other side of the container. The damages were absolutely minor, because the aggressive agents influence was limited in comparison to the zone I.

The panorama of the zone II elements before renovation.

In the zone II, for repairs and filling major defects a R3 class thixotropic repairing mortar was proposed (MAPEGROUT 430), whereas for smoothing the surface a fine-grained cementitious-polymer mortar (MONOFINISH) with hydraulic shrinkage reducing admix (MAPECURE SRA) was suggested. This product was selected mainly because of the repair works conditions and mortars' protection, which was difficult to ensure on the building site. Despite the adequate composition of the offered mortars, an additional protection from shrinkage cracks was chosen, supported by the Producer and the Technical Assistance. Therefore, afterwards, an acrylic paint protective coating was executed.

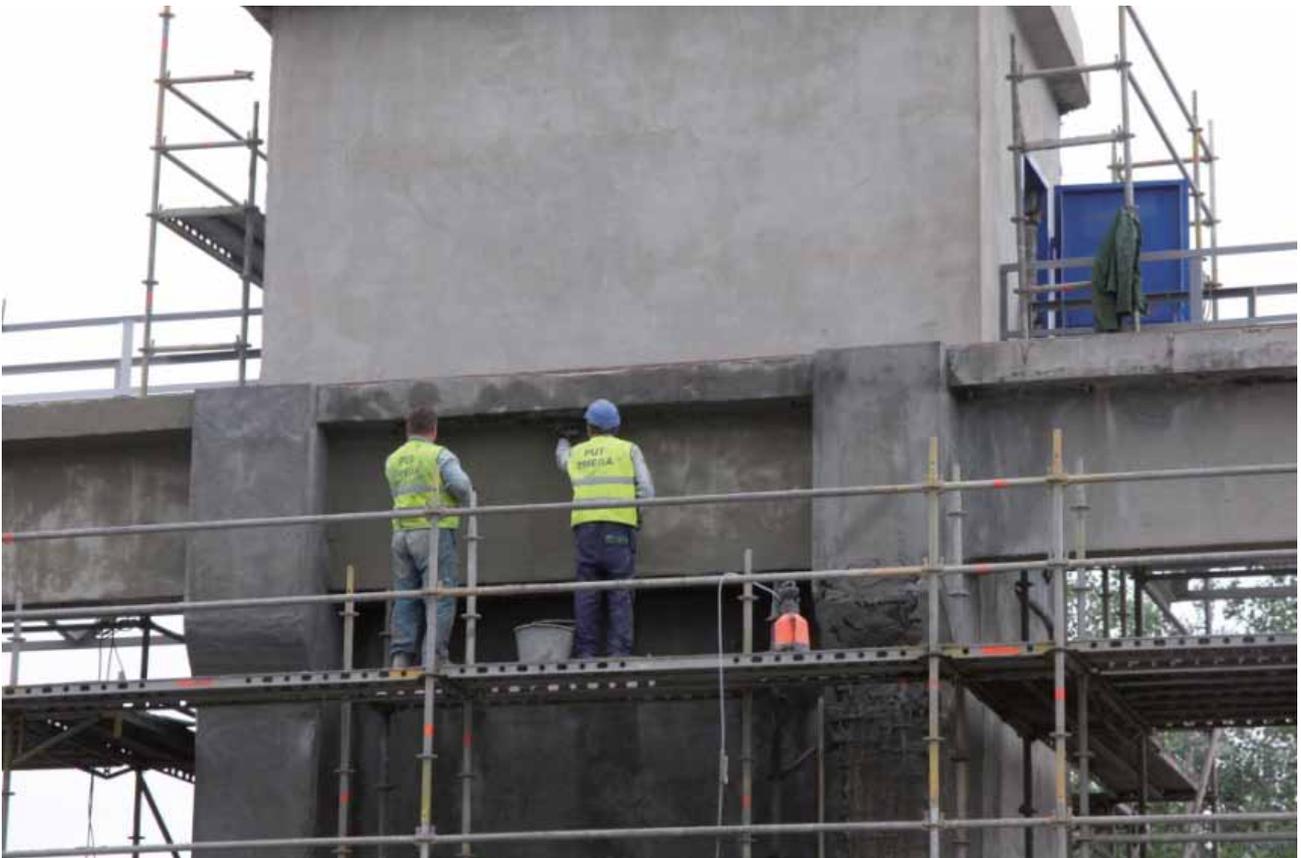
Repair works in the slag drop zone construction.

In March of 2010 the contractor companies initiated the repair works according to the suggested technology. The first step was stream oriented and abrasive cleaning of the whole construction and afterwards a hydrodynamic one. Because of high temperatures and sun exposition, the contractors decided to make a good use of the hydraulic shrinkage reducing admix (MAPECURE SRA), which allowed to eliminate the post application mortars protection. The re-profilation of the heavy load zones construction was followed by the fiberglass mesh and two-component system.

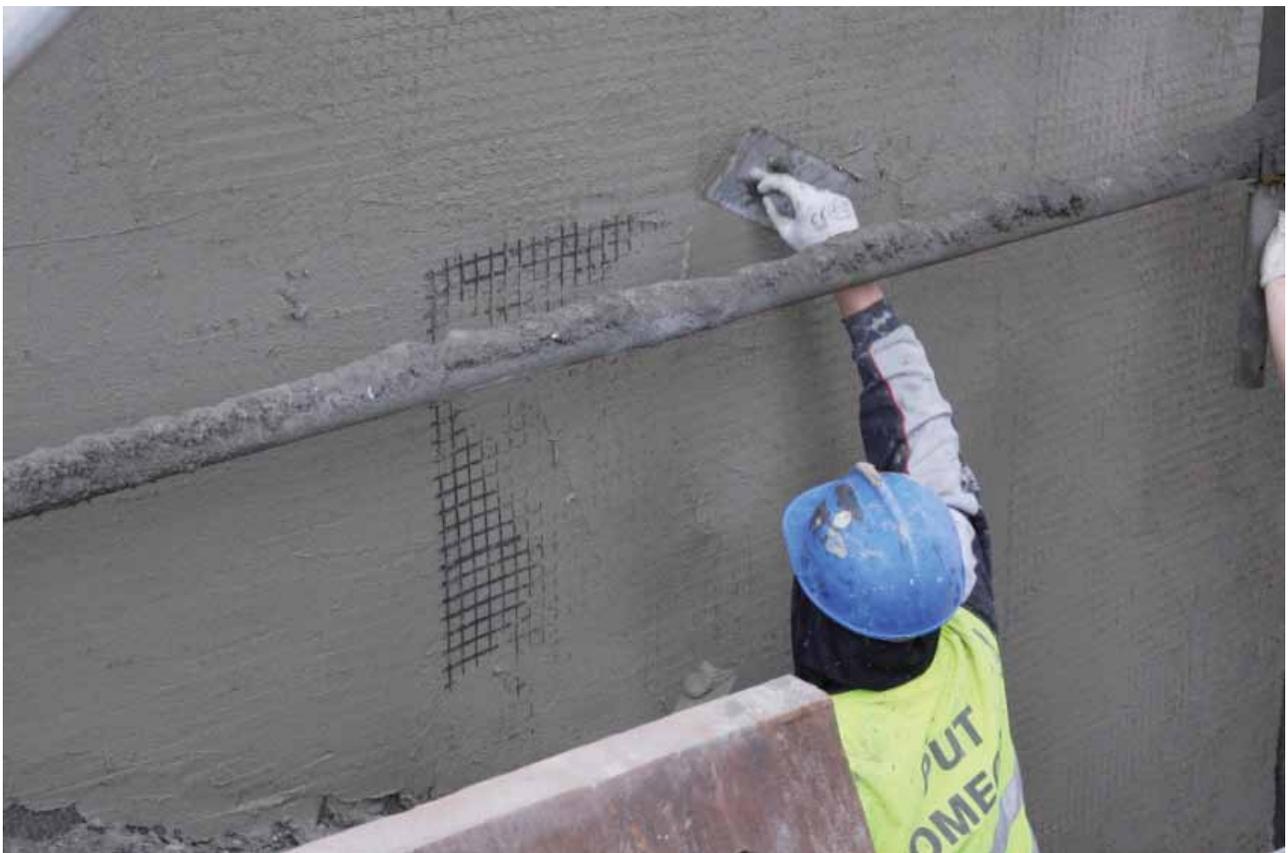
Immerging the alkali-resistant mesh in the cementitious-polymer mortar.

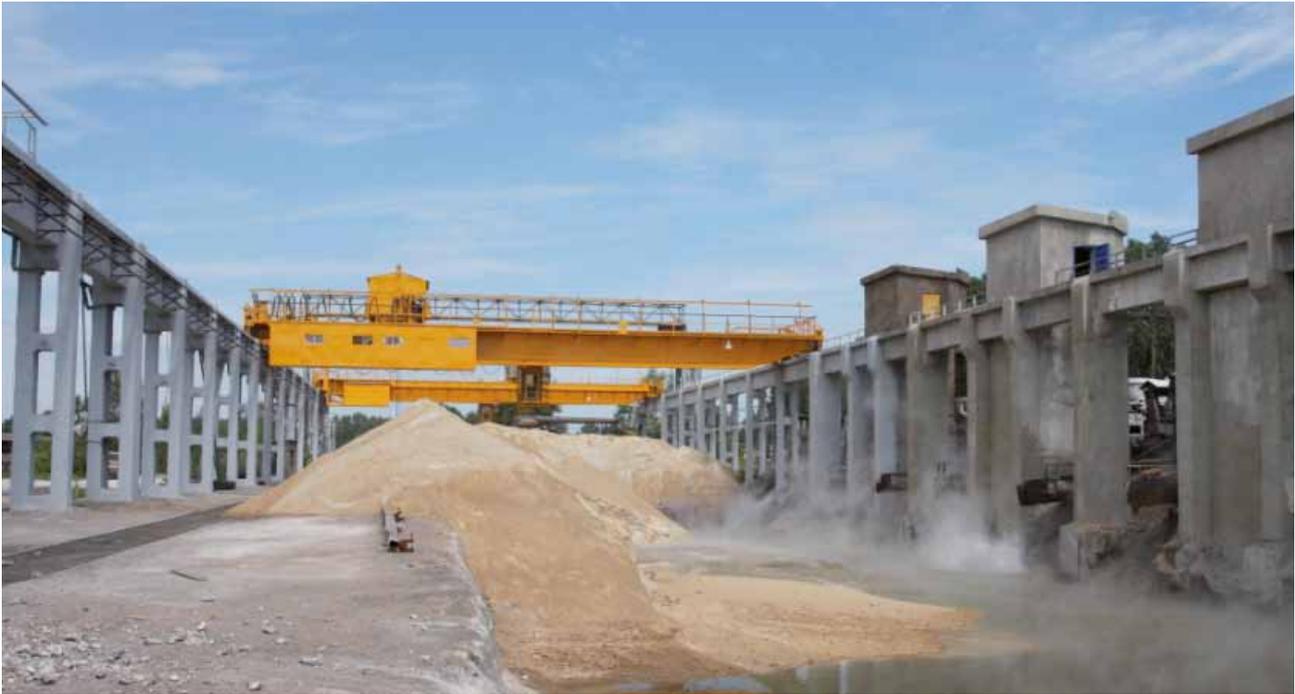
The sight of the slag drop zone construction after renovation.

Nowadays, after the executed repair works, the surface of construction's concrete elements is homogeneous, impermeable, crack and flaw-free.

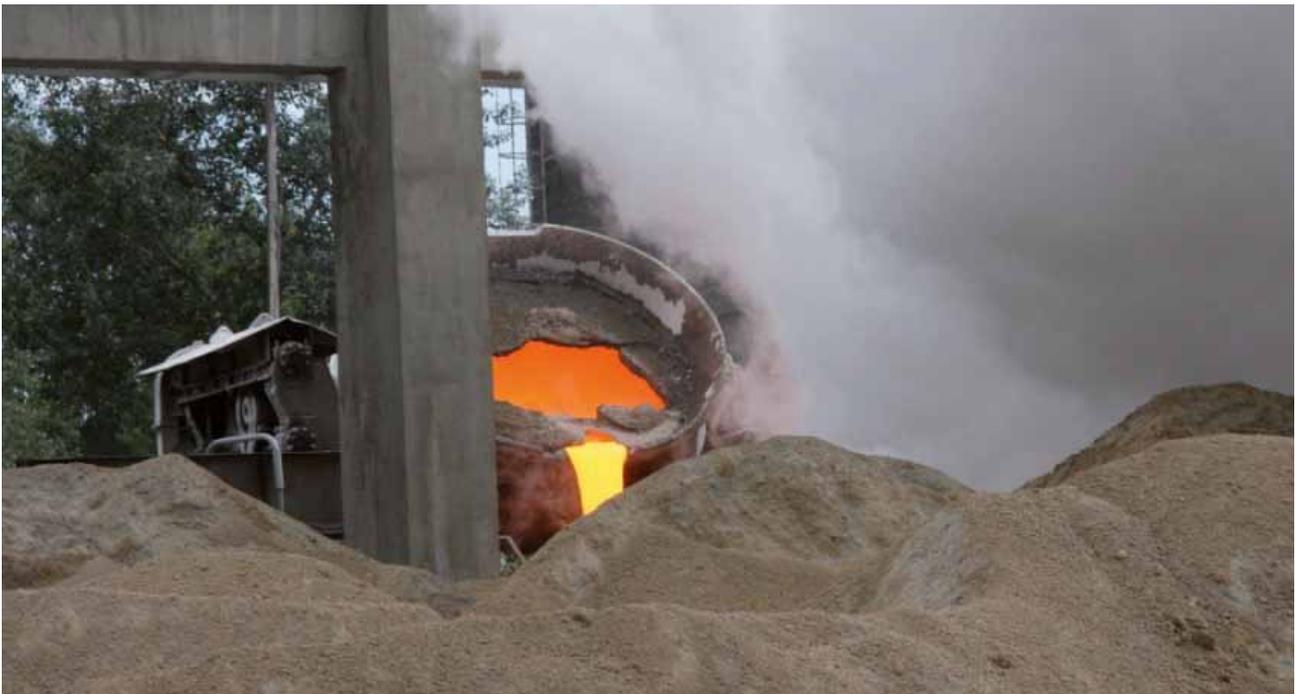
The detail of the slag drop zone construction after renovation.
