RESTORING THE

Diagnostics, Materials Preservation and Restoration Strategies.

by Luigi Coppola, Paolo Banfo, Tiziano Cerulli, Paola Di Silvestro and Paolo Giglio, Mapei S.p.A.

PIRELLI BUILDING

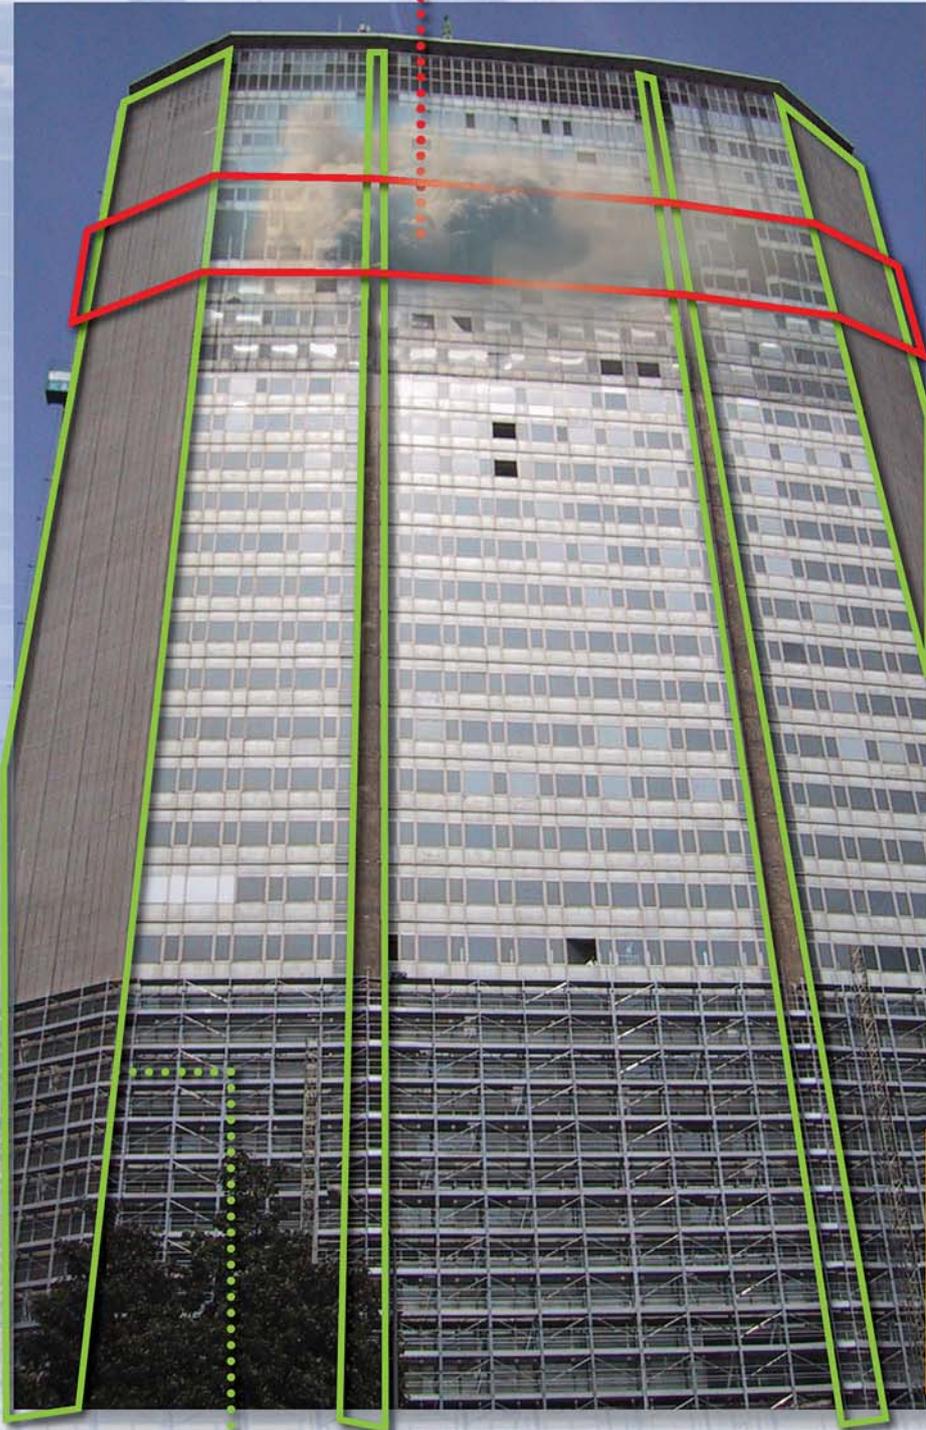
The Pirelli building façade after the crash on 18 April 2002.

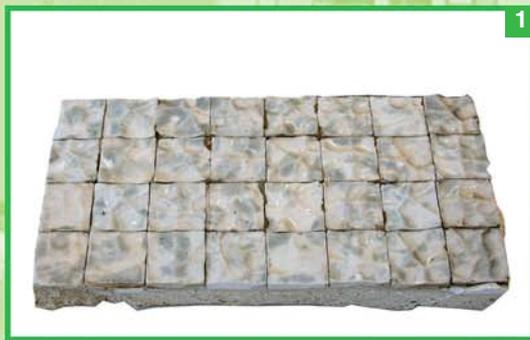
Photo 1. Macro photo of the covering tiles drawn from the Pirelli Building.

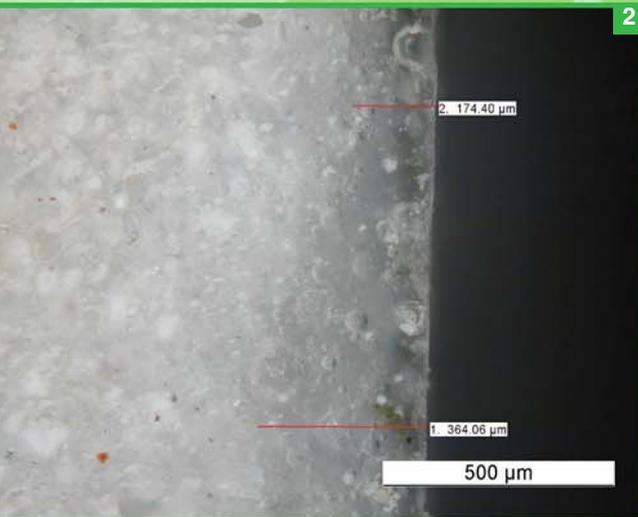
Photo 2. Section of a tile with measurements of the surface layer thickness: the thickness varies from about 100 to about 400 µm.

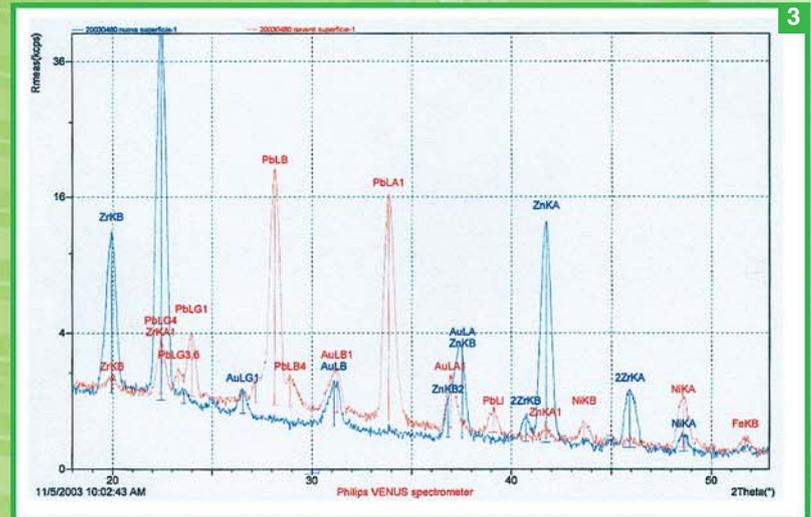
Photo 3. Comparison between the XRF spectra of the surface of an original tile of the Pirelli building (red) and of a Malaysian manufactured one (blue).

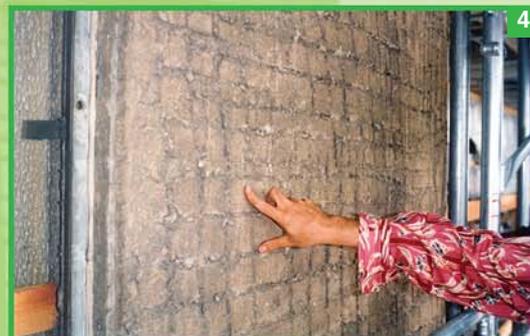
- 1) the complete detachment of the installation mortar and, therefore, of the glass covering leaving the levelling concrete visible (photo 4);
- 2) the detachment of only the mosaic tiles from the surface paste;
- 3) the partial detachment of the installation mortar from the underlying levelling concrete without the collapse of the glass mosaic covering (photo 5).

Photo 4. Complete detachment of the installation mortar and, therefore, of the glass covering leaving the levelling concrete visible.

weak point of the system was represented, in nearly all cases, by the interface between mortar and levelling concrete.

To solve, on the other hand, the type of façade damage characterised by the complete detachment of the installation mortar from the levelling concrete, the decision was made to obtain a cement coat, using NIVOPLAN* mixed with water and 2 kg of PLANICRETE* per bag, levelling mortar for walls with high adhesion to supports (adhesion values > 2.5 N/mm after 28 days) and high flexural strength (8 N/mm²), to reduce the risk of cracking and modulus of elasticity coefficient approaching that of the coatings normally used in façades.

The new mosaic tiles were then laid using KERAQUICK* mixed with LATEX PLUS* diluted 1:1 with water, high performance slip-resistant improved fast setting, highly deformable, cementitious adhesive, classified as C2FT according to EN 12004 and S2 according to EN 12002.

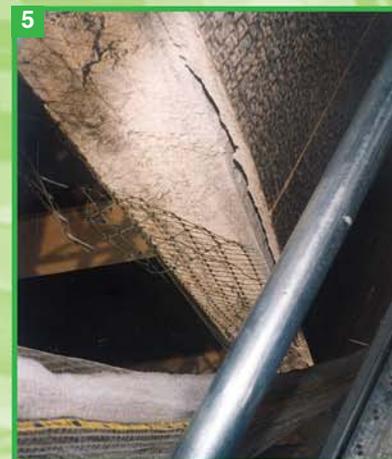
In some areas, this last type of damage was found to have gaps in the order of one tenth of a millimetre, while in other situations, instead, the detachment was so accentuated that, even without exhibiting the collapse of the mosaic covering, it had centimetre-thick gaps between the installation mortar and the levelling concrete. With the exception of some local situations, in no case was the following found:

Photo 5. Partial detachment of the installation mortar from the underlying levelling concrete without the collapse of the glass mosaic.

To determine the restoration technique to eliminate the most common type of damage (partial detachment of the installation mortar without the collapse of the glass mosaic covering), on site tests were conducted, entailing the injection of EPOJET LV*, an epoxy system with very low viscosity (140 mPa·s), in two zones called ZONE A and ZONE B.

As a result of these preliminary test, the epoxy resin injection system was selected to restore the entire façade of the building, in those areas where the problem of the detachment of the installation mortar from the levelling concrete was prevalent.

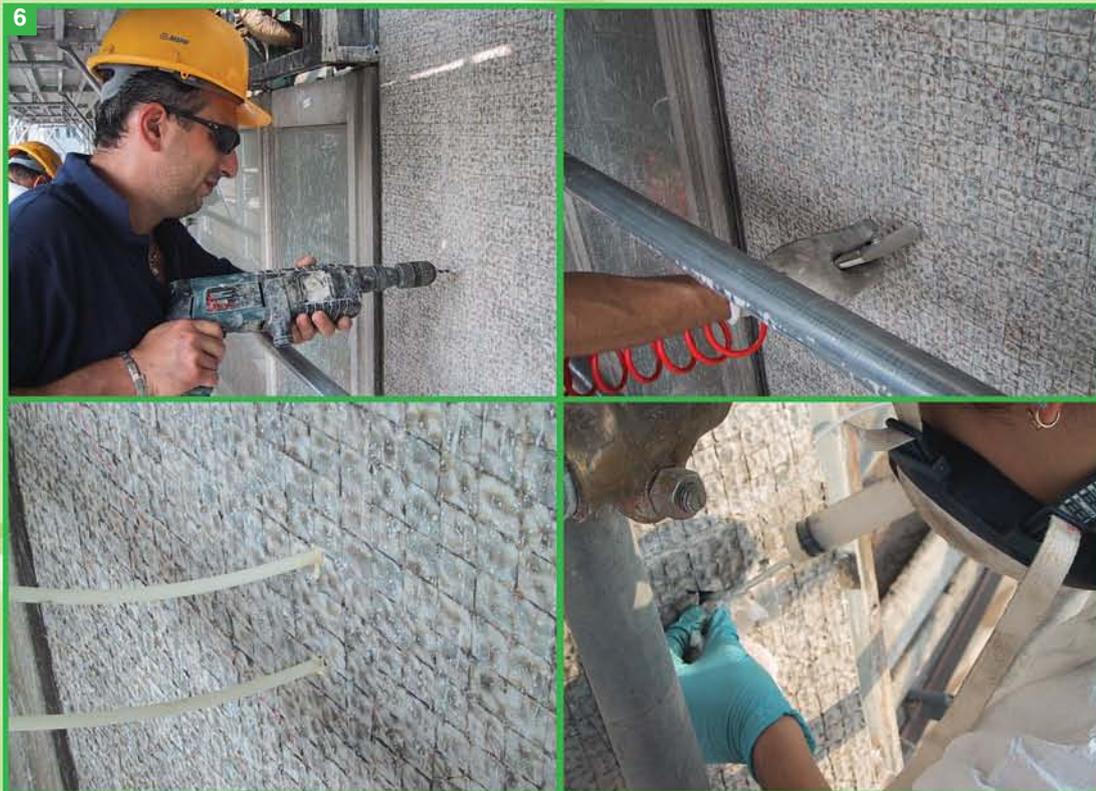
Photo 6. Injection of Epojet LV epoxy resin. Drilling the injection holes (diameter of the holes: 10 mm; depth: 30 mm) in order to intercept the gap between the installation mortar and the levelling concrete. Cleaning the holes with compressed air. Positioning the injection tube and the monitor tube into the holes. Injecting epoxy resin.

The injection work was performed with double membrane pneumatic motor pump, with a maximum pressure of 8 bar and a capacity of 5 litres/min (in small detached areas, injections were made with a syringe), and it comprised the following steps (photo 6):

1. drilling two 10 mm diameter holes to a depth of more than 3 cm, in order to intercept the gap between *installation mortar and levelling concrete*;
2. cleaning the holes with compressed air at the pressure of 7-8 bar;
3. inserting the injection tube and the monitor tube into the holes to a depth of about 1 cm, sealing with EPORIB TURBO*, fast-hardening two-component polyester resin;
4. injection of compressed air at a pressure of 4-5 bar to ascertain whether the injection circuit was fully open between the two holes;
5. mixing the two components of the EPOJET LV*, a low-viscosity epoxy resin and injecting it into the bottom tube until it flowed out of the monitor tube in the top part, at a pressure of 0.5 - 2.5 bar.

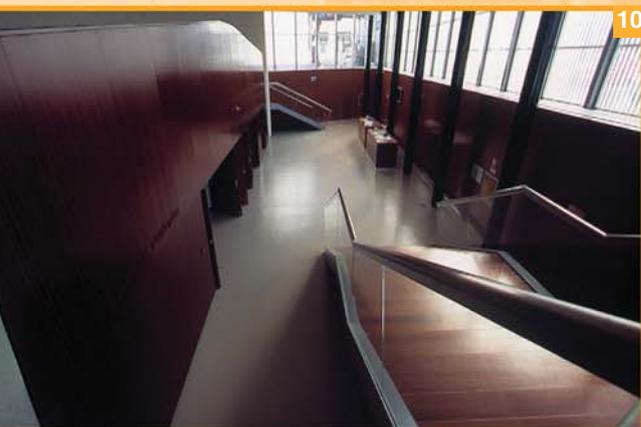
10

Photo 10.
Laying Carrara marble
with white Keraquick.

the high rate of hydration of the binder which it contains allows the moisture content in the adhesive to be limited to a value which avoids promoting the formation of spots on the plates of the stone material laid (photo 10).

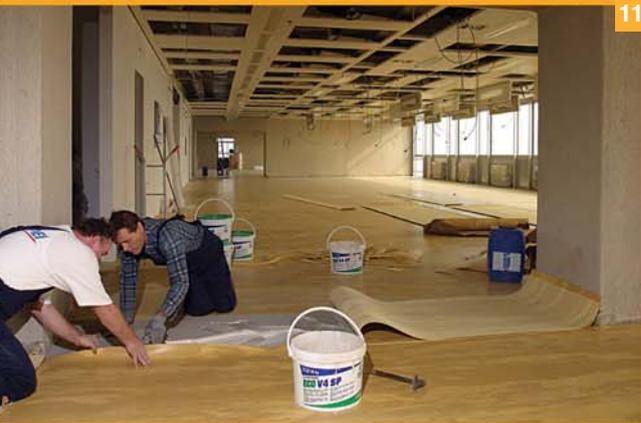
11

Photo 11.
Installation of linoleum
floors with Ultrabond
ECO V4SP

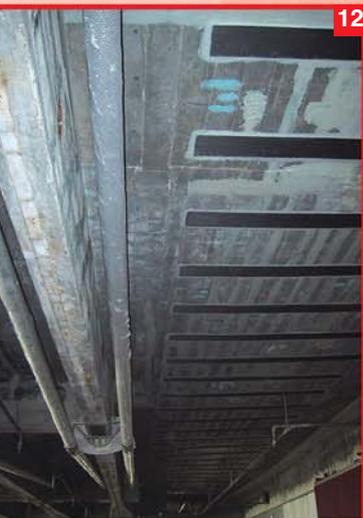
12

Photo 12.
Detail of the post-tension
cables and of the
reinforcement of the floor
slab with Carboplate
E170/50.

As a result of the impact, the engine of the aircraft detached from the fuselage, exiting from the facade of via Fabio Filzi, and the two fuel tanks, located near the wings, exploded. Consequently, a breach opened in the facade and a fire started, with a highly visible column of smoke billowing from the building. After penetrating the façade of the building in Piazza Duca D'Aosta, the aircraft, which had already slowed down due to the impact against the façade, stopped its motion with the impact of the wings against the machinery spaces. On the floor of the 26th storey, there were no substantial damages. However, the shock wave caused by the overpressure generated inside the building, initiated by the fuel tank explosion, caused highly visible downward deformations in the 26th floor frames and upward deformation in the 27th floor frames.

The restoration project therefore entailed the static repair of the beams of the central area of the 26th and 27th floor frames, damaged as a result of the aircraft impact. Given the sizable deformation, the first step was to realign the frame by "forcing" it, in a controlled manner. Subsequently, after rebuilding the damaged sections and sealing the gaps, the damaged structures were returned to their original load-bearing capacity, by a combined action produced by post-tensioned external cables and plating the bottom face of the girders and of parts of the floor with carbon fibre reinforced plastic CFRP (photo 12).

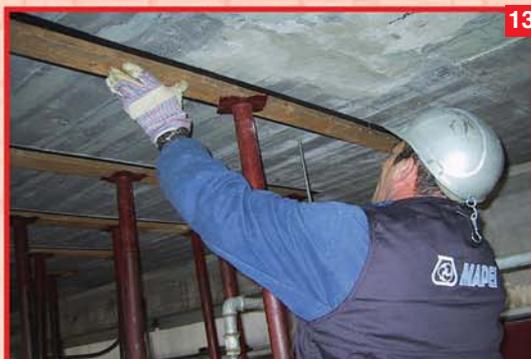
13

Photo 13.
Reinforcing the floor slab.

5. laying the pultruded carbon fibre laminas CARBOPLATE E170/50* (photo 13) exerting a constant pressure on its whole length with a rigid rubber roller and eliminating excess resin with a spatula;
