The Abbey of Tiglieto

Italy's first Cistercian settlement has been subject to careful architectural restoration which had been carried out respecting the appearance of the original building.

Abbey of Santa Maria di Tiglieto - Tiglieto (Genoa, Italy)

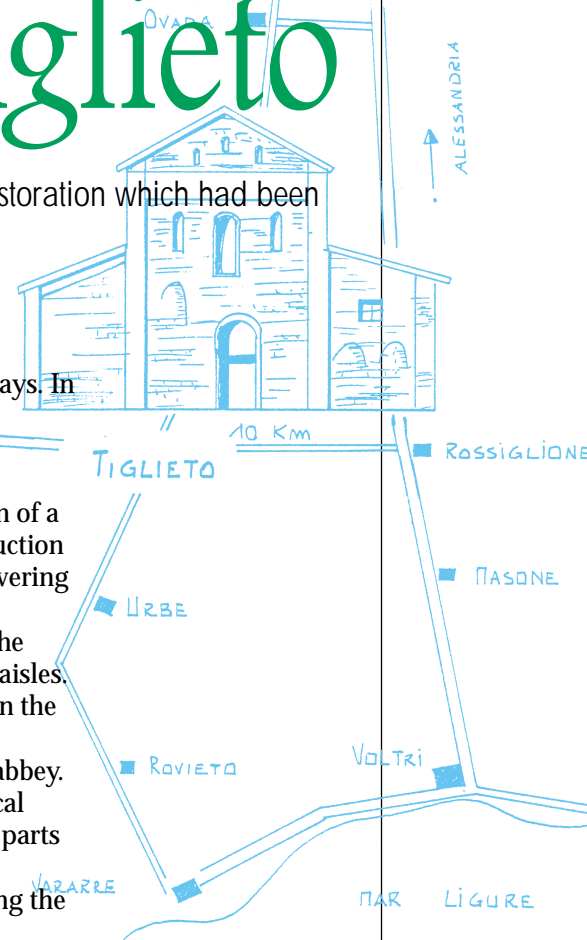
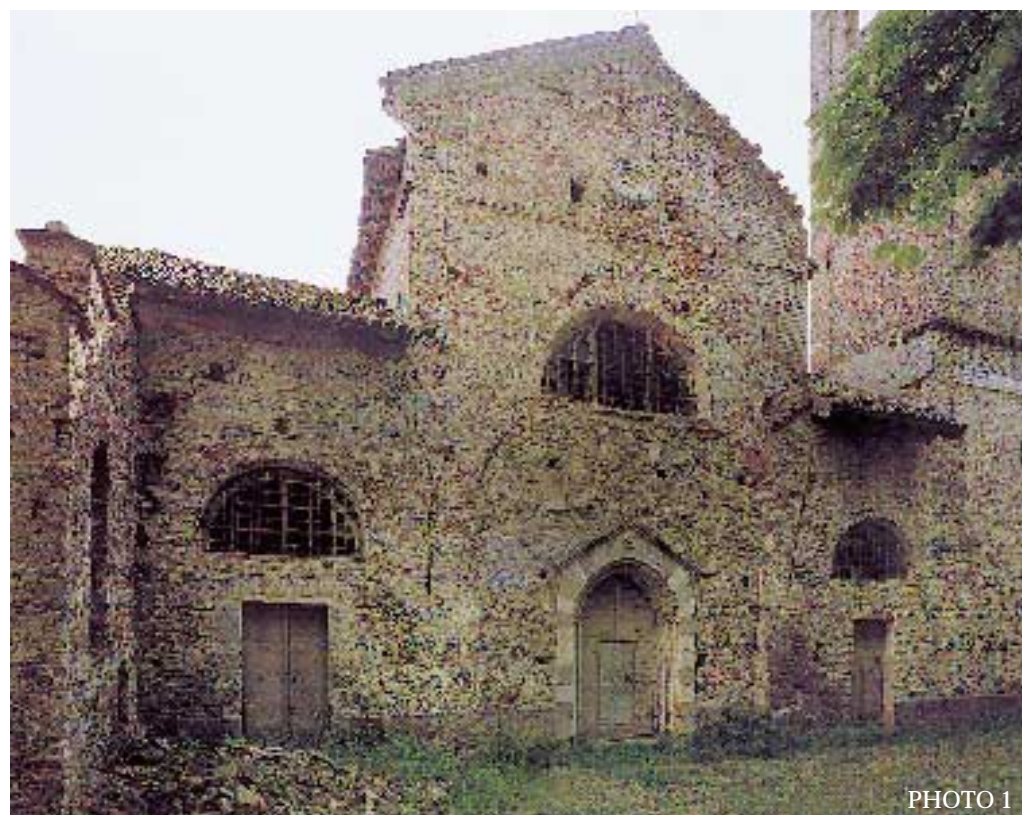
PHOTO 1

during the course of the centuries, the structural stability of the construction has been completely altered, weakening some parts, introducing pressure and greater stress on others while, at the same time, reducing or removing structural links between various masonry elements (photo 1). In other words the architects were faced with a series of disconnected elements that could not support each other's loads and thrusts or withstand possible subsidence in the foundations.

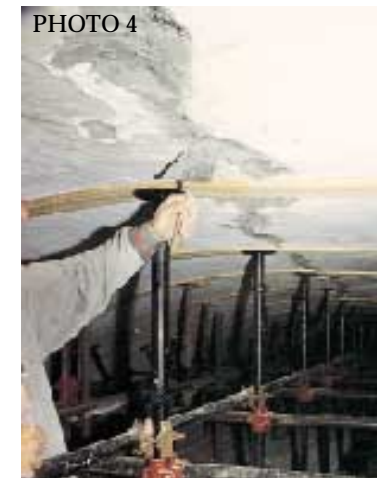
PHOTO 4

The construction of a cover over the extrados required a series of highly sophisticated technical approaches. First of all, after having erected a structural steel scaffolding above and below the nave able to support its whole weight (photos 3 and 4), the cracks in the vault were sealed. MAPEANTIQUE MC, a pre-mixed sulphate-resistant mortar for the restoration of historic buildings was used to repair the cracks from the intrados of the vault. The extrados was then thoroughly cleaned using compressed air (photo 5). The new shell was then constructed over it and supported by beams using the side walls that had already been reinforced.

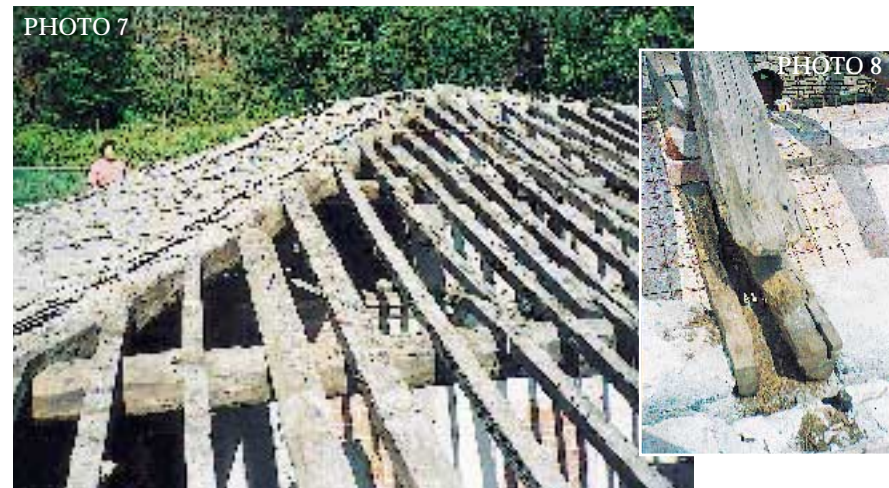
laggings, 18x36x2.5 cm tiling similar to the original scandola oak or chestnut tiles. Before restoration, the roofing was in an advanced stage of deterioration.

The pitches had numerous cracks where water and snow penetrated causing further damage to the already precarious structure. The massive wooden frame of the roof composed of chestnut truss and beams was also

seriously damaged (photo 7 and 8).

The temporary removal of the wooden roofing was necessary for the reconstruction of the vault. This revealed the state of conservation of the trusses. Since some of the trusses were either rotten or missing, the Project Managers decided to reconstruct or insert new sections where required to recreate the original geometrical form of the roof (photo 9).

After verifying the compatibility with the wood, EPORIP was poured into a mould around the trusses and reinforced with stainless steel. The trusses were then covered with a roof similar to the original.
