THE MIRACLE OF ASSISI

THE BASILICA AND MONASTERY OF ST. FRANCIS IN ASSISI

Restored after the earthquakes of September-October 1997

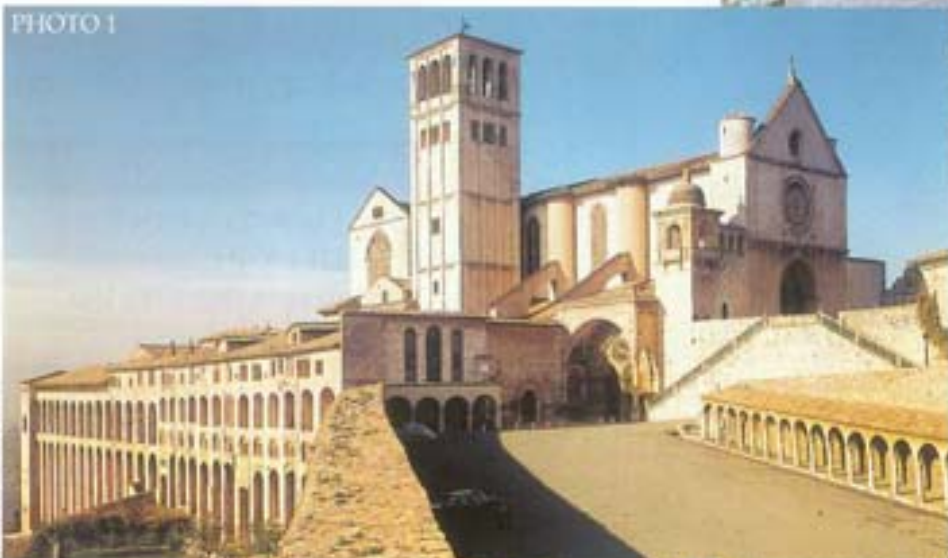
PHOTO 1

There was a story already going around in the twelfth century that St. Francis himself had pointed out the exact spot where he wanted to be buried. It was there that the church housing his remains would eventually be built, along with a monastery for his fellow monks. Situated "in quondam voragine", on the high cliff that now, as then, forms the northwest side of the hill-town of Assisi, the Franciscan complex is built on a site whose distinct topography is determined by the steep incline of the slope. The place was notorious because from time immemorial criminals were tortured and put to death on the gallows there, earning it the name of "The Hill of Hell". Erected in the first half of the 13th century, the monumental complex of St. Francis consists of the two Basilicas, oriented on an east - west axis, and the Monastery which encloses the body of the church for almost its whole length (Photo 1).

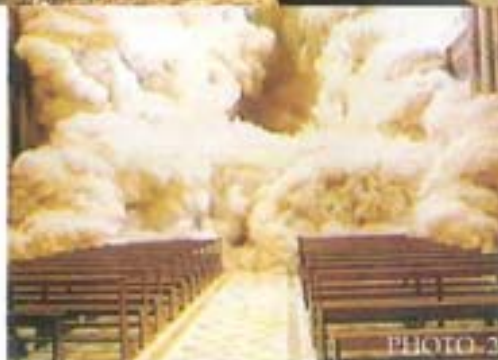
PHOTO 2

September 26th. We were able to see live on television not only the tragedy of those left homeless by the quakes but also the collapse of the vaulting in the Upper Basilica (Photo 2), making it once again the Hill of Hell. Government Commissioner Antonio Paolucci implemented a plan for assessing the damage caused by the

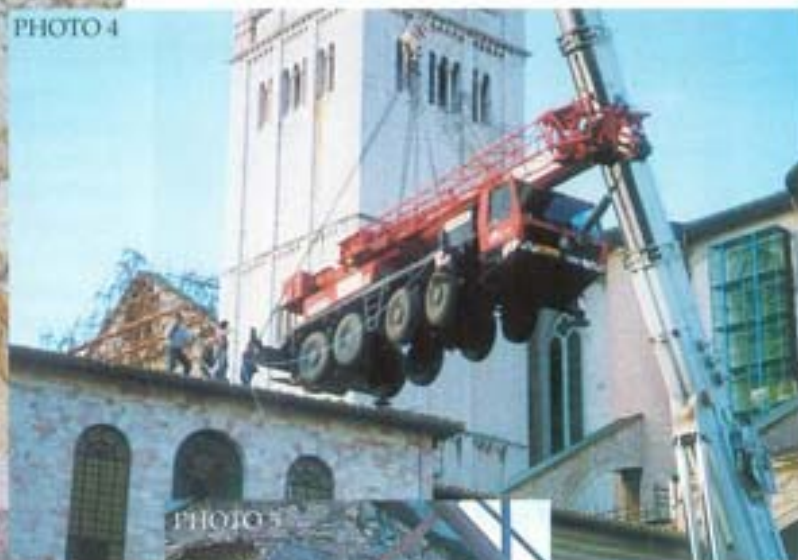
PHOTO 4

The first problem to be tackled was preventing the collapse of the gable at all costs. Since it weighed between 70 and 100 tons, the consequences could have been deadly if the gable had fallen through the roof of the Basilica. This triangular piece of stone was by now little more than a shell, with certain sections that had previously measured 80 cm reduced to a mere 20 cm, and pockmarked and eroded from the recent pelting rain (Photo 3). At this point the gable could not have withstood further shocks and might have collapsed with the slightest movement. On October 14 at 11:40 a.m. the desperately needed repairs were begun. The crew knew that the gable could not be shored up from below without risking lives, so with the help of a crane with an arm 50 meters long, they placed an enormous steel-skeleton frame of mesh and tubing over the gable to prevent it from collapsing (Photo 4). The operation was not successful,

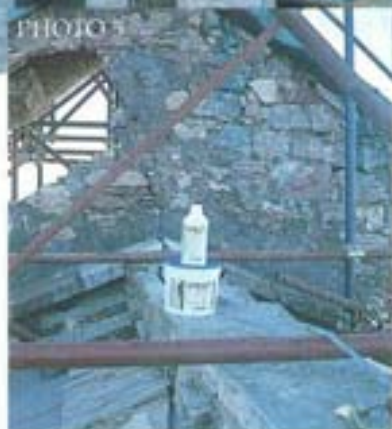
PHOTO 3

earthquake so that immediate action could be taken to eliminate hazardous conditions and prevent further destruction of the artistic heritage. To do so he needed the help of the latest and most sophisticated technology in a perilous race against time. Ongoing sussultory and undulatory vibrations continued to traumatize many areas of the Franciscan complex, severely weakening its stability. With the clock ticking and fearing more after-shocks, technicians began the most pressing work needed to prevent the collapse of the gable of the left transept and the vaulting of the Upper Basilica, with its frescoes by Giotto and Cimabue.

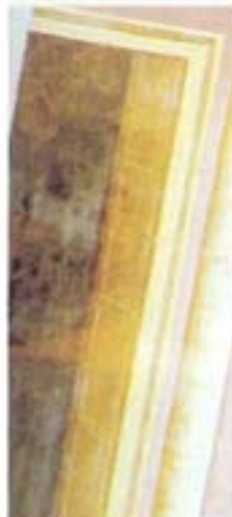
PHOTO 17

the Committee for the Restoration of the Basilica Complex of St. Francis in Assisi, the collapse of the vaulting was caused for the most part by the enormous amount of filler material that had accumulated over the centuries at the juncture of the springers and reins of the vaults, i.e. along the side walls. During the earthquake this loose material exerted very high pressure alternately on either side of the vaulting, causing it to bend tremendously, while making the vaulting and the ribs which support it lose their curvature. To prevent the collapse of the entire structure this accumulated material, weighing 1000 tons, had to be removed. Then the cracks along the entire length of the vaulting had to be repaired, using a binder that had high mechanical strength, yet was similar to mortars used at the time the Basilica was built. Repair of the "period" lime mortar that had been pulverized was done with MAPE-ANTIQUE MC, a light colored dehumidifying mortar for period buildings that possesses the same physio-mechanical characteristics of porosity and vapor permeability as antique mortars based on lime and pozzolan (Photos 17 and 18). Based on special hydraulic binders and natural sand, MAPE-
