THE CHURCH OF SAN JERÓNIMO IN BAZA, SPAIN

SERIOUSLY DAMAGED AFTER YEARS OF NEGLECT, THE CHURCH NAMED AFTER SAN GIROLAMO REQUIRED CONSOLIDATION AND RENOVATION WORK

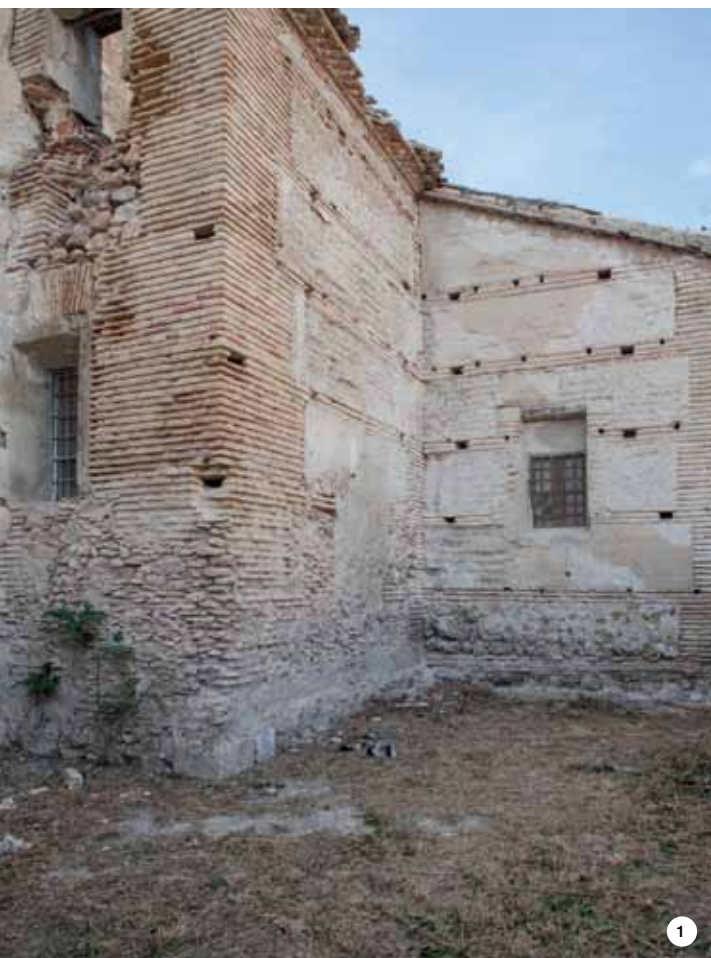
1

PHOTO 1. The external masonry walls at the start of the intervention.

This intervention commenced with the removal of the old, loose stones and a thorough clean of the walls. After drilling holes for the MAPEROD G pultruded bars and the MAPE-ANTIQUÉ I binder to consolidate the vertical surfaces, the next phase was to replace the damaged or missing stones and to consolidate and point the existing stones, again with MAPE-ANTIQUÉ I.

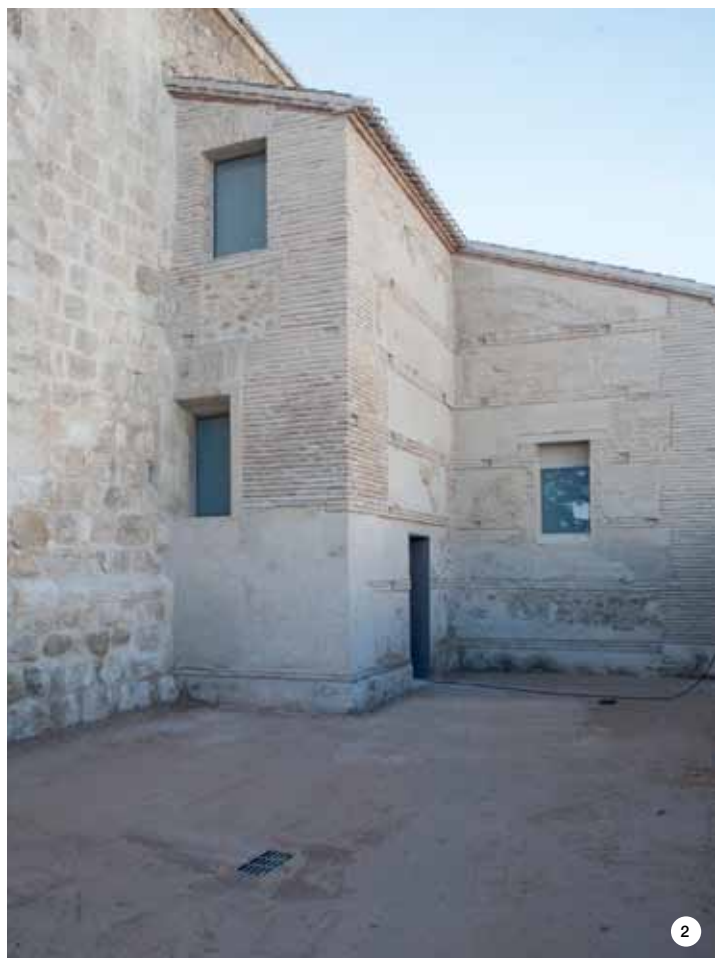
2

PHOTO 2. The same walls after being consolidated with MAPE-ANTIQUE I and repaired with MAPE-ANTIQUE STRUTTURALE NHL mortar.

To repair the render on the walls, it was recommended to apply MAPE-ANTIQUÉ STRUTTURALE NHL high-performance, transpirant, cement-free mortar for render and masonry work, made from natural hydraulic lime and Eco-Pozzolan. This product is particularly recommended for making "reinforced"

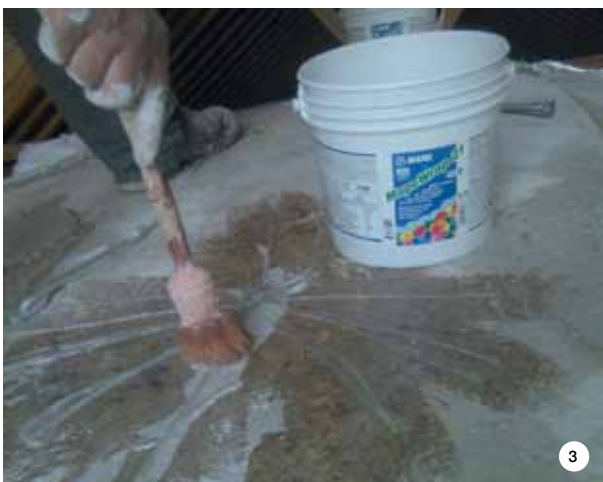
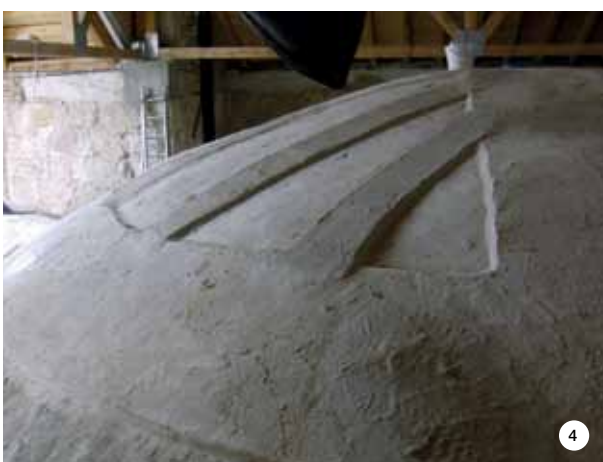
PHOTOS 3 and 4. The MAPEWRAP System was used to consolidate and strengthen the extrados of the cross-shaped vaulted roof.

After cleaning and removing the damaged decorative elements, Mapei technicians recommended anchoring the perimeter walls to the vaulted roof with MAPEWRAP G FIOCCO glass fibre cords impregnated with MAPEWRAP 21 two-component, super-fluid epoxy resin. MAPE-ANTIQUE I lime and Eco-Pozzolan-based, hydraulic binder was then applied by injection to seal the cracks, gaps

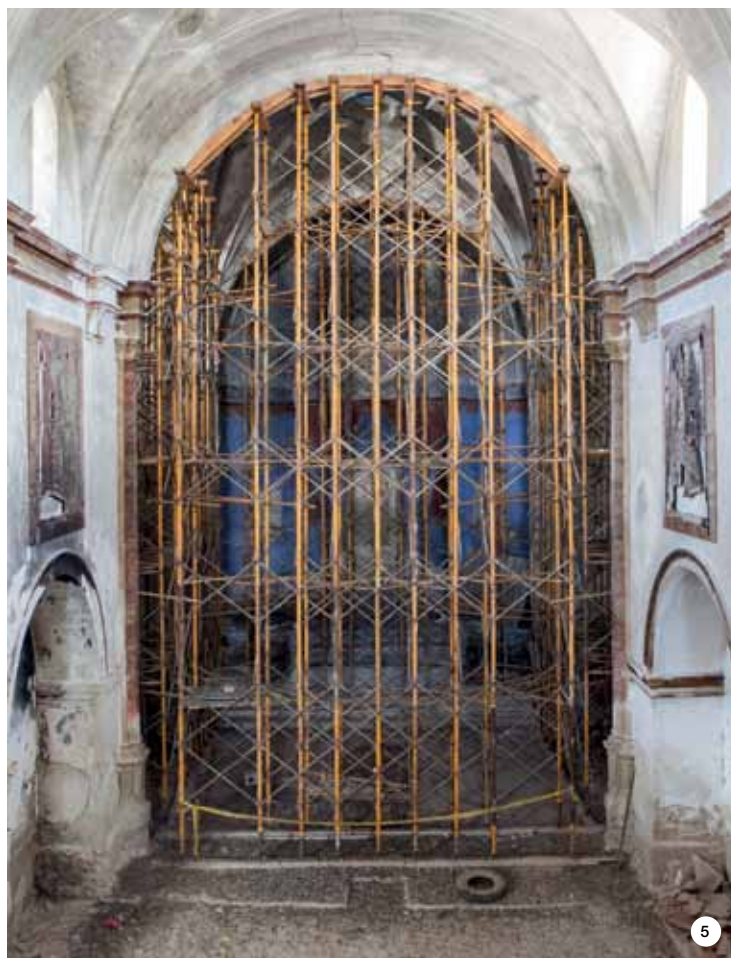
PHOTO 5. The surface of the cross-shaped vaulted roof was repaired with PLANITOP HDM RESTAURO.

After removing the damaged areas of the cross-shaped vaulted roof and cleaning the substrates, holes were drilled in the surface to position MAPEROD G bars and MAPE-ANTIQUÉ I binder. After this intervention, the cracks and surface of the vaulted roof were repaired by applying MAPEGRID G 220 glass fibre mesh directly on an even layer of PLANITOP HDM RESTAURO. Thanks to its high content of synthetic resins, this mortar has excellent adhesion and, once hardened, forms a tough, compact layer which is impermeable to water but permeable to vapour.
