The Abbey of Tiglieto

Italy's first Cistercian settlement has been subject to careful architectural restoration which had been carried out respecting the appearance of the original building.

Abbey of Santa Maria di Tiglieto – Tiglieto (Genoa, Italy)

Restored: 1998

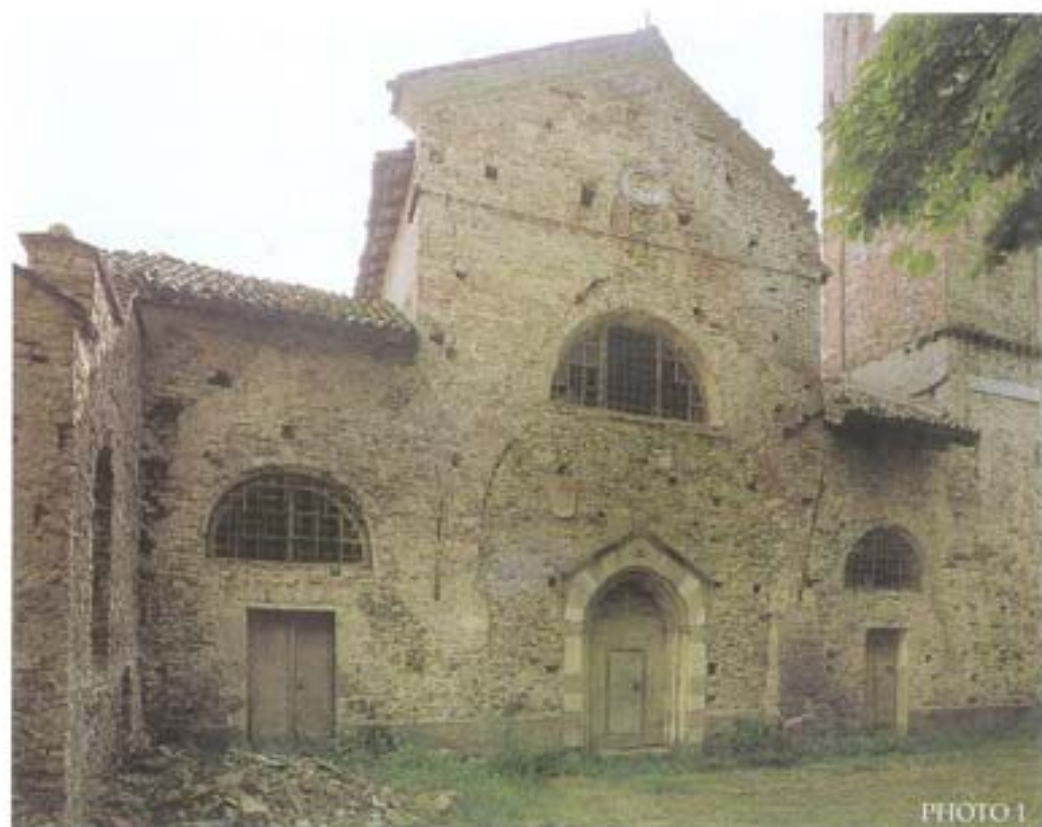
PHOTO 1

during the course of the centuries, the structural stability of the construction has been completely altered, weakening some parts, introducing pressure and greater stress on others while, at the same time, reducing or removing structural links between various masonry elements (photo 1). In other words the architects were faced with a series of disconnected elements that could not support each other's loads and thrusts or withstand possible subsidence in the foundations.

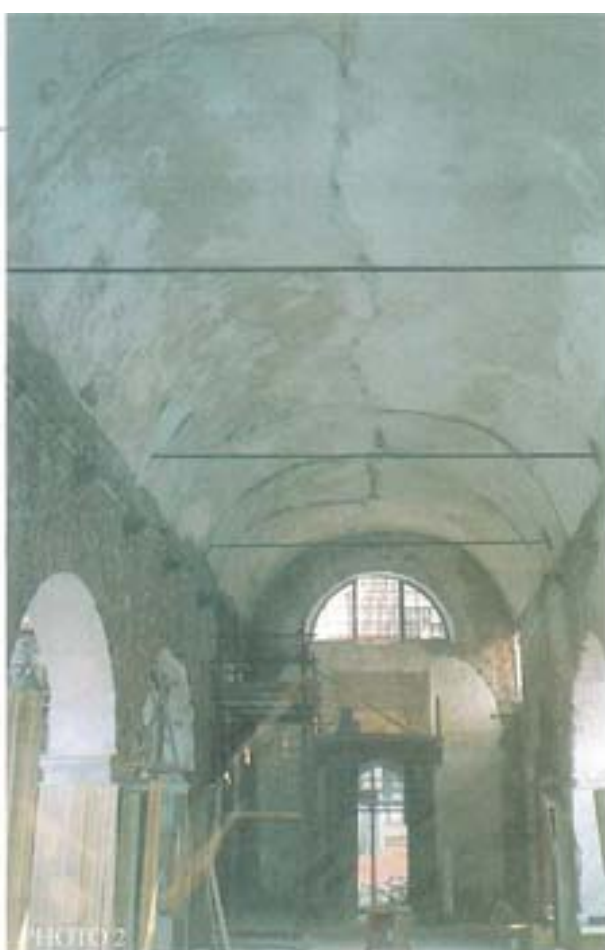
when the building passed into the hands of the Raggi family, is made up of ribbed brickwork approximately 15 cm thick. There was widespread cracking throughout the vault which risked putting the whole structure out of balance. The bearing wall's foundations have probably subsided causing the vaults to deform, increasing the eccentricity of the crown and creating stress on the extrados. Since the walls have very low resistance to tensile stress, cracks opened along the intrados keystone (photo 2).

Restructuring involved the construction of a thin reinforced concrete shell on the extrados of the vault, the erection of new support walls (in reinforced concrete) and the installation of a double series of support ties to efficiently resist the thrust of the vault on the side walls. This

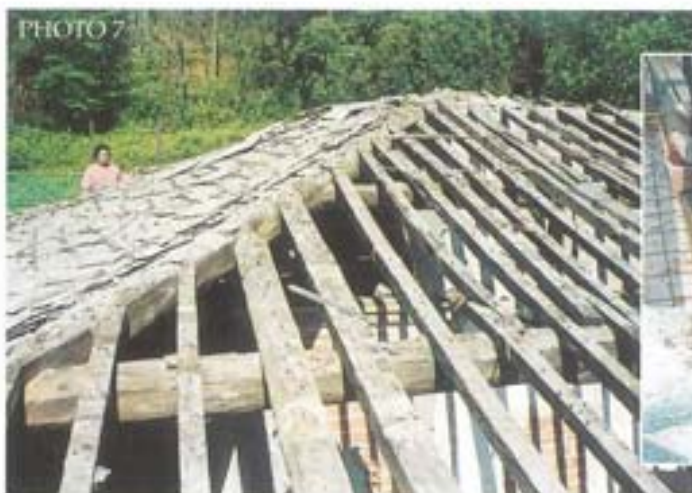
PHOTO 7

seriously damaged (photo 7 and 8).

laggings, 18x36x2.5 cm tiling similar to the original scandola oak or chestnut tiles. Before restoration, the roofing was in an advanced stage of deterioration.

The pitches had numerous cracks where water and snow penetrated causing further damage to the already precarious structure. The massive wooden frame of the roof composed of chestnut truss and beams was also

The temporary removal of the wooden roofing was necessary for the reconstruction of the vault. This revealed the state of conservation of the trusses. Since some of the trusses were either rotten or missing, the Project Managers decided to reconstruct or insert new sections where required to recreate the original geometrical form of the roof (photo 9).

After verifying the compatibility with the wood, EPORIP was poured into a mould around the trusses and reinforced with stainless steel. The trusses were then covered with a roof similar to the original.

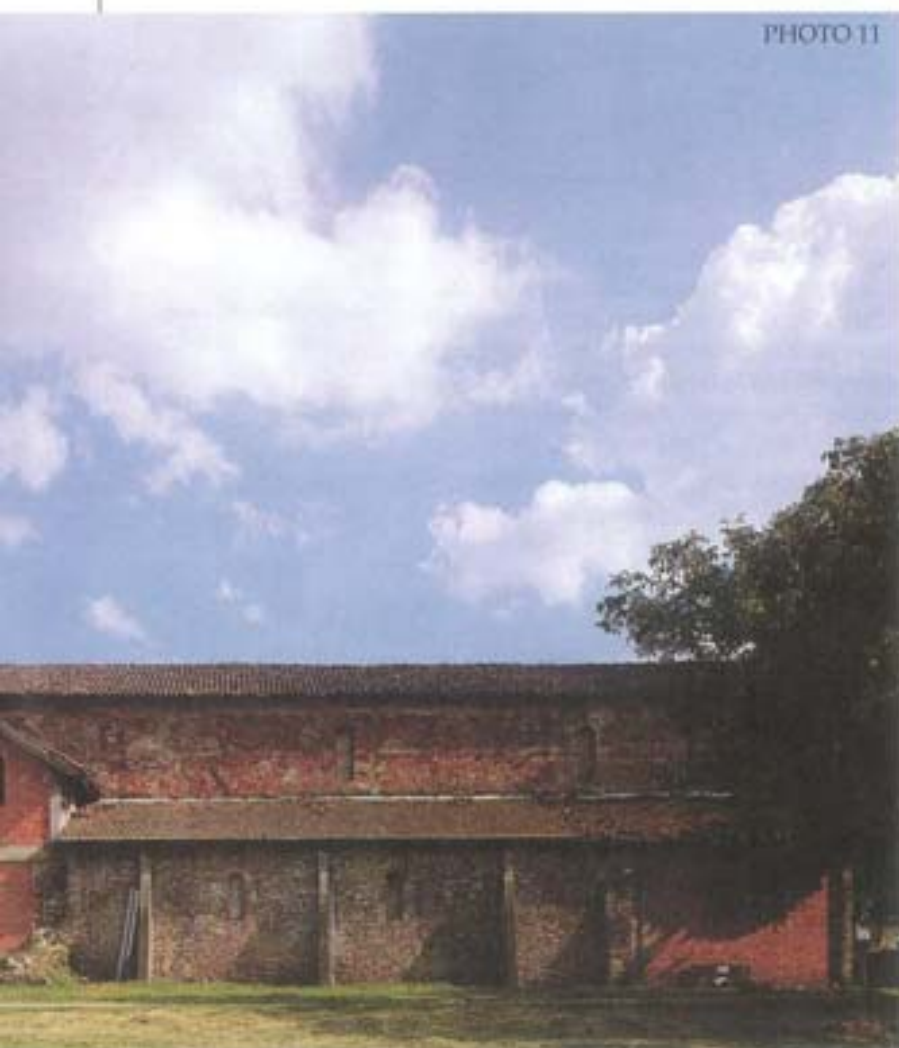
PHOTO 11

Without doubt the Medieval-17th-century bipolarity is a special characteristic of the Tiglieto building; the conservation for future generations of this duality reflects the effort to preserve the building's authenticity (photo 11 and 12).
