# TAKING SHELTER IN THE

The renovation work on the out-fitting wharf at the Sestri Ponente shipyard testifies to how an analysis of the conditions causing deterioration of concrete and choosing specific products are vital in re-establish quality and durability.

# DOCK

Sestri Cantiere navale, Gruppo Fincantieri  
Sestri Ponente (GE)

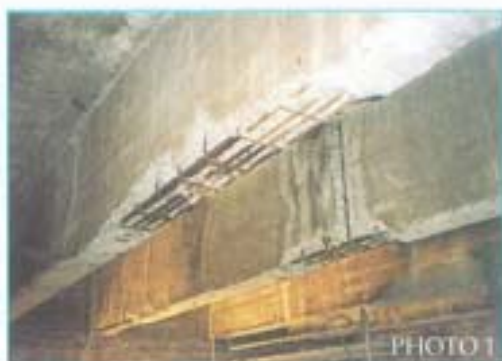
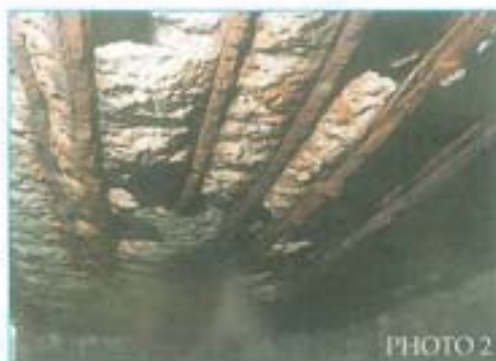
considerably better built. In both cases though, the inner surface of the girders and the concrete slabs were in bad condition. The concrete reinforcement rods were completely exposed and corrosion had reduced the section substantially (photo 1 and 2).

After having thoroughly analysed the problem and laid down all the parameters for the reconstruction project, the technical department decided to remove the layer affected by hydrodemolition in order to remove the chlorides that had penetrated the concrete over the years. The task called for a two-pronged approach: first, the removal of loose and deteriorated parts with electrodemolishers, second, high pressure hydroscaring (2,000 bar, 25 litres per minute) all surfaces. The use of high pressure hydrodemolition was especially
