## *Camerino (Italy)*

# SANTA MARIA ANNUNZIATA CATHEDRAL

AFTER BEING SEVERELY DAMAGED BY THE EARTHQUAKE THAT HIT CENTRAL ITALY TWO YEARS AGO, THIS CATHEDRAL UNDERWENT SEISMIC UPGRADING WORK

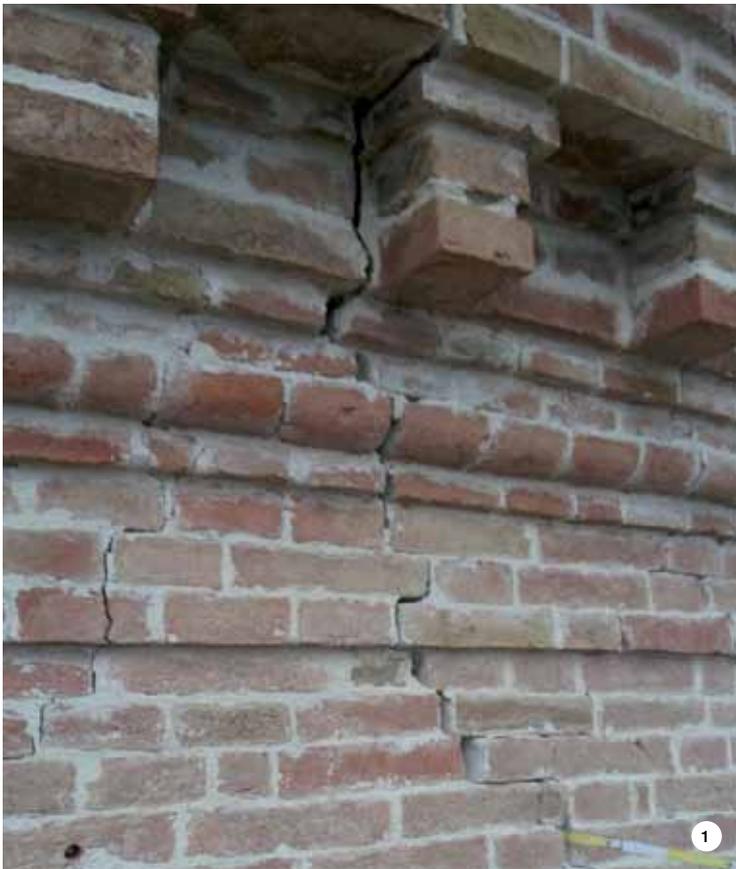
**PHOTO 1.** Some of the deep cracks in the apse, repaired using MAPEI STEEL DRY 316 helical bars.

First of all, the cracks in the masonry were repaired using MAPEI STEEL DRY 316 ultra high-strength “dry-applied” helical AISI 316 stainless steel bars. The bars were inserted into

the masonry by drilling a series of holes slightly smaller than the helical bars. The bars were then inserted in the holes using the special SPINDLE FOR MAPEI STEEL DRY. Once the bars had been inserted, the holes were filled with PLANITOP HDM RESTAURO mortar.

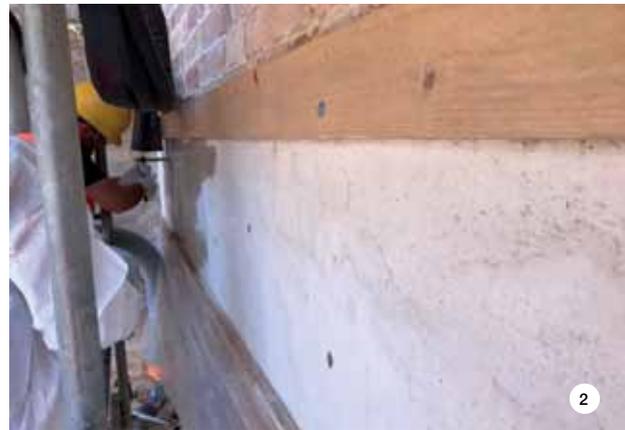
**PHOTO 2.** The substrate was made from PLANITOP HDM RESTAURO mortar.

The first phase of the banding intervention was to form the levelling layer by applying PLANITOP HDM RESTAURO two-component, pre-blended, fibre-reinforced, high-ductility hydraulic lime (NHL) and Eco-Pozzolan based light-coloured mortar. PLANITOP HDM RESTAURO was specifically developed to smooth and level layers on stone, brick and tuff surfaces. When used in combination with glass and basalt fibre meshes, it helps strengthen facing walls.

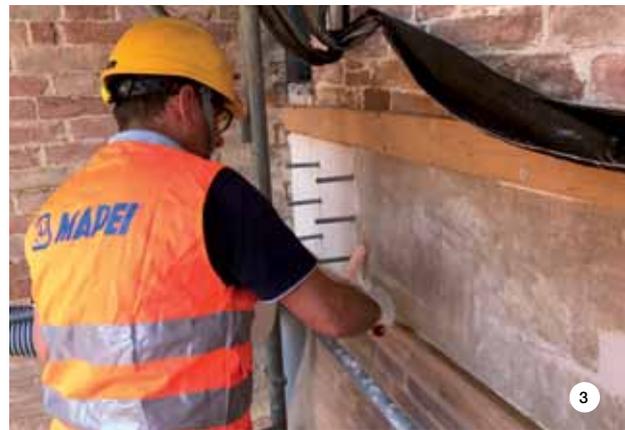
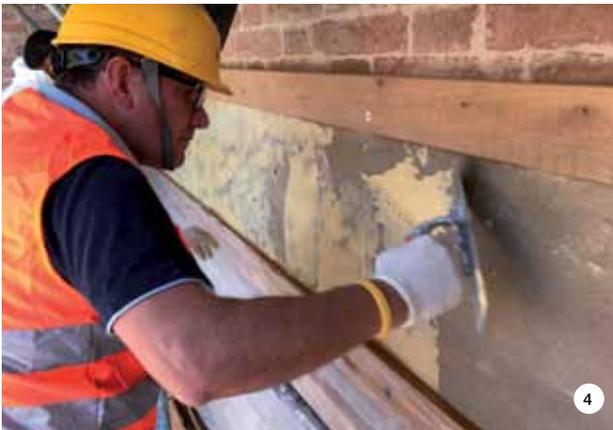
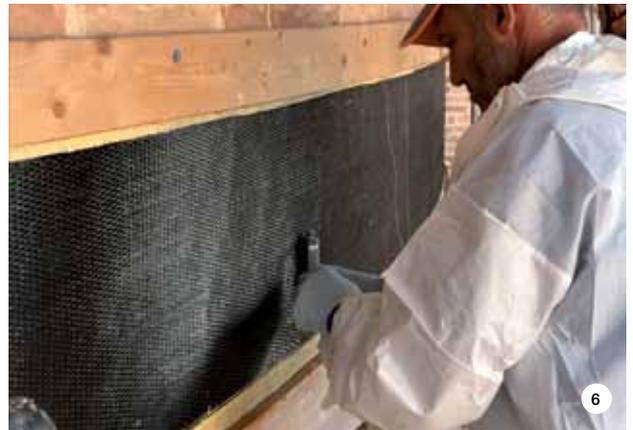
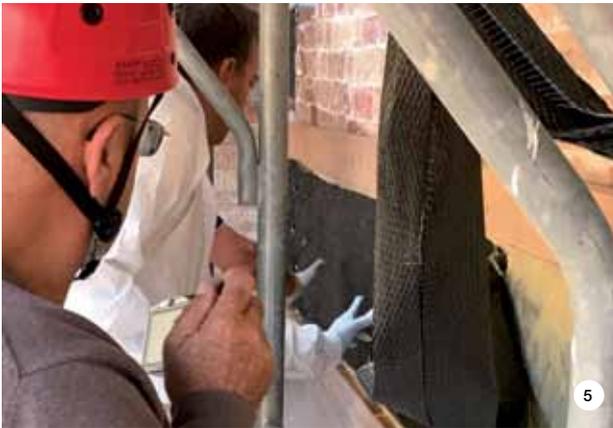
**PHOTOS 3, 4, 5, and 6.** MAPEWRAP PRIMER 1 primer

and MAPEWRAP 31 T adhesive were applied on the substrate, followed by MAPEWRAP C UNI-AX 600 fabric.

The bands were made from products from the MAPEWRAP SYSTEM line, particularly recommended for the repair and static and seismic strengthening of damaged structures. Mapei Technical Services recommended using MAPEWRAP C UNI-AX 600 high strength uni-directional carbon fibre fabric with high modulus of elasticity, which is particularly recommended for seismic upgrading work. The first step was to apply MAPEWRAP PRIMER 1 epoxy primer and then, on the fresh layer, an even coat of MAPEWRAP 31 T adhesive on the area to be strengthened.

Thereafter, MAPEWRAP C UNI-AX fabric was applied and pressed down firmly to make sure it adhered to the substrate and to avoid creases or folds. To prevent the formation of gaps or breaks in the bonding layer, and to make sure the adhesive penetrated into the fibres of the mesh, MAPEWRAP ROLLER was passed over the surface. A second coat of MAPEWRAP 31 T was then applied over the fabric.

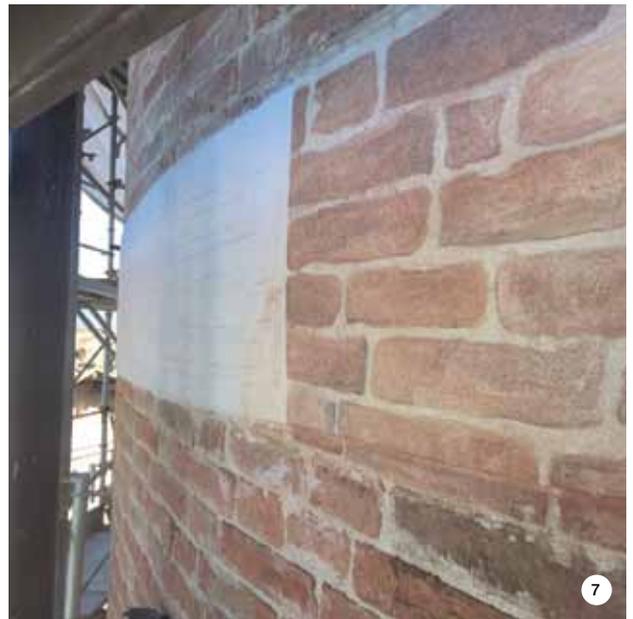
**PHOTO 7.** Restorers were able to "recreate" the original appearance of the wall on the new substrate.

Firstly, the surfaces to be decorated were skimmed by applying a layer of PLANITOP 200 water-repellent cementitious skimming mortar. Then, once the mortar had dried, a team of restorers from a specialised company redesigned and decorated the mortar in very fine detail.
