TAKING SHELTER IN THE DOCK

The renovation work on the out-fitting wharf at the Sestri Ponente shipyard testifies to how an analysis of the conditions causing deterioration of concrete and choosing specific products are vital in re-establish quality and durability.

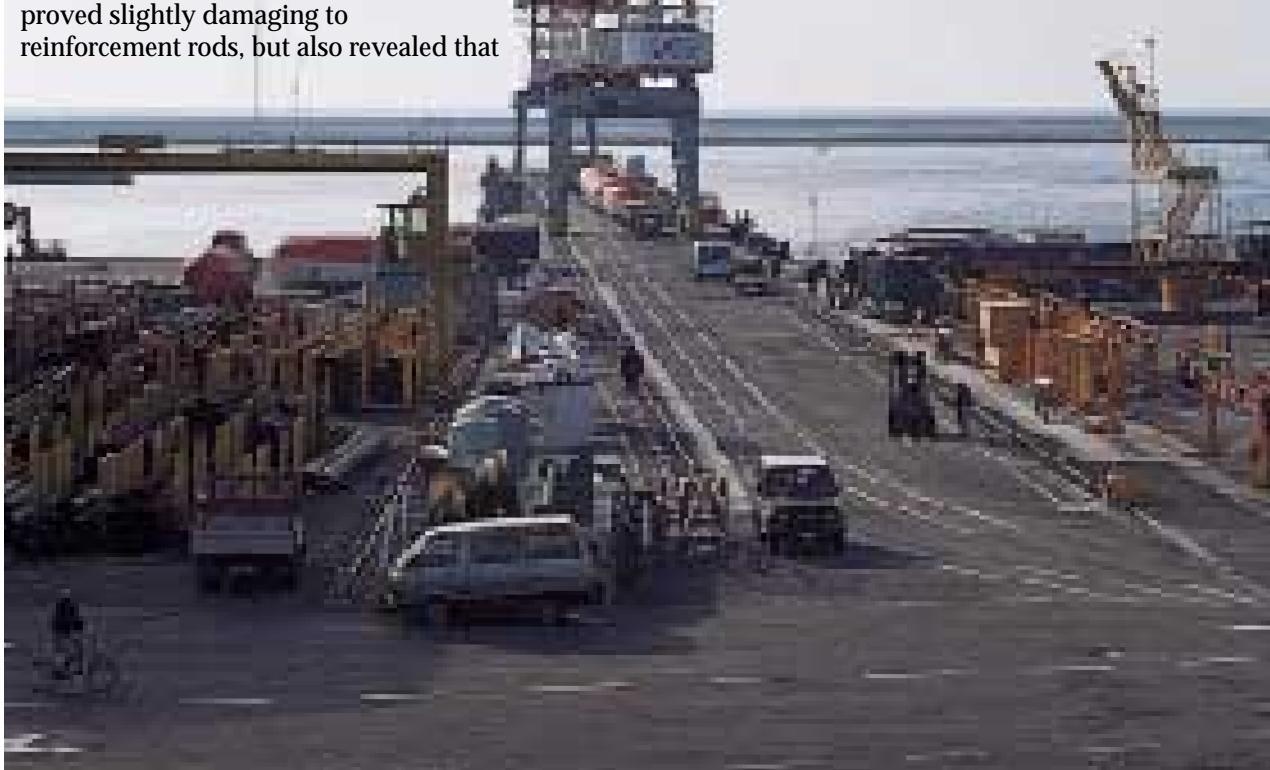
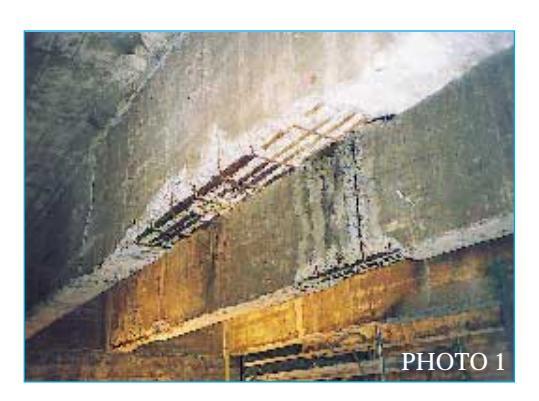
considerably better built. In both cases though, the inner surface of the girders and the concrete slabs were in bad condition. The concrete reinforcement rods were completely exposed and corrosion had reduced the section substantially (photo 1 and 2).

After having thoroughly analysed the problem and laid down all the parameters for the reconstruction project, the technical department decided to remove the layer affected by hydrodemolition in order to remove the chlorides that had penetrated the concrete over the years. The task called for a two-pronged approach: first, the removal of loose and deteriorated parts with electrodemolishers, second, high pressure hydroscaring (2,000 bar, 25 litres per minute) all surfaces. The use of high pressure hydrodemolition was especially
