# 2011

## **ICRI Project Awards**

Cooling Tower Strengthening and Rehabilitation

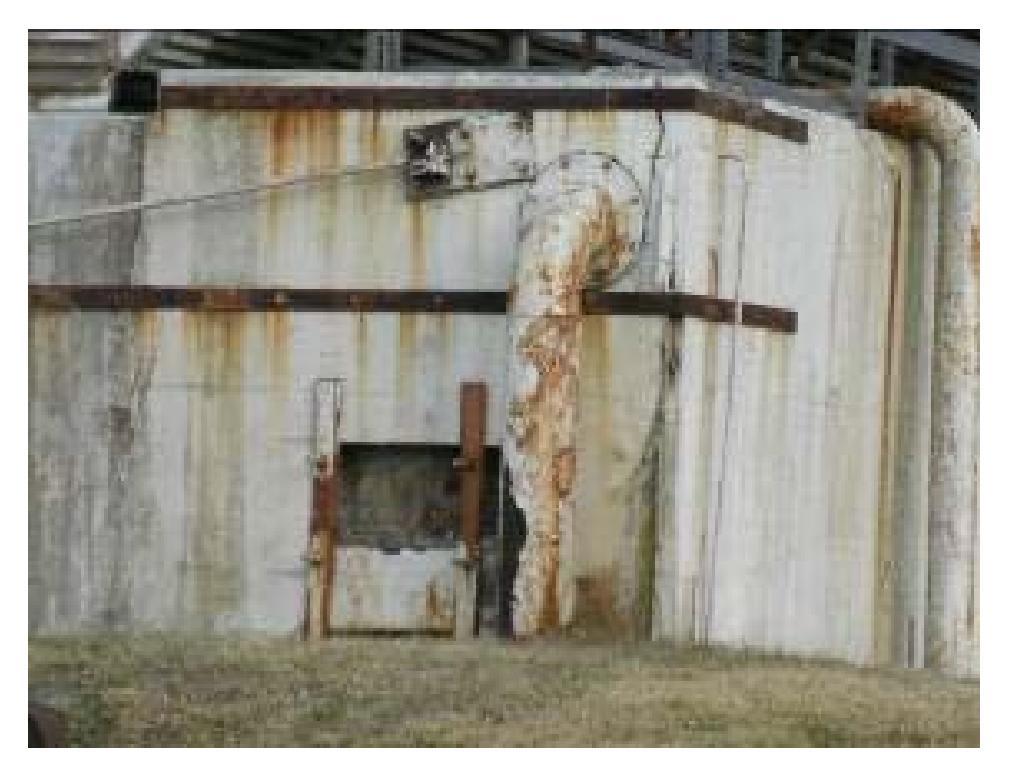
The corrosion was so severe under the walkway it caused all 8 of the 1-3/8" diameter steel tie-back rods to corrode completely off. This allowed the retaining wall to shift, opening large cracks in the corner of the structure.

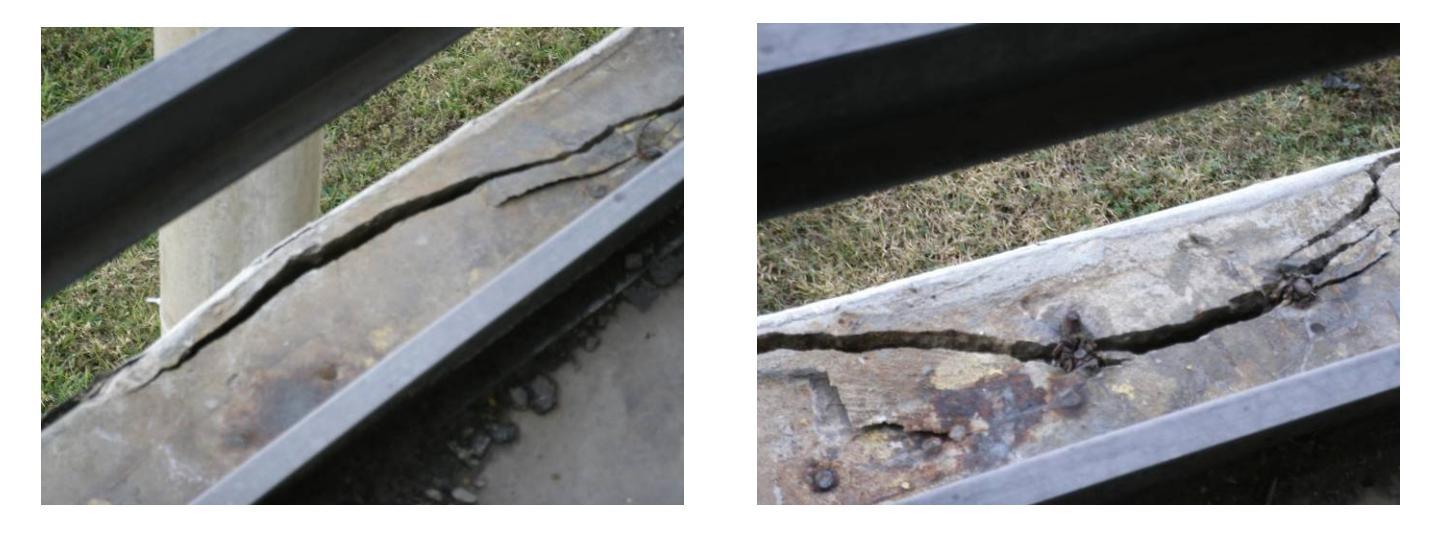
Due to the advanced corrosion and extremely poor condition of the concrete, operation of the facility became dangerously close to forcing a shut down and the site conditions were becoming unsafe for the employees at the plant.

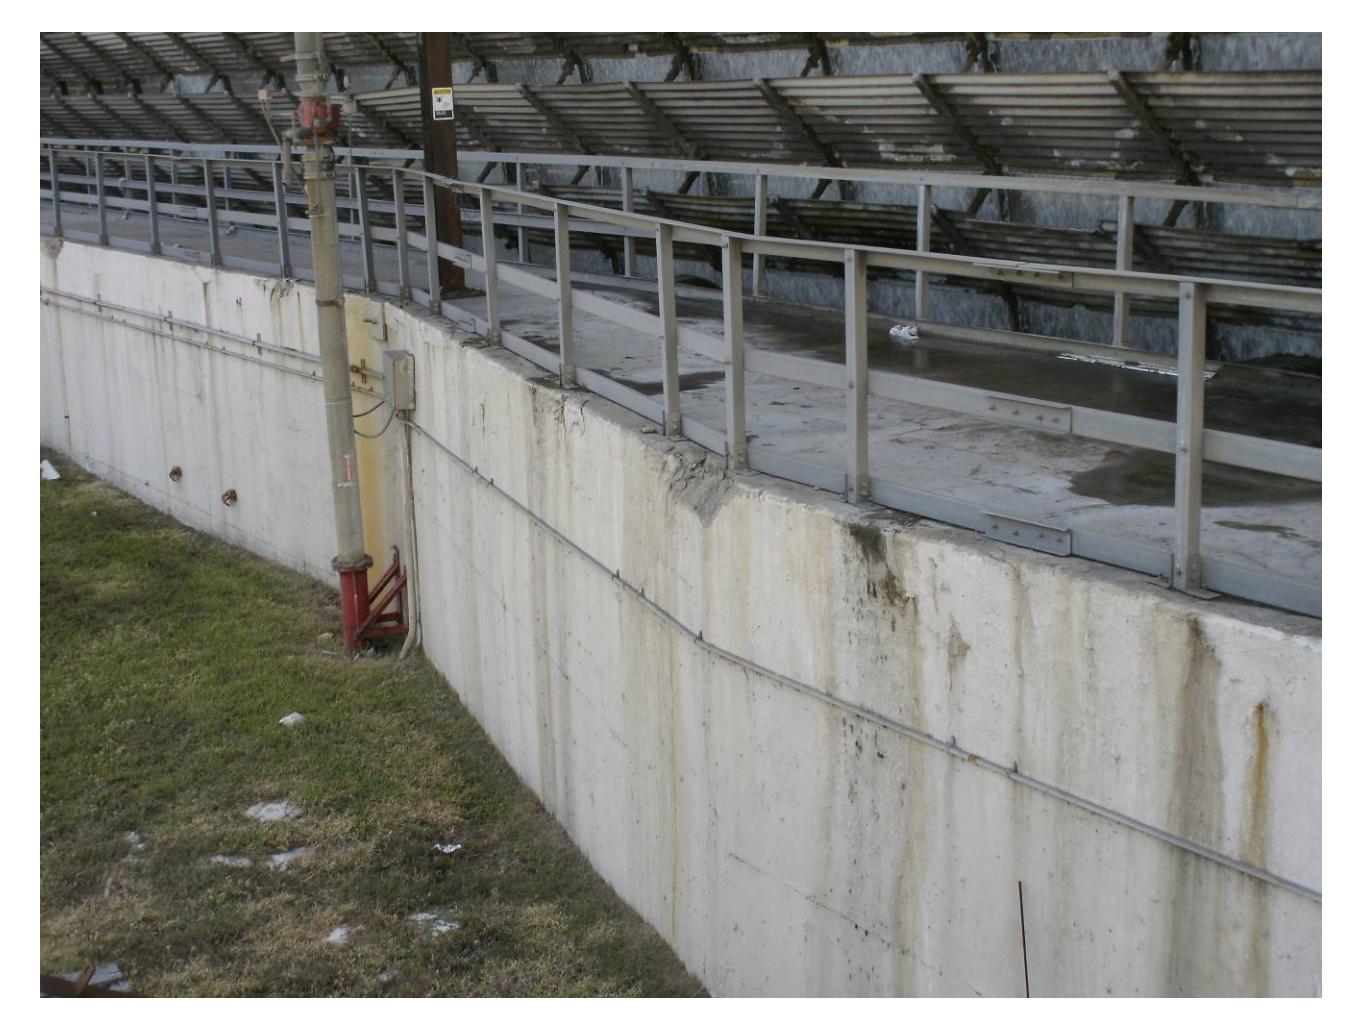
Severe damage to the retaining wall required large sections of concrete to replaced

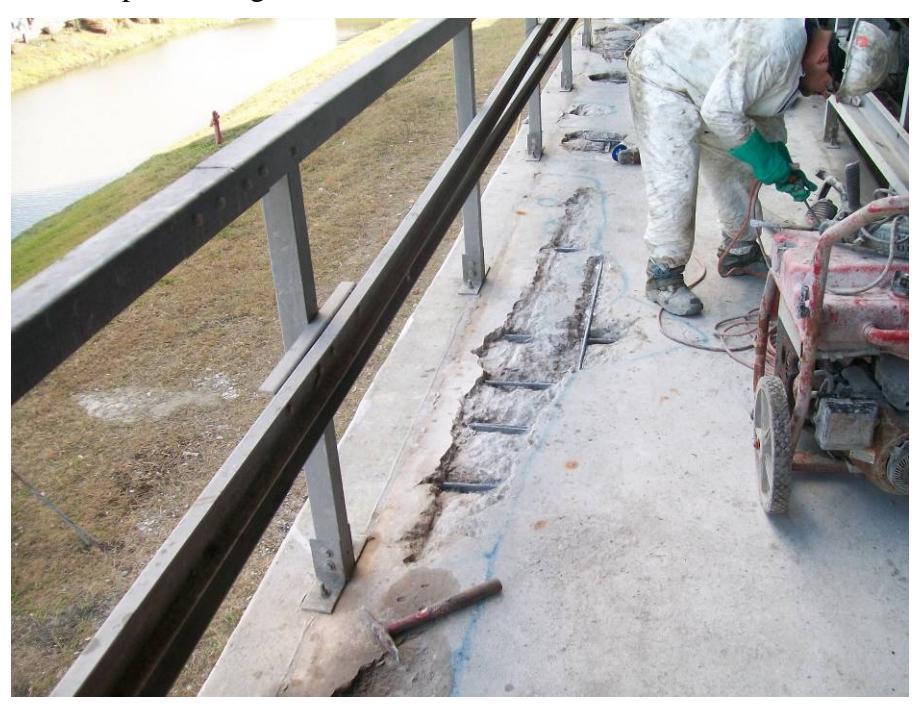
The topside of concrete walkway was marked prior to saw cutting a straight edge.

On all concrete repairs, saw cutting around the spalled areas was completed creating right angles wherever possible. As per ICRI and ACI standards, the poor concrete was removed from behind the rebar to allow for placement of the repair material to completely encapsulate the primed rebar and reestablishing the protective passivating environment.

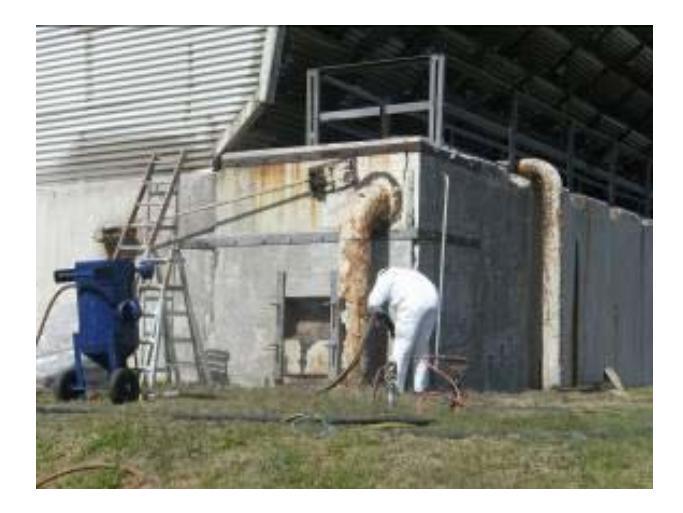
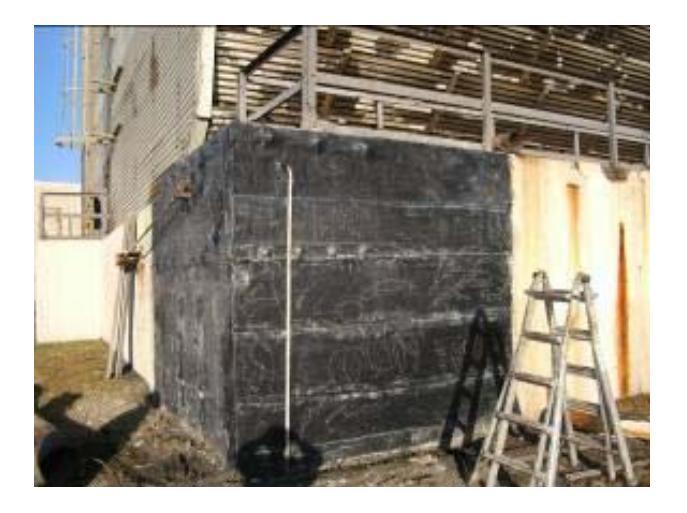
An extremely corrosive environment, combined with limited access, excessive slab reinforcement, poor concrete condition, and continuous exposure to chlorinated water, posed a significant challenge to overcome.

The first area to address was the southeast corner of the retaining wall that supported the 255 foot walkway. With the steel tie-backs corroded off and the large cracks within the wall it was imperative to strengthen this area prior to proceeding with repairs to the walkway above or the inside of the narrow water flumes. After repairing the spalls and cracks, both the inside and outside areas were wrapped with CFRP to secure the structure.

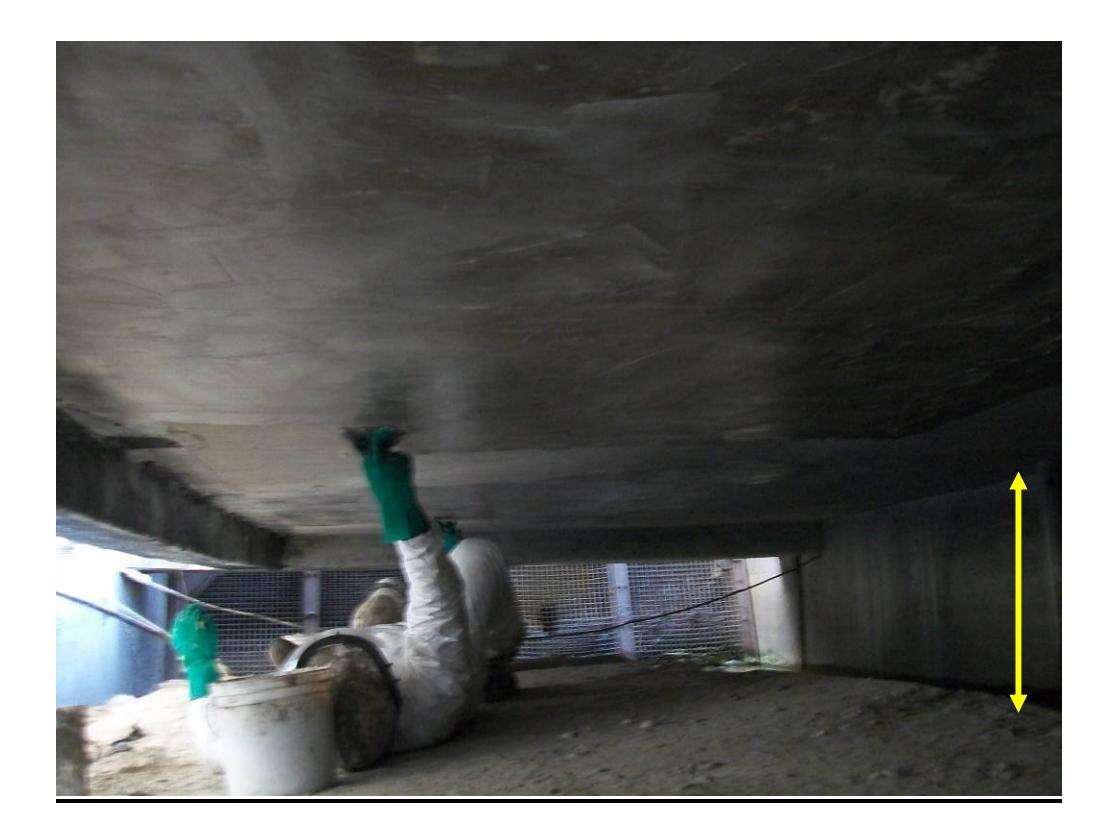
The client could only shut down one cell out of six of the cooling tower at a time. This meant that all work had to be completed while the cooling tower was running and fully operational. The total length of each cell was approximately 40 feet and the width of the return flume (cell) was approximately 8 feet. The largest obstacle was the fact that there was only 4 feet of clearance from the bottom of the slab to the top of the water.

The clearance problem was overcome by fabricating a floating platform 40 feet long and 8 feet wide. The contractor dismantled the platform and brought it to the project piece by piece and erected it in the water. The platform had two floats approximately 2 feet wide on each side enabling the water to run between the the "pontoons" and not impede the flow of the water in the flume area. There were handrails constructed at both ends. When one cell was complete it was simply floated down to the next one. At the end of the project, the floats were dismantled, placed on a trailer and shipped back to their shop.
