Reference no. T1742-1

Laboratory measurements of the reduction of transmitted impact sound by floor coverings on a heavyweight reference floor (According to ISO 10140-3)

Laboratory measurements of the reduction of transmitted impact sound by floor coverings on a heavyweight reference floor

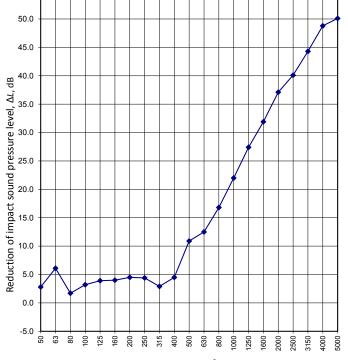
Frequency, f, Hz

Rating according to ISO 717-2:

$\Delta L_{\rm w}$ = 19 dB

$C_{I,\Delta} = -11 dB$

$C_{I,r} = -1 dB$

$C_{1,50-2500} = 0 \text{ dB}$

The third octave band change in impact sound pressure levels ΔL are presented in both table and graph formats. The third octave band normalized impact sound pressure levels for the bare floor, $L_{n,0}$, are also presented in table. Single figure ratings are also presented. The weighted change of impact sound pressure level $\Delta L_{\rm w}$, determined according to ISO 717-2, is presented. $\Delta L_{\rm w}$ is determined by fitting a reference curve to the third octave band normalized impact sound pressure levels from 100Hz to 3150Hz for the change in impact sound pressure levels L which have been added to the normalized impact sound levels of a standard floor (as given in ISO 717-2). From this curve a weighted change of impact sound pressure level $\Delta L_{\rm w}$ is produced, and gives a single figure determination of the improvement of the normalized sound levels transmitted through the floor from impacts, which the floor covering can give (higher is better).

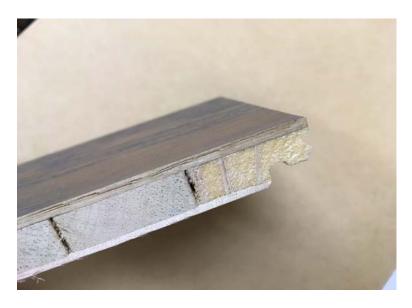
Figure 1: Section view of Godfrey Hirst-14.5 mm Oak timber laminate

A 3..04 m x 3.33 m sample of loose laid Godfrey Hirst-14.5 mm Oak timber laminate flooring (14.5 mm x 190 mm x 1820 mm planks)

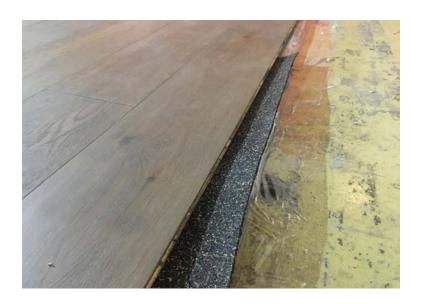
Figure 2: Oak timber flooring on the 4 mm Mapesonic underlay

Loose laid 4 mm thick Mapesonic CR (cork/rubber underlay)

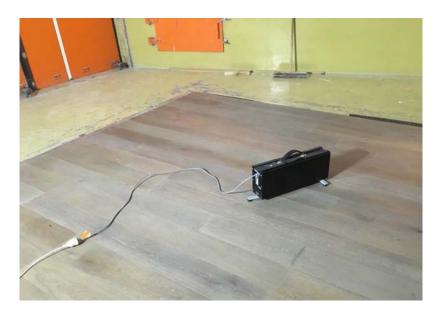
Figure 3: Tapping machine on the finished sample.

The tapping machine is placed on the three different covering samples. The impact sound pressure level is measured in the room below the floor, using a rotating microphone, in third octave frequency bands. The tapping machine is also placed on the bare concrete floor plug in positions on both sides of each floor covering

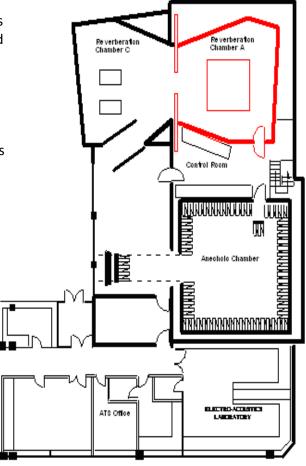
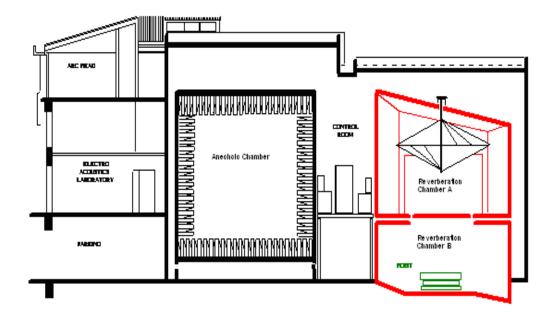
The three Reverberation Chambers are linked by heavy steel doors and a removable Standard Industrial Floor Section which is removed and repositioned by a hydraulic hoist. The three chambers are vibration insulated from one another so that sound can ony pass from one to the other via the

All three reverberation chambers may be described as hexagonal prisms; each has 6 vertical sided walls, perpendicular to the floor. The roofs of chamber A and C are plane, but inclined at 12 degrees from horizontal. Chamber B has a plane, horizontal roof which is the floor of chamber A above it. The floor of chamber B is also horizontal, but has two angled sections at its North West and south east ends. The centre section is horizontal because a floor jack is installed there. The floor jack may be raised hydraulically to the ceiling of chamber B, the centre of which consists of a floor plug between the two chambers. This plug may be disconnected from chamber A and lowered down into chamber B, leaving a 3.2m x 3.2 m opening between the two chambers. This allows for the measurement of airborne and impact insulation of floor and roof elements.
