# **LABORATORY MEASUREMENT OF THE REDUCTION OF TRANSMITTED IMPACT SOUND OF CERAMIC TILES ON UNDERLAY**

Test report ID: T1931

# LABORATORY MEASUREMENT OF THE REDUCTION OF TRANSMITTED IMPACT SOUND BY FLOOR COVERINGS ON A STANDARD FLOOR

Mapei New Zealand  
30 Fisher Crescent, Mt Wellington  
Auckland 2010, New Zealand

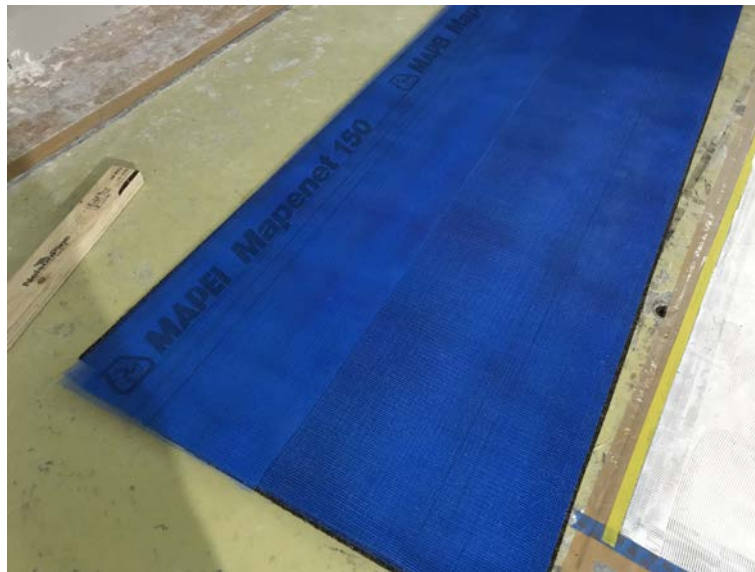
Figure 1.3: Mapenet 150 mesh

**Second layer:** 2 coats of *Mapelastic Smart Waterproofing Membrane* applied with a flat trowel (approximate thickness per layer 1.5mm) with *Mapenet 150 Mesh* embedded into the body of the first layer. (0.5hrs curing time between coats and 3.5 days curing time before next layer)

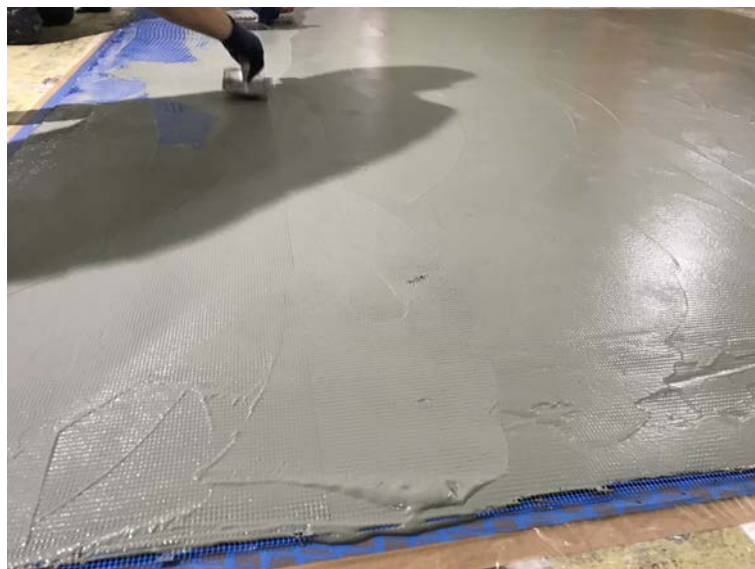
Figure 1.4: Applying Mapelastic waterproofing layer

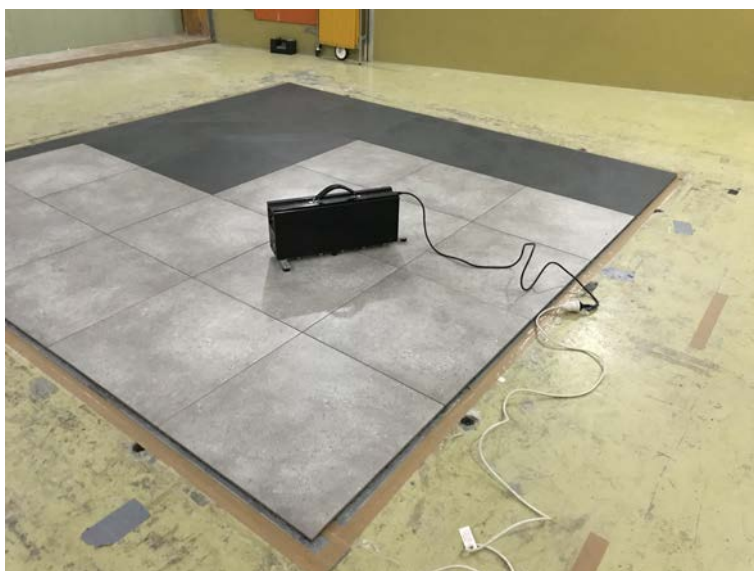
Figure 1.6: Impact tapping machine on sample

The normalized impact sound pressure levels are obtained in accordance with the recommendations of ISO standard 10140-3 “Measurements of impact sound insulation.” The BK3204 tapping machine is placed sequentially in four different positions on the floor. The impact sound pressure level is measured in the room below the floor, using a rotating microphone, in third octave frequency bands. The impact sound pressure levels are normalized against the room absorption. The room absorption is calculated from the reverberation time and room volume. The reverberation time is measured from the decay of a steady state sound field. Corrections are applied, where necessary, for airborne sound transmission and background noise. The airborne sound transmission is determined using a loudspeaker and the microphone.
