Choinière Dam and tunnel concrete repair

Granby, QC, Canada

Repairing a dam and drainage tunnel against leaks

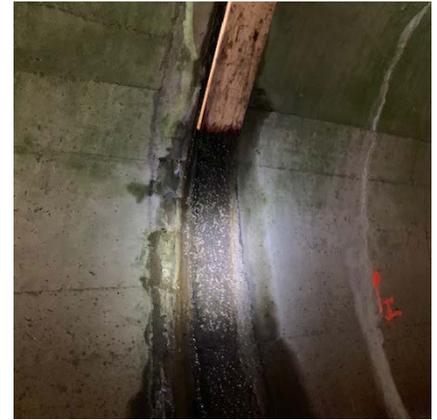
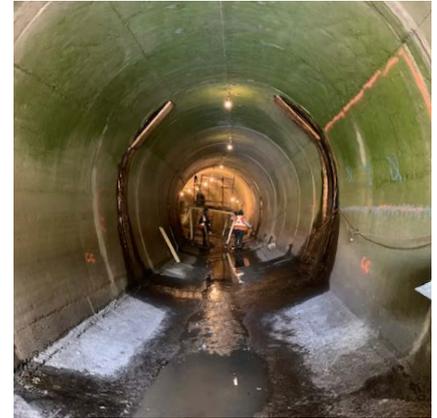
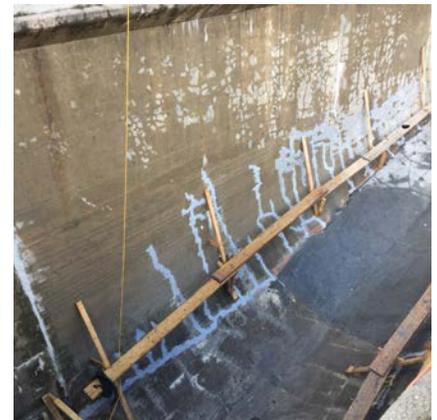
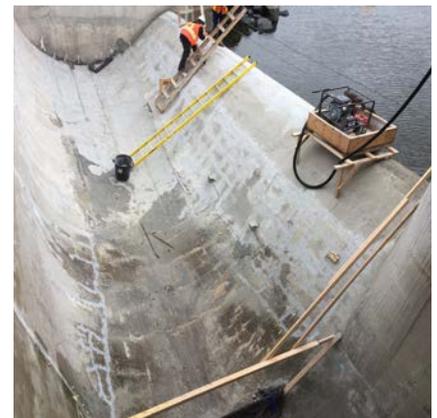
In the tunnel, where the joints were experiencing water ingress, the more heavy-duty **Foamjet T** was used. This specialty product from the MAPEI UTT (Underground Technology Team) line is a high-viscosity, ultra rapid-setting, polyurethane resin that is designed for consolidating and waterproofing structural elements that are subject to high-pressure water ingress in environments such as dams and tunnels.

The two components that make up *Foamjet T* must be mixed together by a special pump for two-component resins. To carry out an injection, *Foamjet T* Part A and *Foamjet T* Part B – in the ratio of 1:1 by volume – must first be separately conveyed through the pump and into the nozzle that was previously placed on the injector. Both parts are then mixed by a helicoidal mixer that is placed within the nozzle.

After mixing, *Foamjet T* must be injected continuously through the crack. When the two components are mixed, the viscosity of the mixture increases substantially; therefore, the injected mixture will not separate or be washed out by the water pressure.

The increase in volume of the foam and its fast reaction stops the water ingress within a few minutes. In the absence of water, *Foamjet T* hardens without increasing in volume and rapidly seals the crack.
