Stanley Park Seawall Gets a Facelift with MAPEI's *Planitop*® 12

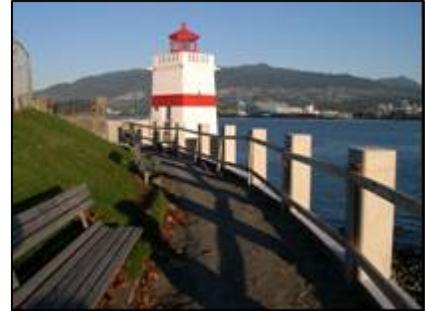
The area to be repaired included the concrete coping at the top of a retaining wall that divided a parking area above from a walkway along the seawall below. The original product specified for the project was difficult for the Fricia team to work with and the resulting color was too dark to blend well with the rest of the wall. Ron VanDer Meulen, the project manager for Fricia, contacted his distributor Richform Construction Supply and asked what other products might be available to do this type of work. Glenn Best of Richform suggested that he consult with MAPEI's technical sales representative, Dave Randall.

The original coping atop the seawall had become too eroded and damaged from exposure to the harsh sea air for the renovators to apply the *Planitop 12* directly to the wall. Before beginning the

repair, the coping was hydroblasted to remove all of the loose concrete and to profile the surface so that it was ready to accept a topping repair material.

Dave Randall helped customize the repair by suggesting that the finisher apply a slurry bond coat composed of *Planicrete*[®] AC mixed with *Planitop 12* in a 1:1 ratio. (*Planicrete AC* is a concentrated liquid latex admixture that can be used to enhance the performance of repair mortars.) The finisher followed this preparation with a coating of *Planitop 12* at a minimum ¼ inch thickness. The cured repair produced a color that closely matched the rest of the retaining wall.

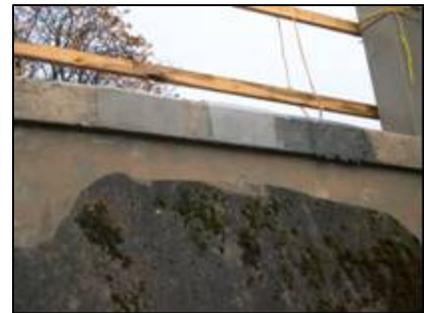
After discussing the repair project, Randall suggested to VanDer Meulen that he try MAPEI's *Planitop 12*, a fiber-reinforced cementitious mortar with excellent thixotropic (nonslip) characteristics. Randall provided technical support by taking a sample of *Planitop 12* to the jobsite and performing a demonstration. Fricia's concrete finisher immediately saw the advantages of the single-component repair mortar, noting how easy it was to apply and finish. (*Planitop 12* is shown in the center of the picture at left.)

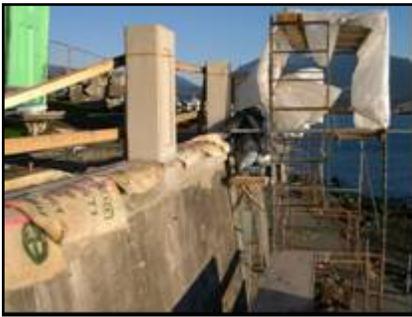
The demonstration was very successful, so the next step was to convince the engineering consultant to approve the use of *Planitop 12* rather than the originally-specified material. Oon-Soo Ooi of Golder and Associates was pleased with the compressive strength, flexural strength, resistance to salts, polymer content and final color of the *Planitop 12* repair, "...but expressed concerns with the shrinkage that occurs with cementitious mortars exposed to wind and sun when curing." Randall suggested the use of a wet-curing method using burlap to lower the amount of shrinkage that could occur in the Vancouver climate. Everyone agreed on this proposed solution, and the project was completed using *Planitop 12*.
