# The Havana School of Arts Complex

## Restoration and renovation of an iconic example of Cuban architecture

**Havana School of Arts Complex** – the School of Plastic Arts, the School of Modern Dance – Havana (Cuba)

**Work:** reinforcing, waterproofing and finishing the cupolas and the bovedas; laying and grouting terracotta tiles on the bovedas and cupolas; rebuilding the damaged concrete sections; protecting and decorating the masonries.

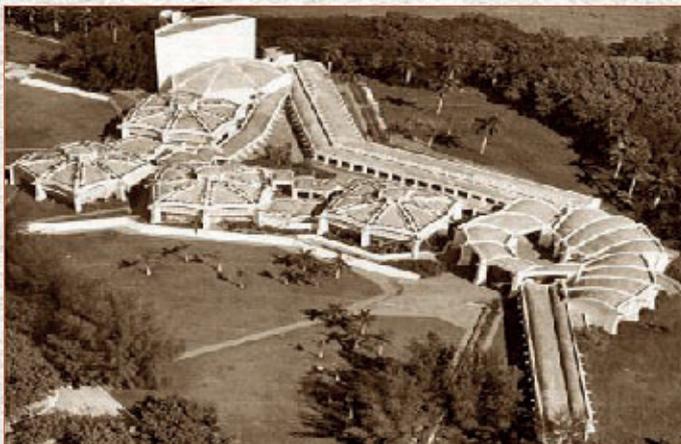
The School of Modern Dance Before Renovation

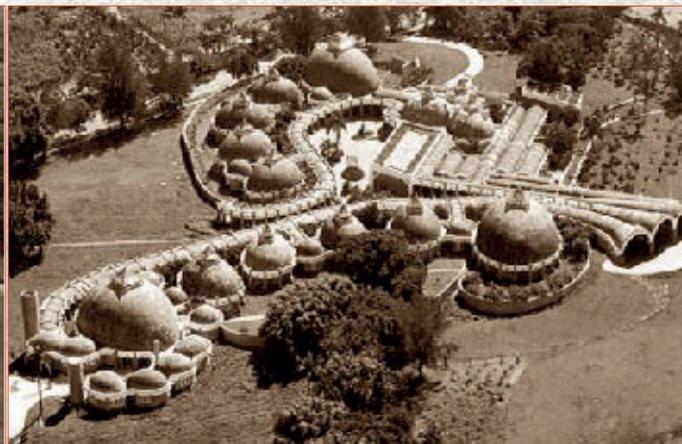
The School of Plastic Arts Before Renovation

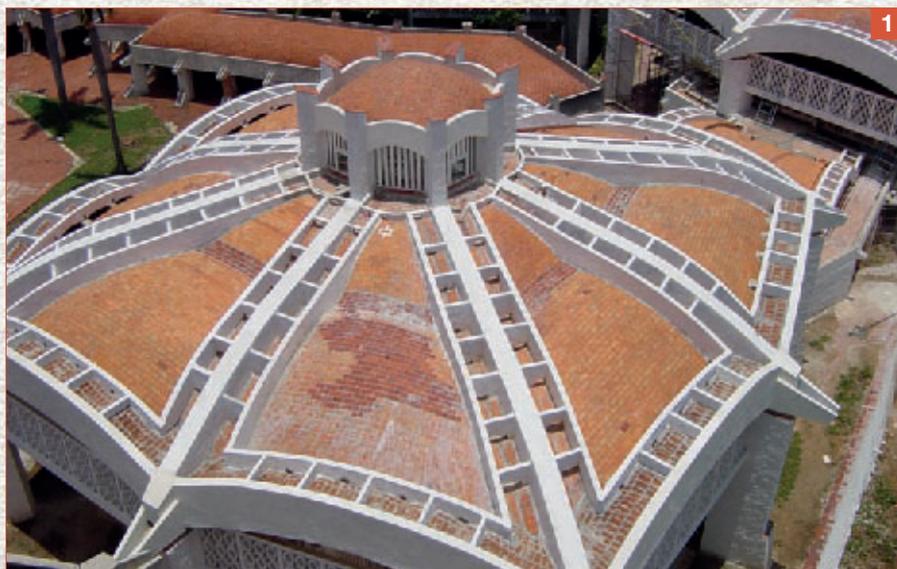
Photos 1, 2, 3 and 4.

After removing the tiles, the external coverings of the cupolas and the *bòvedas* (Catalan-style vaulted roofs) were waterproofed by applying two layers of Mapelastic on their surfaces. To increase performance of the waterproofing system, the first layer was reinforced with Fibreglass Mesh while it was still fresh.

For the external coverings of the cupolas and the bòvedas, the expansion joints and the perimeters of the vaulted roofs were first sealed by applying MAPEBAND\* alkali-resistant rubber tape with felt bonded in place using MAPELASTIC\* mortar, and MAPEFOAM\* polyethylene foam cord. The next phase was the waterproofing cycle, carried out by applying two layers of MAPELASTIC\* cementitious mortar on the surface, to create waterproof and protective coatings with a high degree of flexibility.

To improve the already excellent performance characteristics of the MAPELASTIC, especially when it is applied on surfaces which are particularly cracked or subject to stresses such as in this case, the first layer was reinforced using FIBREGLASS MESH\* while it was still fresh.

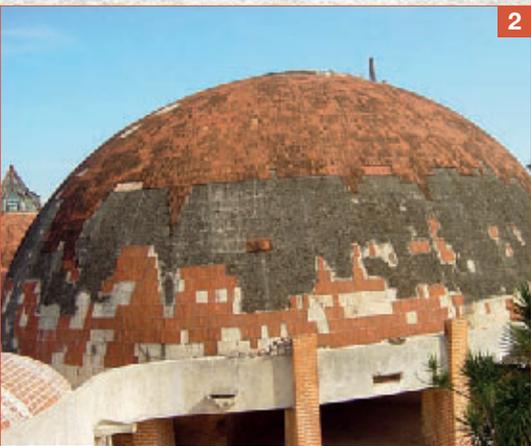
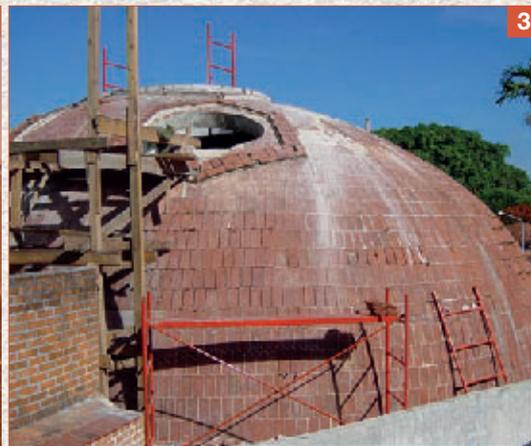
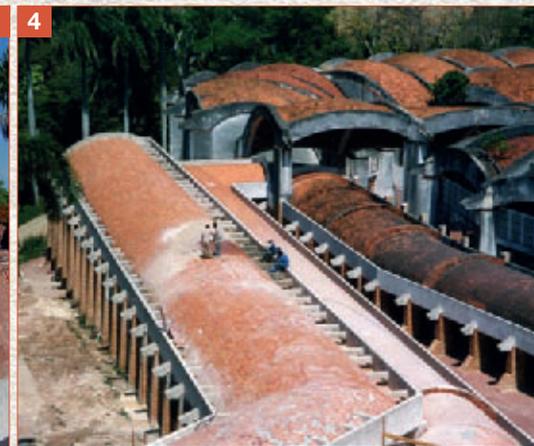
Photos 5 and 6.

The tiles were laid on the cupolas and on the *bòvedas* with Kerabond adhesive mixed with Isolastic latex. The tile joints were then grouted using Keracolor GG mixed with Fugolastic.

At this point, it was now possible to lay the tiles on the cupolas and on the bòvedas. The tiles were manufactured especially for this project, by following the original indications of the architects. KERABOND\* cementitious adhesive was chosen to bond the tiles, mixed with ISOLASTIC\* flexible latex (instead of water) to improve its

performance and deformability to C2 class requirements (improved cementitious adhesive) according to EN 12004 standards, and S2 class requirements (highly deformable adhesive) according to EN 12002 standards. The tile joints were grouted using KERACOLOR GG\* high-performance grout, in this case mixed with FUGOLASTIC\* liquid additive, to achieve particularly high

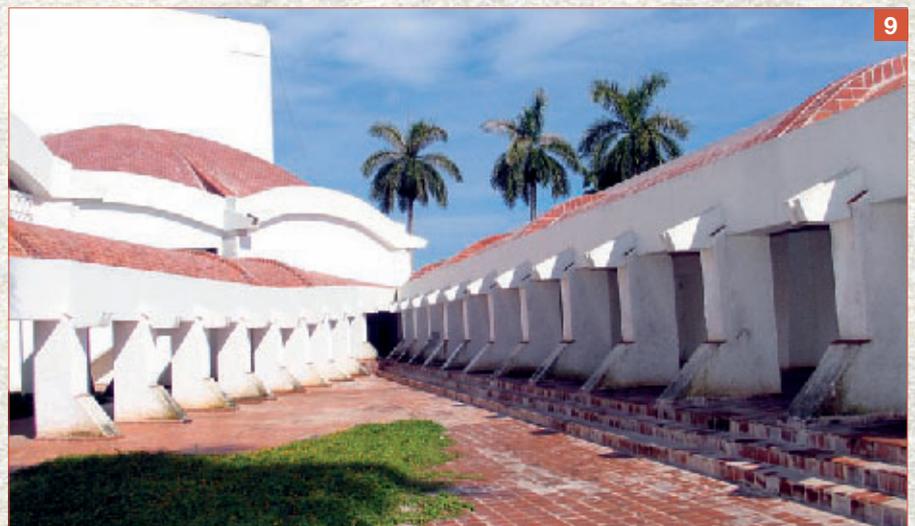
9

Photo 9.  
The restored surfaces were smoothed and levelled with Mapefinish mortar mixed with Planicrete latex.

The rebuilding operation was then completed by applying MAPEFINISH\* two-component cementitious mortar mixed with PLANICRETE\* synthetic rubber latex, to even out small imperfections in concrete and to create a

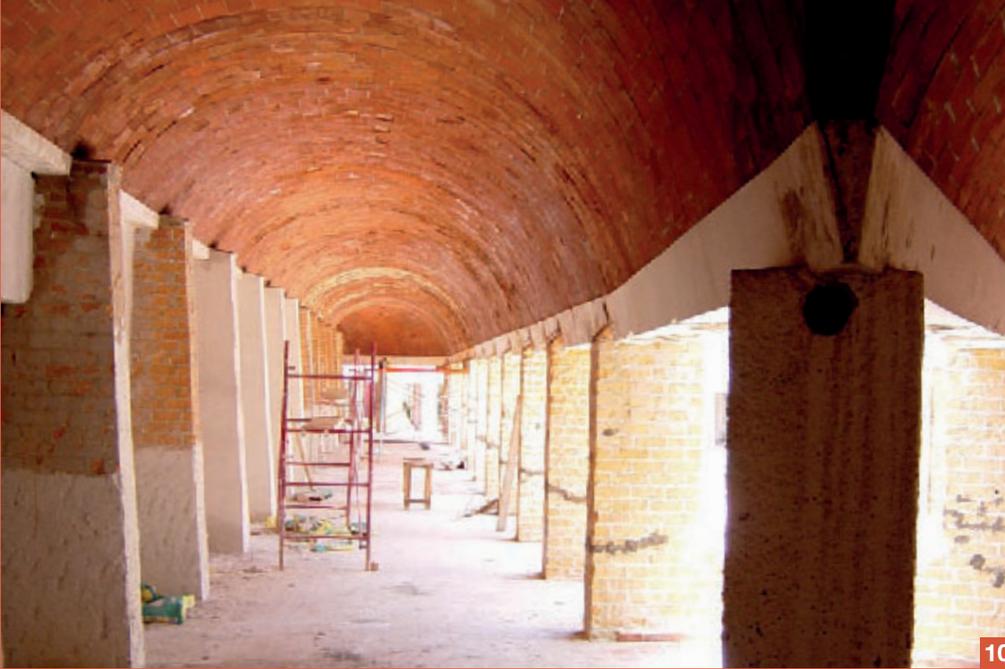
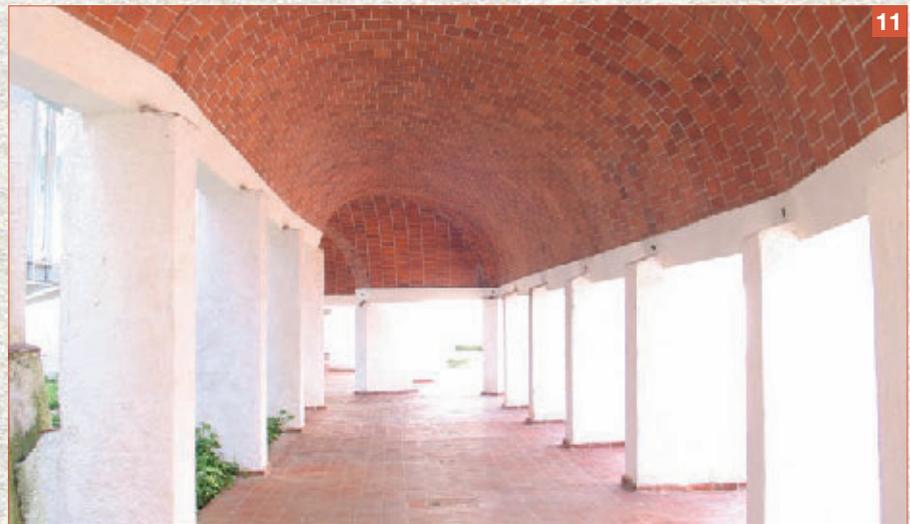
*Photos 10 and 11.  
Inside the buildings, the pillars on which the vaulted roofs of the bòvedas and cupolas are positioned, were initially consolidated by injecting Mape-Antique I. The tiles were then laid using Kerabond+Isolastic. The tile joints were then grouted with Keracolor GG and Ultracolor.*

Inside the buildings, the pillars on which the vaulted roofs of the bòvedas and cupolas are positioned were initially consolidated by injecting MAPE-ANTIQUE I\* hydraulic binder, made from inorganic materials with a poz-zolanic reaction.

The tiles which were in a poor condition were then removed and were replaced using new ones, again laid in place using KERABOND\*+ISOLASTIC\*, while the joints were grouted using KERACOLOR GG\* and ULTRACOLOR\*.

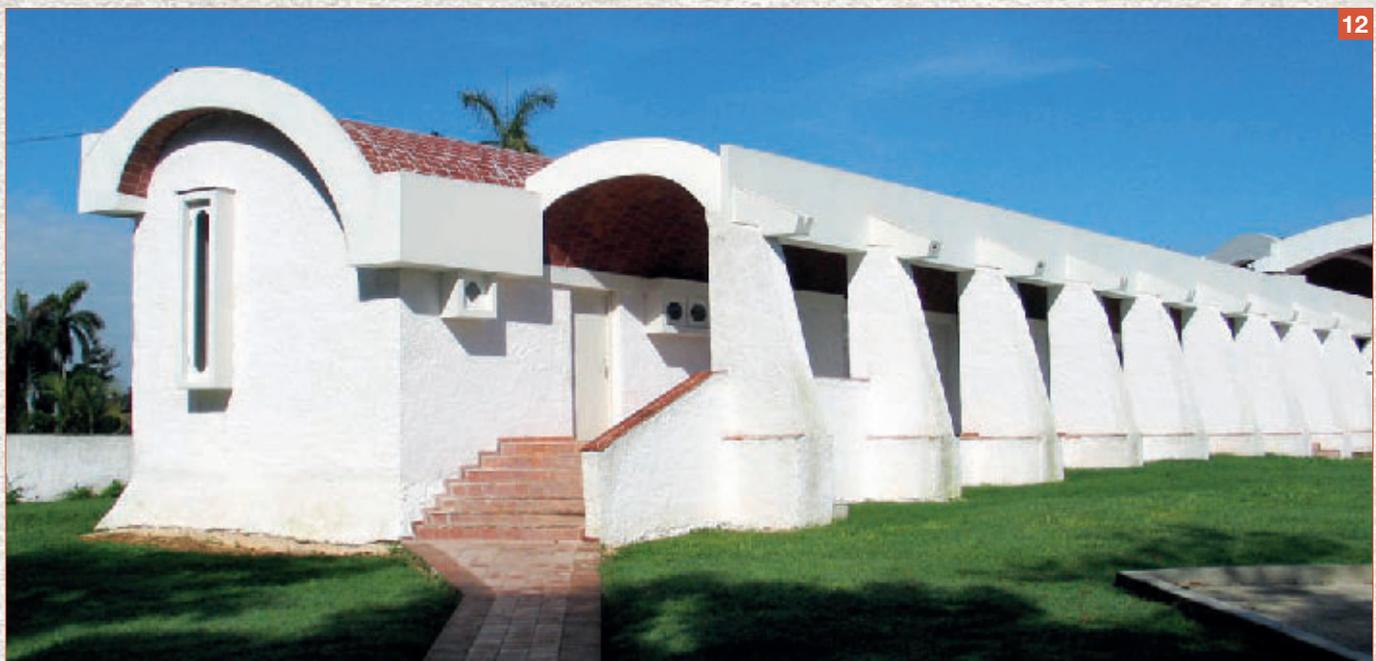
*Photo 12.  
The final protective coat for the concrete was made using Elastocolor Primer, followed by Elastocolor Paint, using a colour similar to the original one.*

For the final protection, ELASTOCOLOR PRIMER\* high-penetration fixing primer was spread on the concrete. This product penetrates deep down into the substrate, and guarantees excellent insulation and a good bond for the successive painting cycle. This was carried out using ELASTOCOLOR PAINT\* protective elastic paint, in a colour specially chosen to be as similar as possible to the original one.

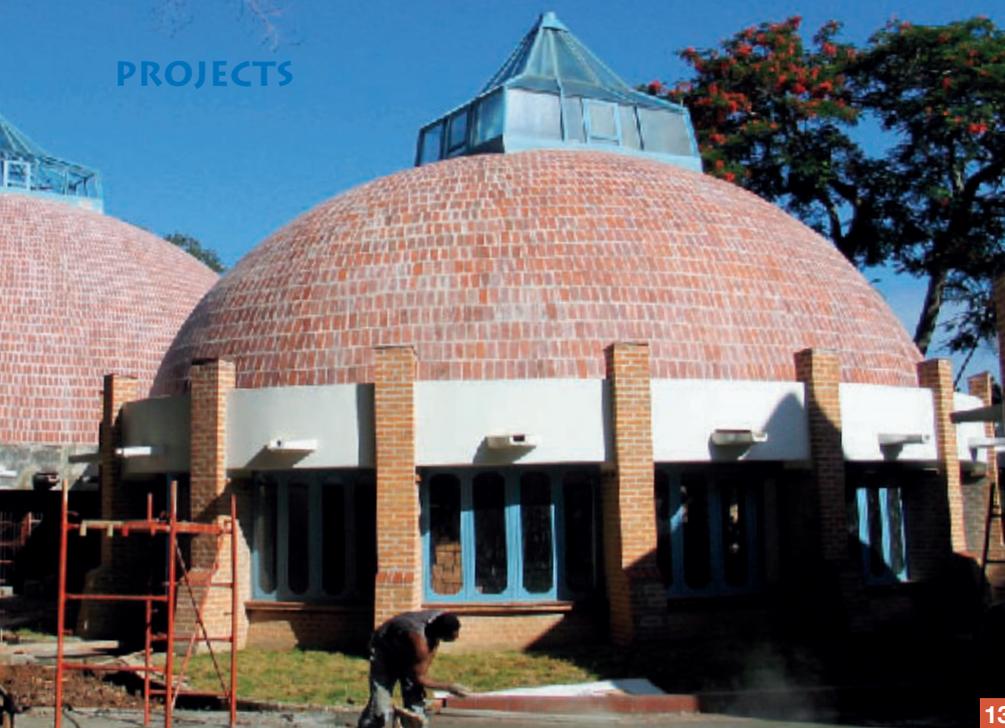
13

*Photo 13. The parts of the structures covered with ceramic tiles were protected using Antipluviol S and Antipluviol W colourless impregnating solutions.*

Two products from the ANTIPLUVIOL line were used to protect the structure covered with ceramic material. ANTIPLUVIOL S\* and ANTIPLUVIOL W\* colourless impregnating solutions, with the former having a siloxane resin base and the latter a silane and siloxane base in watery emulsion, which protect the surface from the rinsing action of the rain, but without altering its final appearance. When applied on porous substrates, these products penetrate deep down and form a water-repellent layer inside the pores and capillaries. The first part of the intervention, which was to prove long and complex, was carried out successfully thanks to the excellent cooperation between the building company which carried out the work, the designers and the Mapei Technical Service Department. This important restoration project has still to be completed, and at the moment, renovation work is being carried out on the remaining buildings.

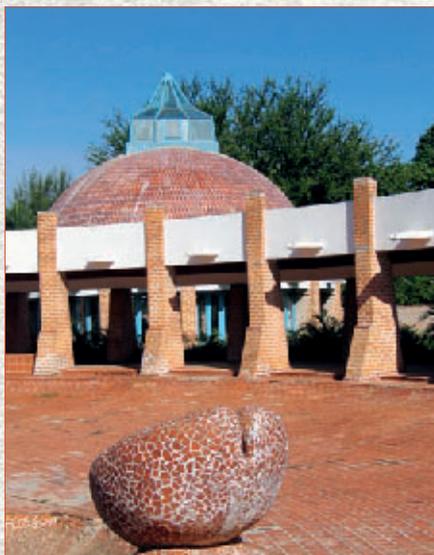
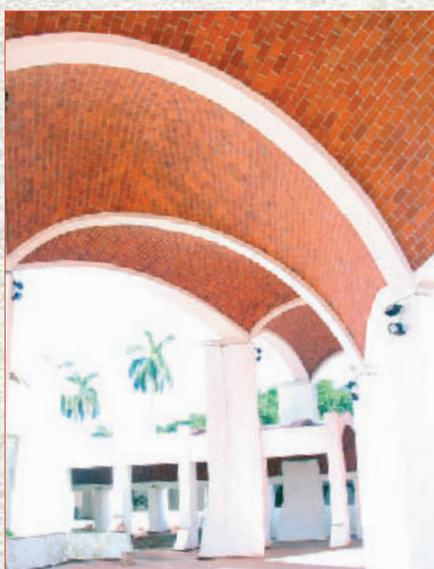
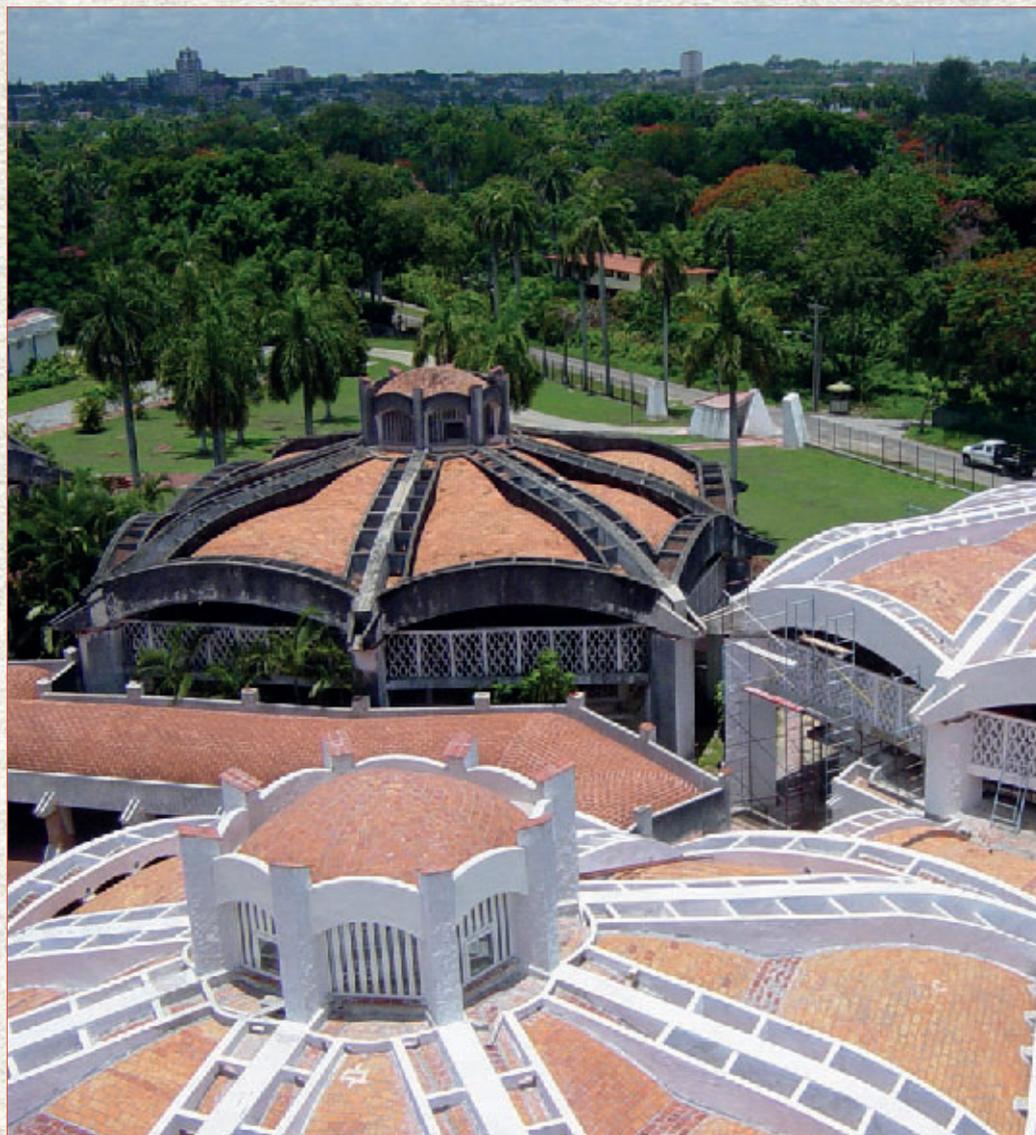
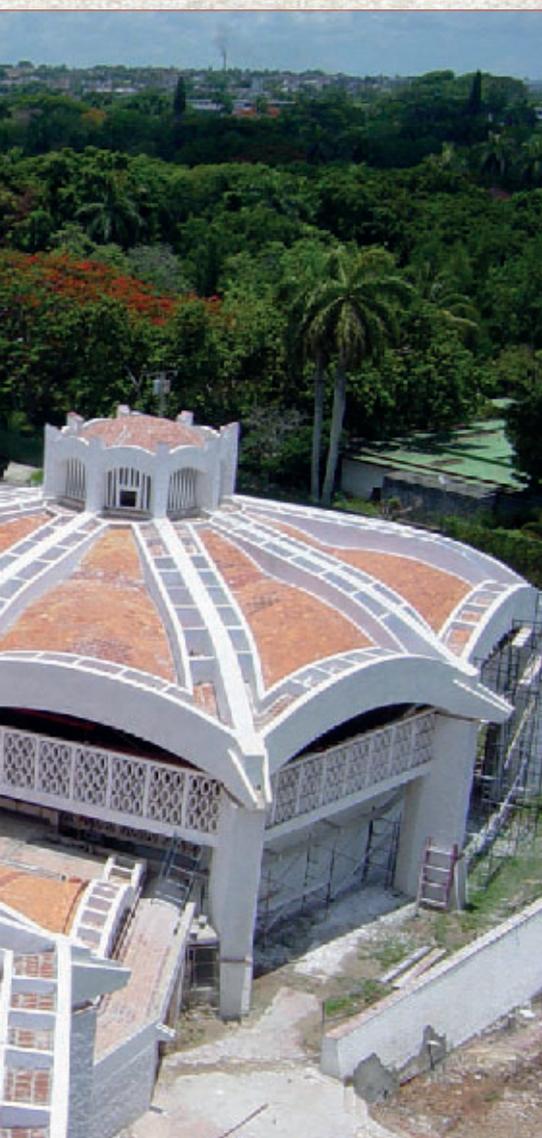
*Below. The final result of the renovation work.*
