# SANT'APOLLINARE NUOVO

High technology systems have been used in the restoration and reconstruction of the Basilica complex of Sant'Apollinare Nuovo in Ravenna.

The Basilica of Sant'Apollinare Nuovo in Ravenna was built during the reign of Theodoric (493-526) as an Arian Christian Palatine Chapel attached to the adjacent Theodoric Palace. Its mosaics are among the works of art listed by UNESCO as being the "Heritage of Mankind". 1,500 years after its construction, the Basilica complex was badly in need of restoration. The work was one of the many projects financed as part of the Holy Year 2000. The contract was awarded to the Consortium Ravennate delle Cooperative di Produzione e Lavoro and the work was executed by the Ediltecnica company of Ravenna.

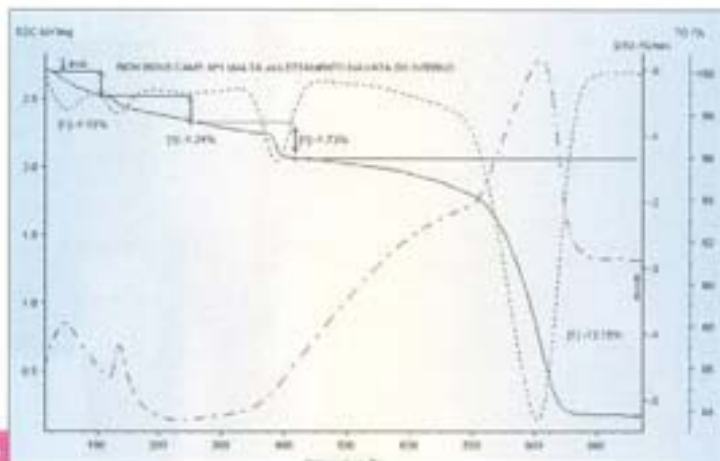
**A.** TG/DSC analysis of the brick mortar bed in the right-hand aisle revealed the amount of gypsum present, along with the amount of organic substances, lime and calcium carbonate contained in the mortar.

Tests made on samples of the mortar bed in the right-hand aisle of the Basilica showed that the mortar was composed of common lime (that had completely carbonated), mixed with siliceous aggregate, quartz, and sodium and potassium feldspar. The amount of gypsum found suggested it did not result from pollutants present in the atmosphere but that it was originally used to modify the plasticity of the mortar (a technique used in the past).

During restoration, the presence of the gypsum made it necessary to use a special technique based on technologically advanced material. Gypsum reacts with cement-based materials to form ettringite. Ettringite causes delamination of the strata and destroys the material.

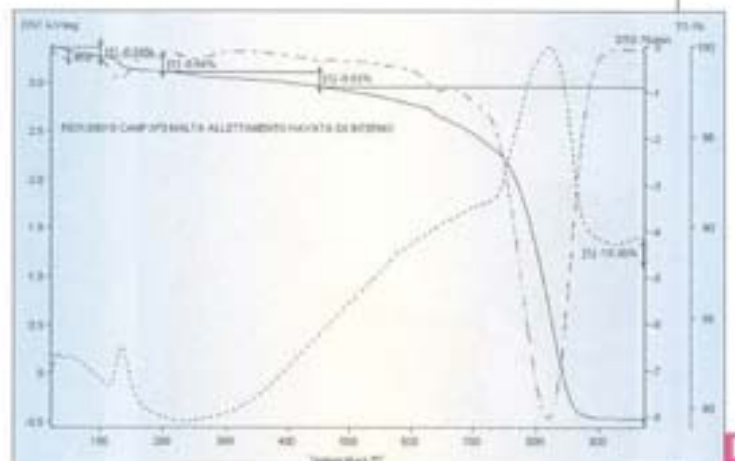
**B.** TG/DSC analysis of the brick mortar bed in the left-hand aisle.

Here the analysis of samples from the mortar bed showed the mortar was composed of lime mixed with siliceous aggregate. X-ray diffraction revealed the presence of ettringite produced by the reaction between the free lime, gypsum, and clay present in the sand that was used in the plaster.

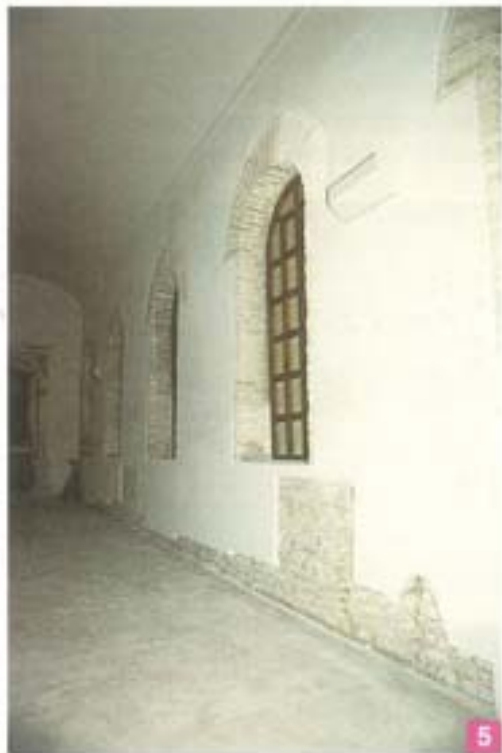
4. Applying a coat of MAPE-ANTIQUÉ MC mortar which is insensitive to aggressive agents, yet has performance characteristics similar to those of antique lime-based mortars.

MAPE-ANTIQUE MC was used for pointing the brick, part of which was left exposed. MAPE-ANTIQUE MC is a light-coloured dehumidifying mortar which is insensitive to aggressive agents. However, it has a degree of porosity, modulus of elasticity and mechanical strength similar

to those of antique lime-based mortars. MAPE-ANTIQUÉ FC, a pre-mixed ready to use fine grain sulphate-resistant mortar, was used to finish the renders. Using the MAPE-ANTIQUÉ system also enabled dimensional stability to be achieved in a short time because of the low level of lime present in the system. After only one week the concentration of lime was minimal, unlike normal binders in which the level of lime stays high for years.

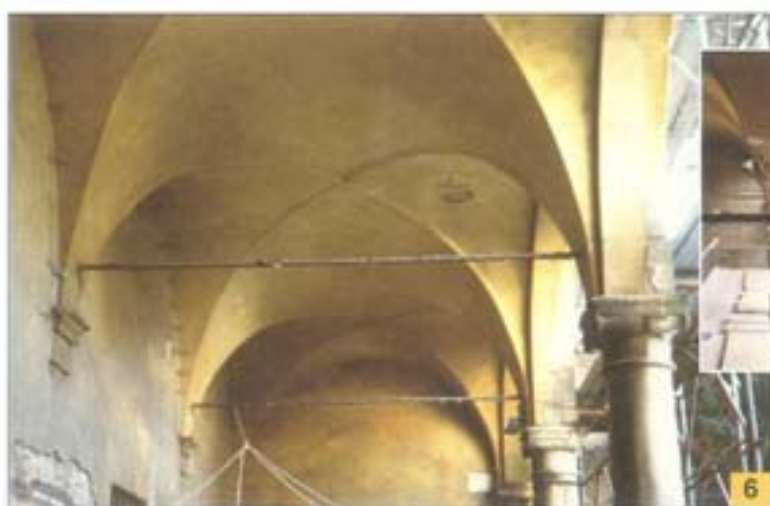
5. The right-hand aisle where a transpiring render was applied using the MAPE-ANTIQUÉ system.

The lab results enabled Mapei to determine the test techniques to be used for the restoration of the Basilica. The MAPE-ANTIQUE system was used for the restoration. On both aisles a scratch coat of MAPE-ANTIQUE LC was applied. MAPE-ANTIQUE LC is a special cement-free, sulphate-resistant binder for macroporous renders.

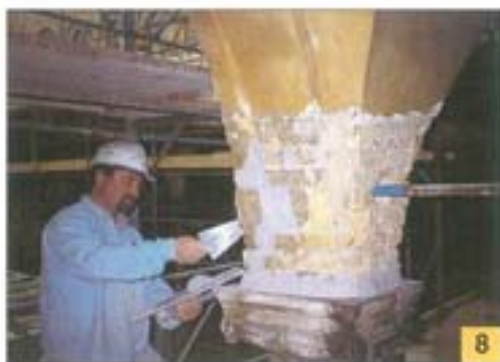
6. Detail of the metal tie rods reinforcing the arches of the cloister before the start of restoration.

Then the damaged brick surface was soaked with water, saturating the cracks as well. The tie rods were given a protective coating of MAPEFER, a cementitious mortar with corrosion inhibitors for metal reinforcement. Then the bricks were coated with MAPE-ANTIQUE MC mortar in order to contain an injection of EPOJET through tubes. EPOJET is a super-fluid epoxy resin that is waterproof and polymerises without shrinkage. MAPE-ANTIQUE FC was used as a finishing.

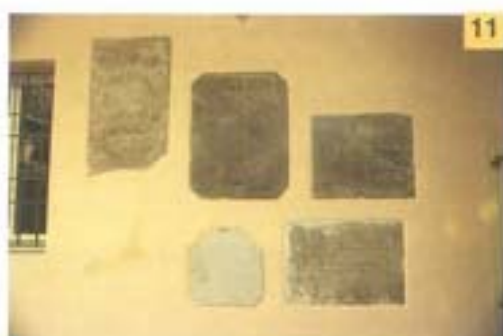
10

10. After restoration, the arches of the 16th century cloister can support the weight of the floors.

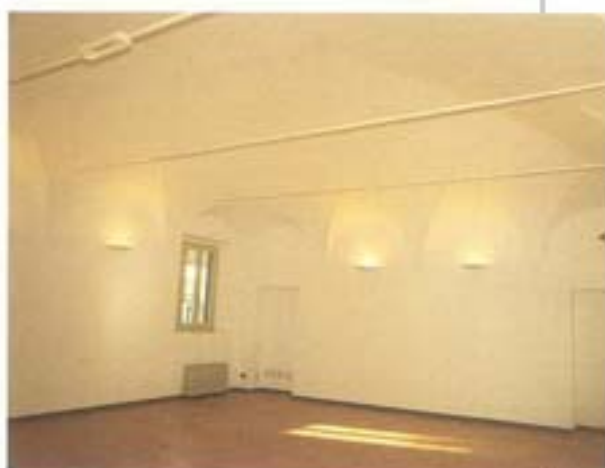
11

11. The two-metre high transpiring render applied using MAPE-ANTIQUÉ MC + MAPE-ANTIQUÉ FC.

The same system made up of MAPE-ANTIQUE MC + MAPE-ANTIQUE FC was used to construct a two metres high transpiring render on the wall of the cloister that supports the Mosaic Museum. The same system was used in the private sacristy of the Archdiocese of

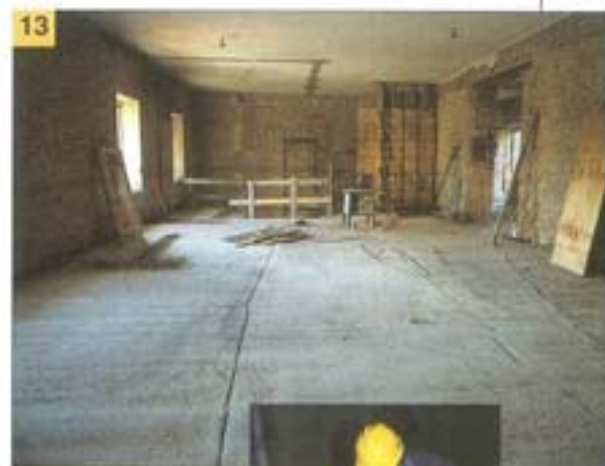
13

13. The area dedicated to housing the Mosaic Museum and its 5th century mosaics prior to laying the new flooring. The surface will have a neutral, unobtrusive look so as not to distract from the mosaics on display.

mosaic floors of the Theodoric Palace that date back to the 5th century A.D. The exhibit spaces required a very neutral type of floor that would not distract from the mosaics. A sheet of polythene was laid over the concrete slabs before placing a floating TOPCEM screed 5 to 6 cm thick over it. TOPCEM is a fast drying special,

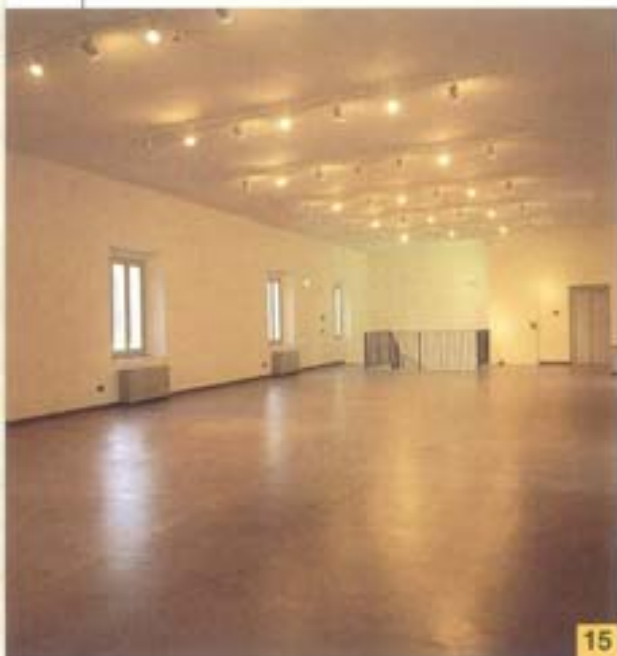
15

15. The waxed ULTRAPLAN Mosaic Museum floor.

normal setting hydraulic binder. ULTRAPLAN, a fluid, cementitious self-levelling ultra-fast setting compound, was later poured over the screed. The hardened ULTRAPLAN was then treated with a wax finish.

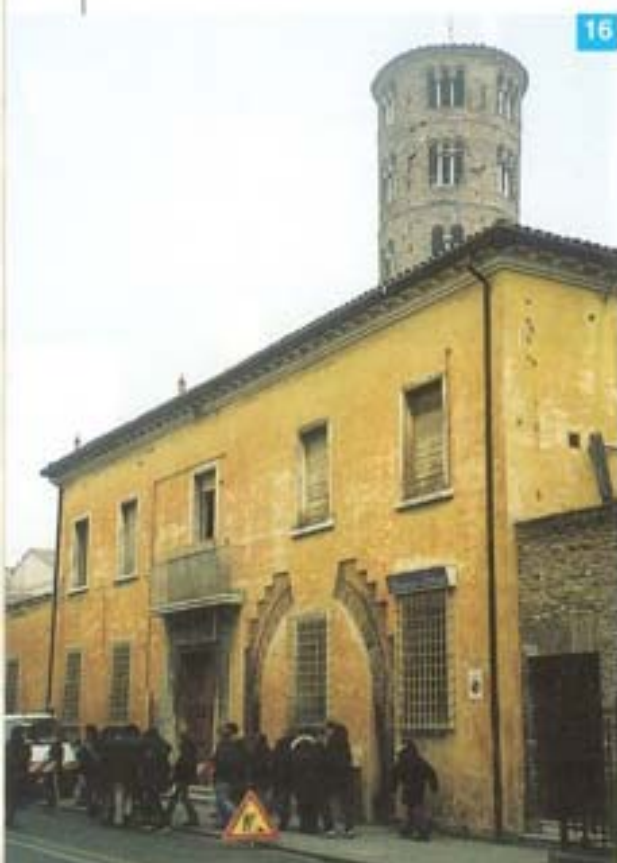
16

16. The exterior of the former Corso Cinema before restoration: the plaster was completely carbonated due to the presence of ethringite.

walls were badly decayed. Analysis revealed the composition of the original mortar which was now completely carbonated: 1 part gypsum, 1 part hydraulic lime and 3 parts inert silicas. Here, too, the presence of ethringite led Mapei to assume that there had been an attempt at restoring the building using antique materials in more recent times.

The new restoration was performed using a mortar with cement-free binders. A scratch coat of MAPE-ANTIQUE MC was applied, followed by a finishing coat of MAPE-ANTIQUE FC. The same system was used on the two metre high support columns and walls of the modern cloister.

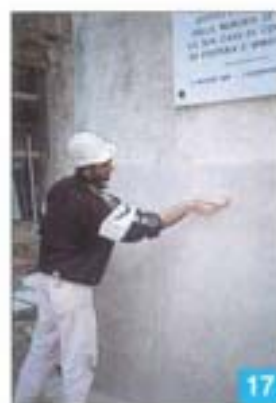
17

17. MAPE-ANTIQUE MC being finished with a coat of MAPE-ANTIQUE FC, a light-coloured, cement-free fine-grain mortar.

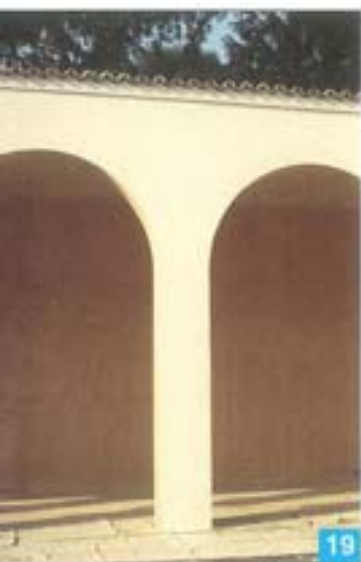
18. A new façade for the Holy Year: the external masonry walls face the Corso (main thoroughfare) and are plastered with MAPE-ANTIQUE MC + MAPE-ANTIQUE FC.

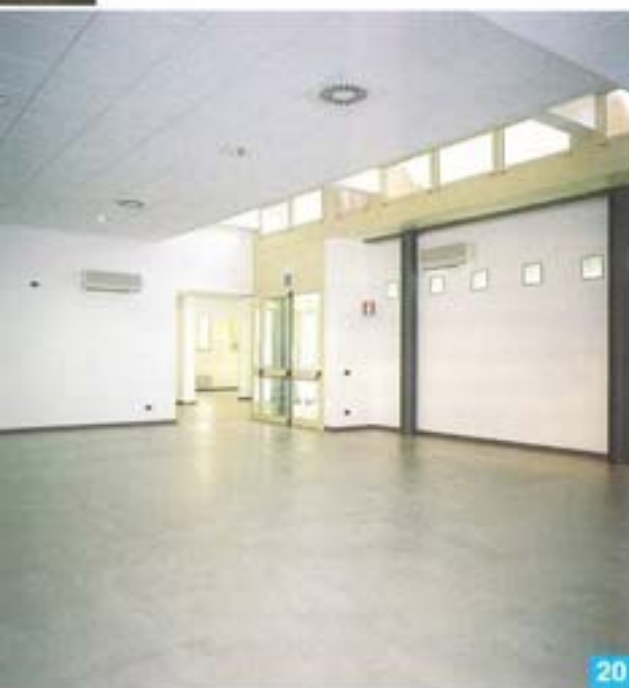
20

20. The modern entrance hall of the Mosaic Museum with its unobtrusive floor.

industrial flooring in buildings and especially in show rooms has become a fast growing phenomena if not a fad. The system TOPCEM+ULTRAPLAN was used because of its excellent practicality, quality, and aesthetic effect and was used for the floors of a room in the Mosaic Museum and in different areas between the Basilica and the Theodoric Palace. The areas restored with this system are the entrance hall, the multi-purpose auditorium, the visitors' welcome centre, the restaurant and the management offices.
