The three

The Three Crowns office building in Augsburg, Germany gets an impressive new look after a complete remodeling.

Project: Three Crowns Building, Augsburg, Germany

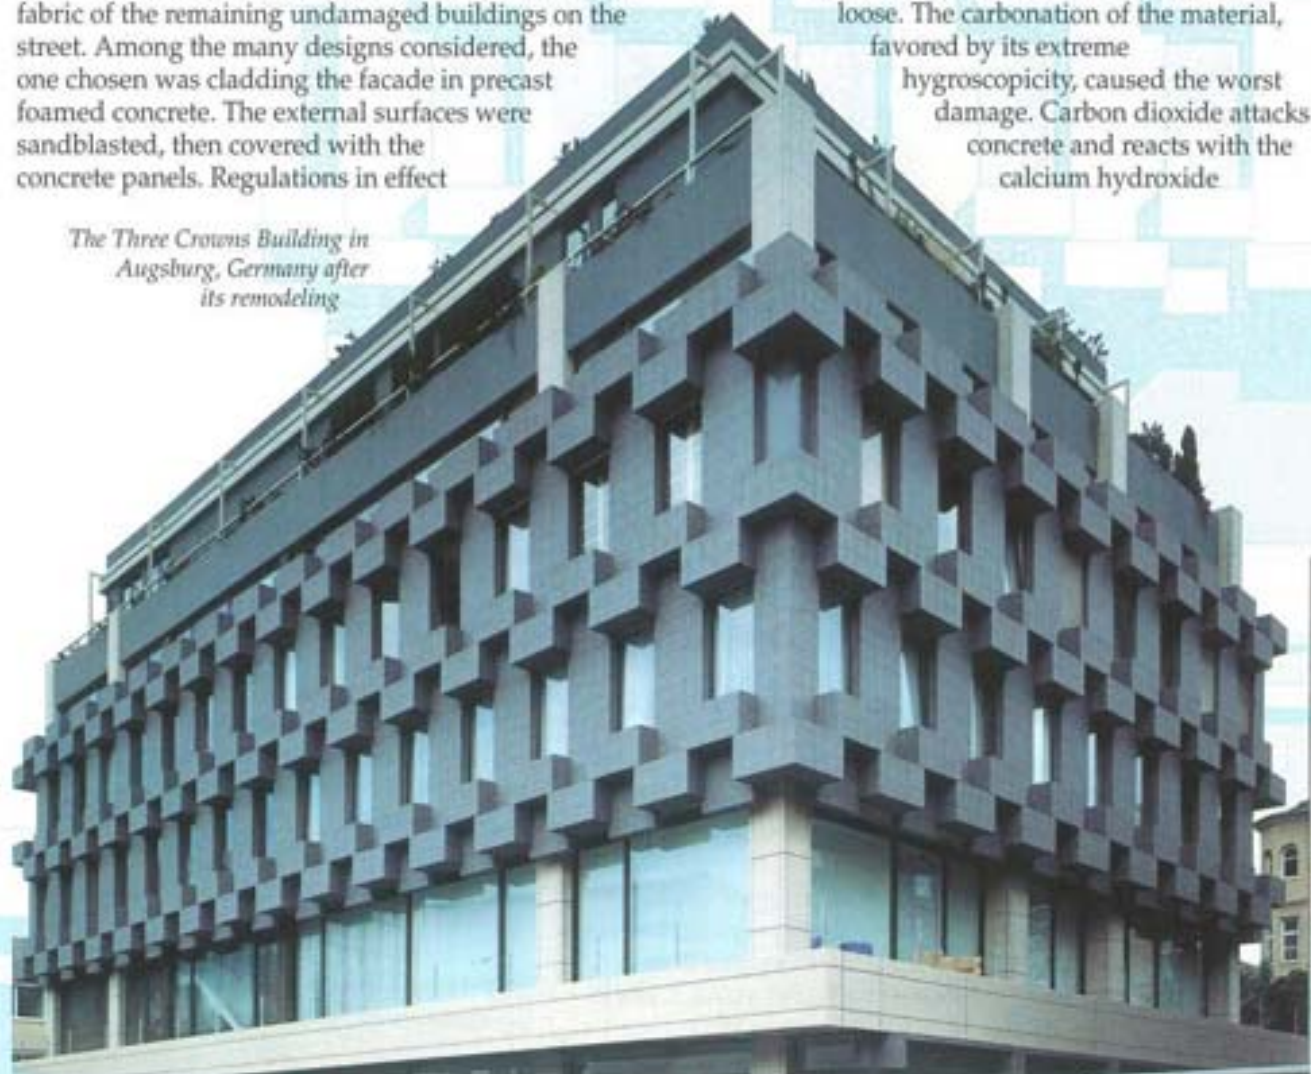
The Three Crowns Building in Augsburg, Germany after its remodeling

After the underlying masonry was properly prepared, repair work was started on the damaged concrete, following methods outlined in DIN standard 18349, specification VOP, section C. The concrete was repaired with special cementitious mortars. The tile was then applied on a surface measuring about 2,100 square meters (22,600 sq ft) using methods prescribed in DIN standard 18157, section 1, as called for in the design and the installation criteria for external cladding in DIN 18515, section 1, of April 1993.

KERABOND* was used to bond the cladding. This product is a powdered ceramic tile adhesive that complies with DIN 18156, section 2, modified with ISOLASTIC*, an elasticising latex for cementitious adhesives. This adhesive is highly flexible and reduces the stresses caused by thermal expansion between the ceramic cladding and the concrete substrate. The adhesive was applied to both tiles and the substrate using the backbutter and float method. This eliminates voids on the substrate, preventing water from seeping in under the tiles, causing them to come loose when ice forms.

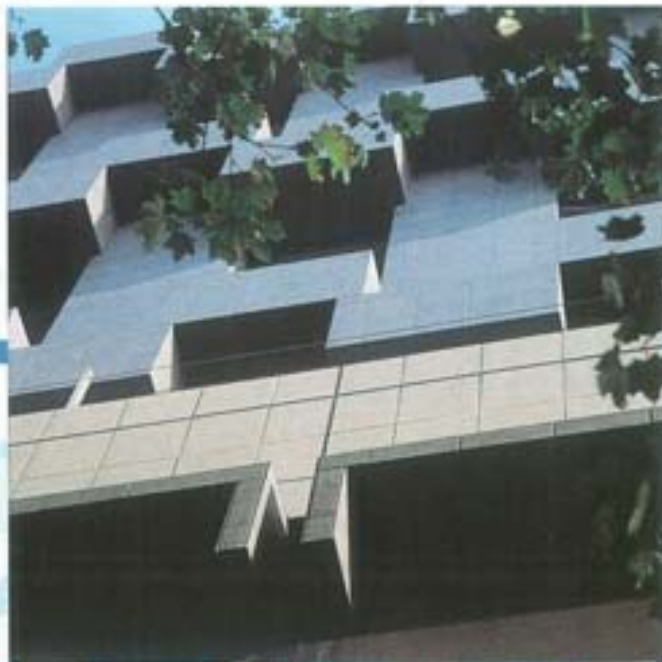
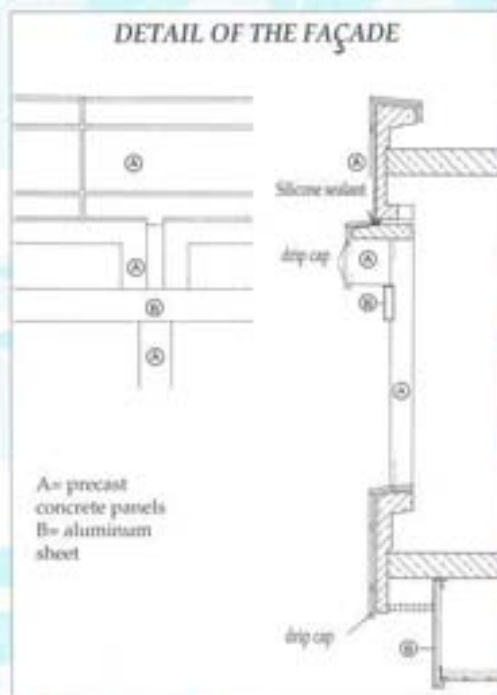
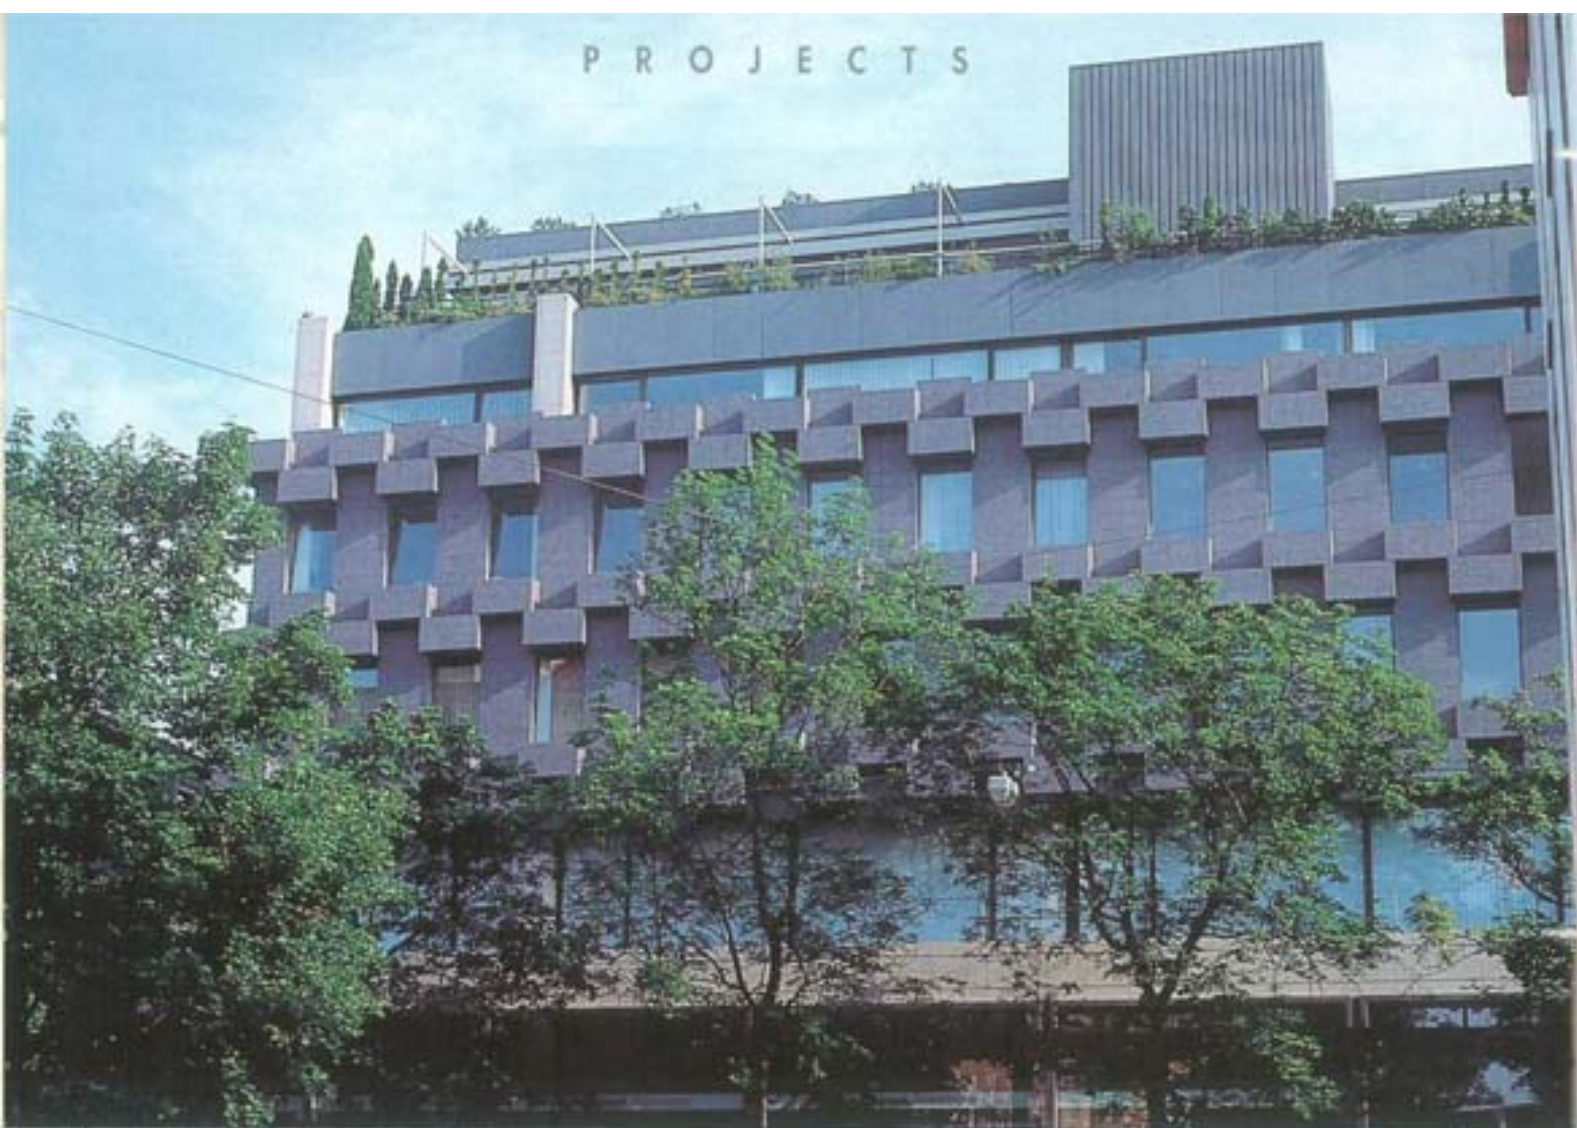
At left and on opposite page, details of the facade with its eye-catching porcelain tile cladding

A trial application was carried out using AP 756 30x30 cm/12"x12" porcelain stoneware tiles by Flaviker. Adhesives and grout were selected that

the 5 mm-wide joints. ULTRACOLOR is a fast-setting, fast-hardening cementitious grout that is flexible and water-resistant. A customized shade of ULTRACOLOR was used to give the facade a uniform color, as requested by the city planning commission. The expansion joints on the facade and the aluminum profiles of the windows were sealed with a one-component polyurethane sealant. Using ceramic tile installed with hi-tech materials and systems satisfied the architect's requirements and dispelled all the doubts initially expressed by the city zoning and planning commissions about the size of the tiles used. The long custom-colored vertical and horizontal grout lines make the parapets stand out in bold relief, yet pull all the elements together into a harmonious overall look that is now much admired by all concerned.
