*Oratorio della Passione
in Sant'Ambrogio, Milan*

**REPAIRING THE PLASTER WORK
AND RESTORING THE FRESCOES**

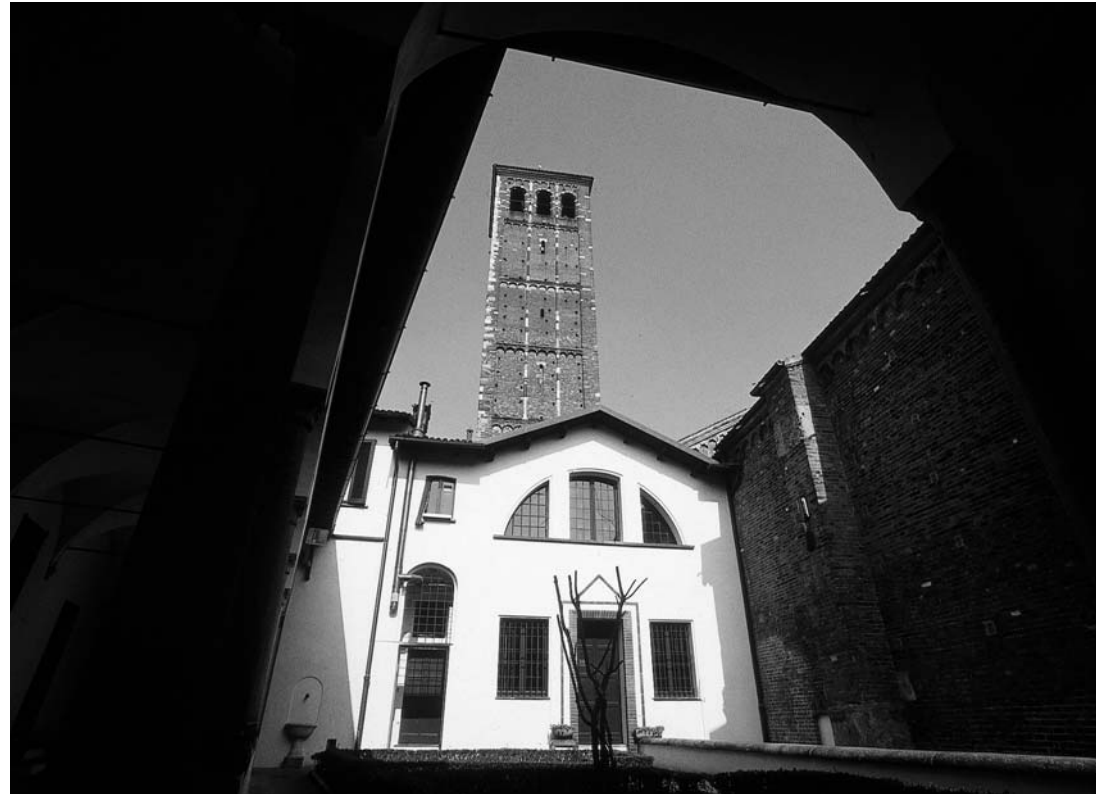
Overall view of the main façade of the Oratorio della Passione showing the Campanile dei Canonici.

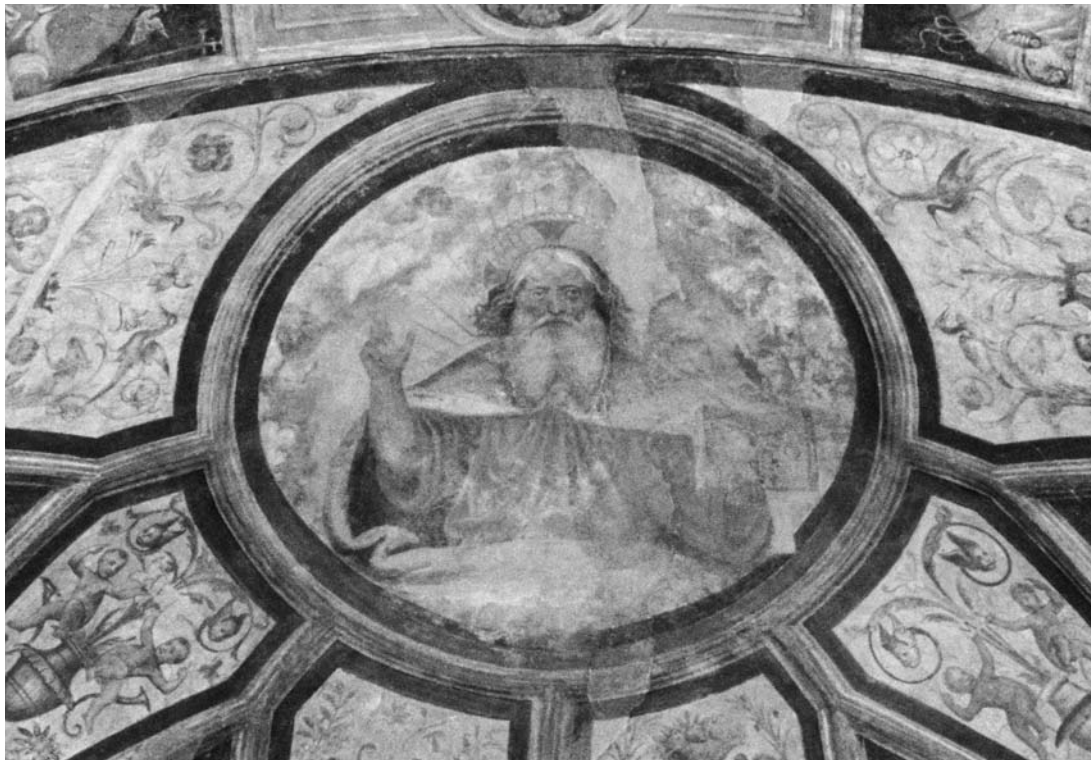
Central detail of the apse vault: The Everlasting Father.

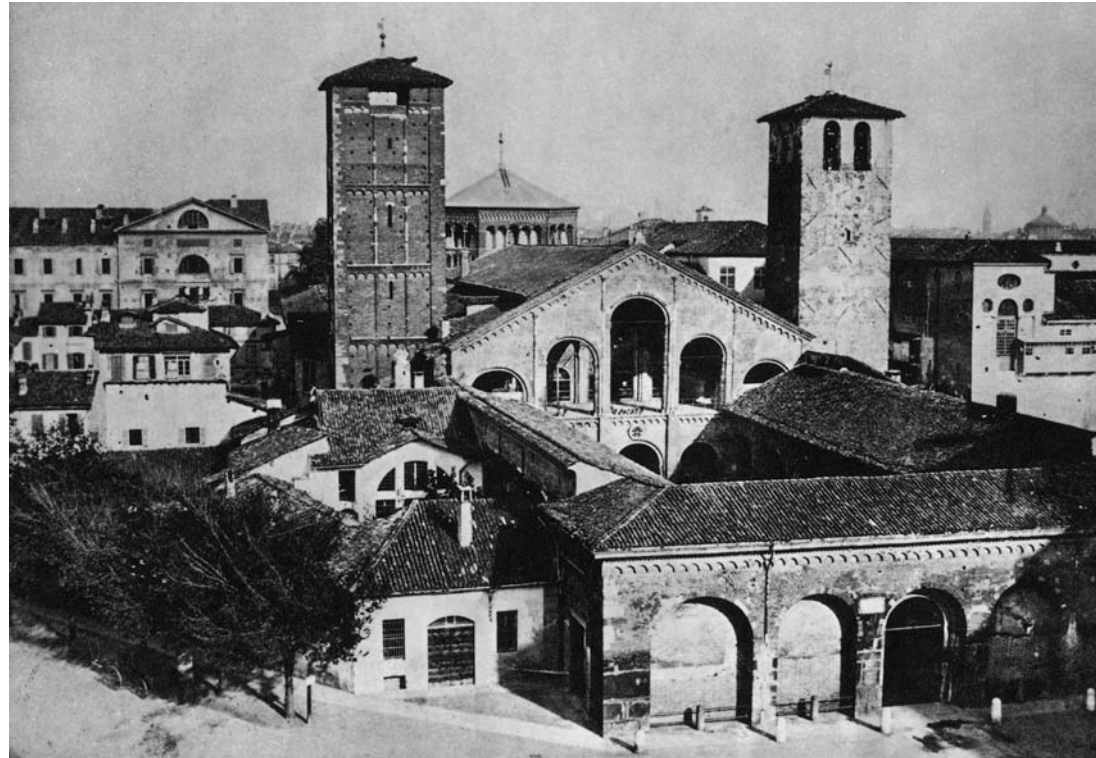
The Basilica di Sant'Ambrogio, as it looked about a century ago: photo from 1875.

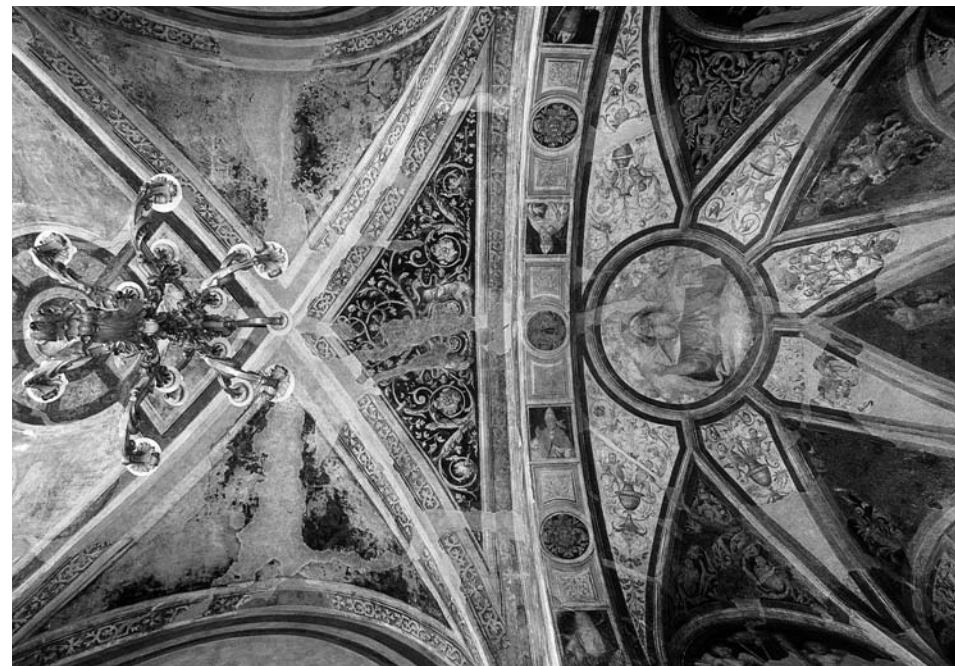
Detail of the hall and apse vault after completing repairs.

The restoration work on the vault decoration was more intricate. The extensive cement patches designed to repair damage inflicted during the war had hidden some of the old decorative paintings in several spots and also caused efflorescence due to all the soluble salts found in the material itself.

Different methods were used according to the state of repair of the pictorial decoration. Where it was easy to read the overall pattern of the design, it was decided to opt for a philological reconstruction of the gaps to restore continuity to the ornamentation. The lack of any designs for the central vaults, set around the rota marked by the Angel of Death, meant the basic colour scheme was taken up again so that visitors looking up from the hall below can “grasp” a unitary pattern, without falsifying – i.e. imagining – the state of affairs that time has failed to conserve to History.

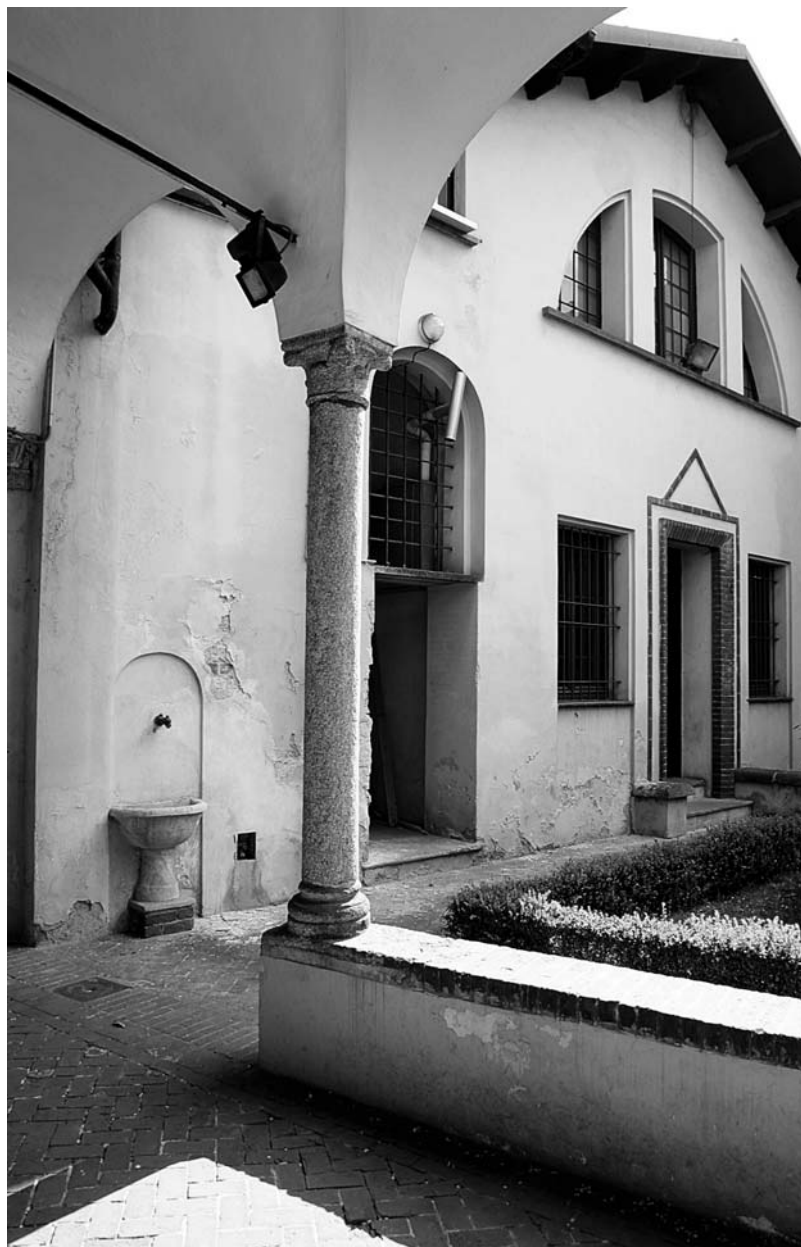
Main façade of the Oratorio della Passione before repairs.

The last part of the description of the repair work concerns the plaster work on the portico and main façade of the Oratorio della Passione. The plaster was removed down to the masonry underneath for a total of 150-170 cm.

The substrate was washed carefully the next day in order to get rid of any loose or flaking parts and any other organic or inorganic foreign pollutant (soluble salts). The plaster work was reconstructed using Mapei-Antique Rinzafo and Mapei-Antique MC and then "smoothed off" using Mapei-Antique FC, following the same procedures described in paragraph 1.

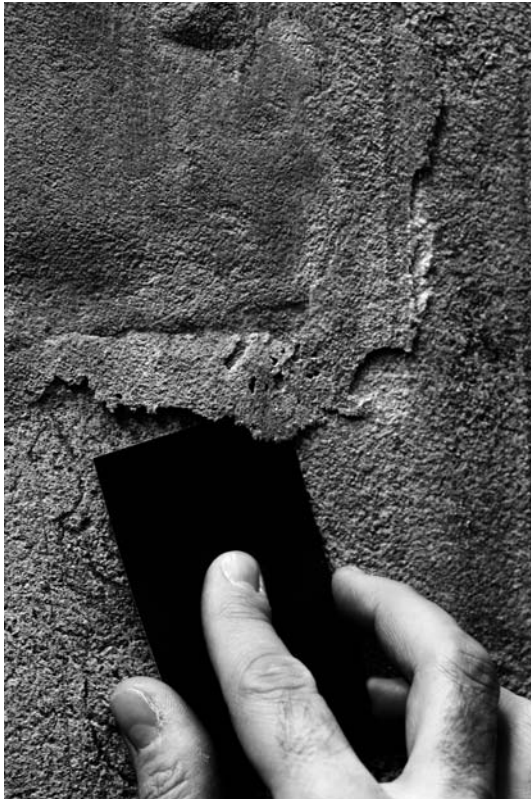
Before carrying out any repair work, a number of stratigraphic studies were carried out on the portico walls, main façade, lunettes and hall walls, reaching as far down as underlying substrate. These operations were performed to assess the firmness and quality of the underlying finishing work in need of restoration, and to check none of the original paint work was still there.

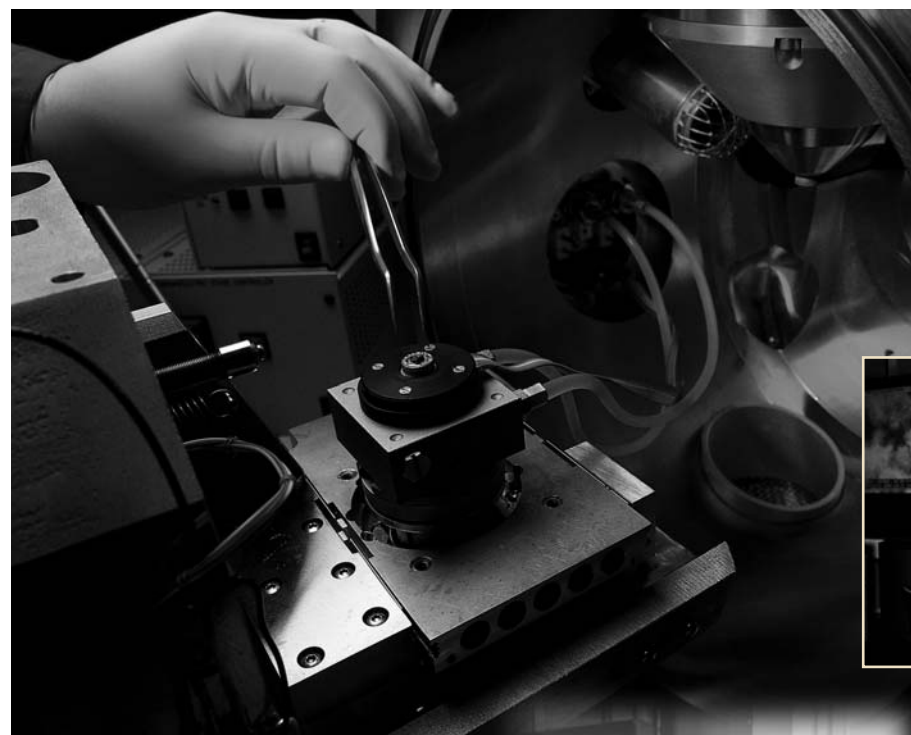
*“Environmental”
electronic microscope
with FEG source
(ESEM) - Mapei R&D
Laboratories in
Milan.*

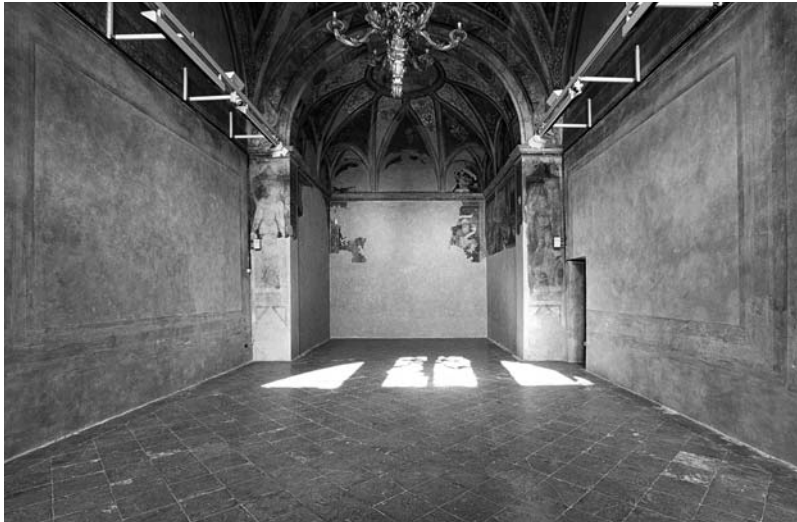
Overall view of the hall after repairs.

The tonachino was carefully removed from the aisle walls (two side walls and fake façade wall) and from all around the edge of the presbytery, since there were no signs of any old paint work to protect and the tonachino was damaged, flaking and completely detached from the rendering below. All the plaster work involved in the 20th century painting/decoration was then washed repeatedly, using a rice paper diaphragm as a precaution.

After carrying out the aforementioned operations, the plaster over the floor was all removed over a height of 30-50 cm down to the brick work below. It showed the usual signs of decay due to widespread rising damp that had caused saline efflorescence to form. It is worth mentioning that, even though it would have been better to remove more plaster than was actually the case, it was decided to only remove as much as was absolutely necessary, since a premium was placed on safeguarding as much painted surface as possible, as specified by the Superintendent’s Office.

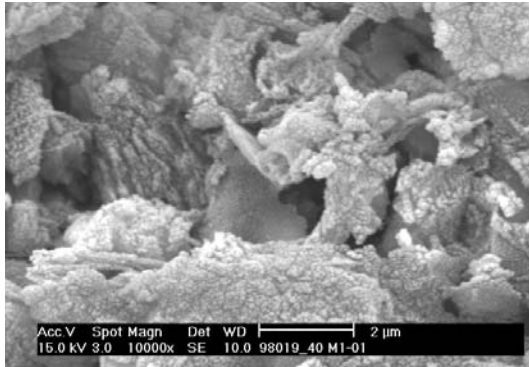
Micro-photograph under an electronic microscope of very old mortar: note the completely carbonated amorphous mass.

(Picture taken at the Mapei R&S Laboratories in Milan).

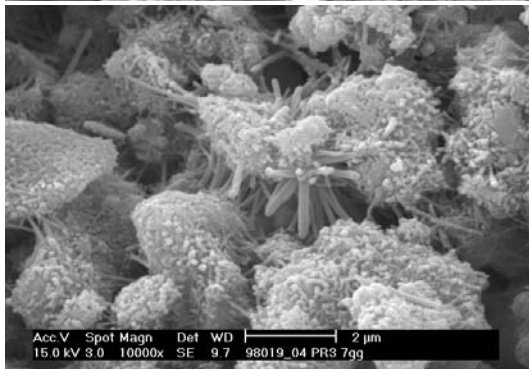
Micro-photograph under an electronic microscope of the hydraulic lime:

You can see the tiny needles of the C-S-H polymer characterising hydraulic binders.

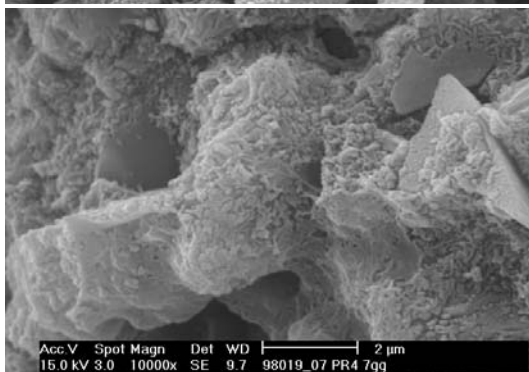
Micro-photograph under an electronic microscope of Mape-Antique after 8 days' ageing:

note the rounded structure typical of a system that has already "stabilised".

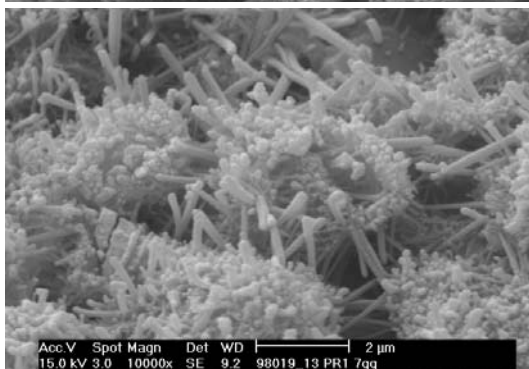
Micro-photograph under an electronic microscope of cement: here again you can see the tiny needles of the C-S-H polymer.
