Maintaining the

Redeveloping the canals and banks of a stunningly beautiful city like Venice is no easy matter.

Canals of Venice

Venice canals, Italy

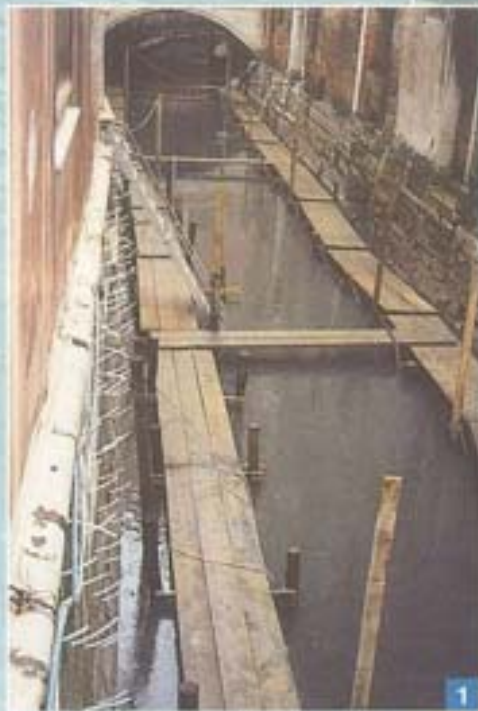
Photo 2.
The bank walls in Venice are made from various building materials: the photo shows the example of a brick wall.

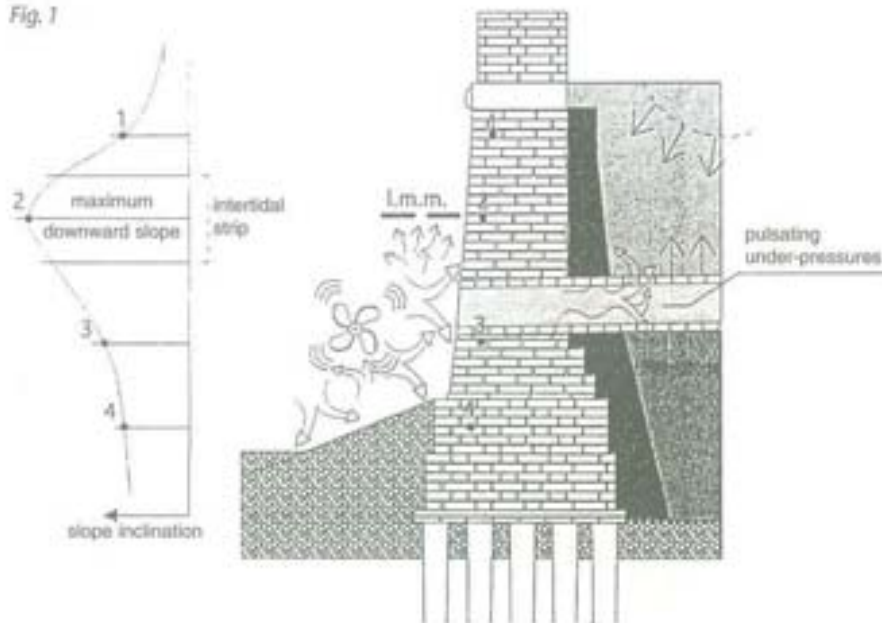
Fig. 1

Figure 1.
How cavities form on
the wall faces.

The delicate issue of the maintenance of banks and canals, and the kind of damage and disrepair they suffer due to the gradual wearing away of bank walls, has called for careful scheduling of operations, both when first being carried out and then later during maintenance and protection work. Unless the constant washing effect of the water, that is

seeping more and more easily into the underwater walling, is effectively combated, then the banks are gradually weakened and the bearing structure suffers increasingly serious damage. Unless quick and effective action is taken, the worsening state of general

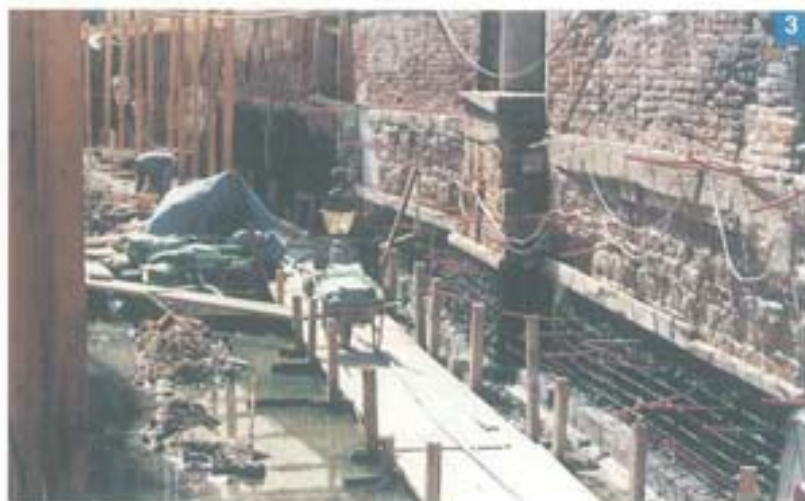
Photo 3. A dry canal. *Stabilcem*, a superfluid expanding cement binder used for filling cracks and cavities and porous gaps in rock and concrete, is injected into the canal bank. The product has here been used in the HV (high viscosity) version, specially developed for this building work.

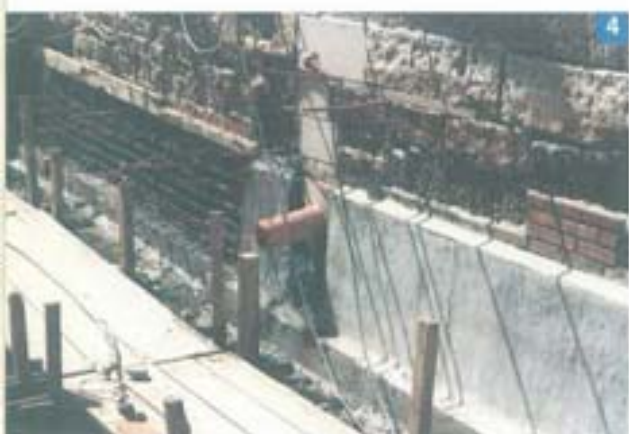
Figure 2.
Excavations in the
presence of water for
maintenance and
hygiene purposes.

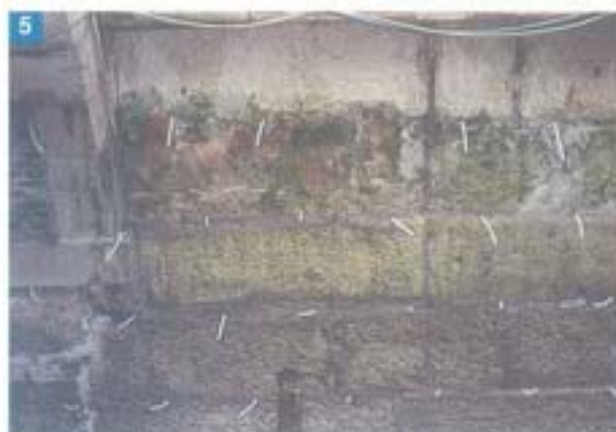
Photo 5.
Stabilcem is injected
after sealing the grouts
on the wooden coating
with Mapegrout T60S,
a mortar resistant to
chlorides and
sulphates.

walls are filled while guaranteeing the injected product does not decay over time, even if subject to both mechanical and chemical stress. The product's properties produce a smooth-flowing and cohesive paste, keeping its fluid-expansive characteristics unaltered without bleeding or segregation risks. This means the muddy residue in the wall structure is useful again, due to both their beneficial retaining/interstitial-saturation action and to positive alterations to mechanical resistance and elastic modulus. After sealing the grouts in the wooden coating using MAPEGROUT T60S*,

a sulphate-resistant fibre-reinforced controlled-shrinkage mortar resistant to chlorides and sulphates, the injection holds even, as in this case, in the presence of wet environments or where water is likely to seep in.

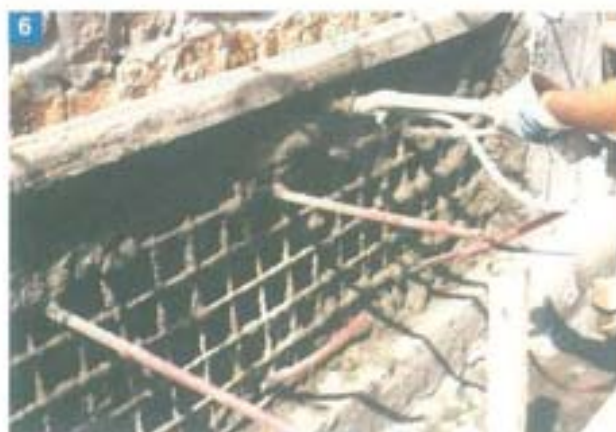
Photo 6.
A protective layer of
plaster was applied at
the foot of the
foundations using
Mapegrout T60S as a
mortar and an
electrically welded
stainless steel mesh.
The mesh was "guided"
into position to
withstand the ebb and
flow of the tides and
constant aggressive
action of the water,
and to act as plaster-
carrier reinforcement
to make it more
resistant to accidental
bumps and bangs.

At the foot of the foundations, from less than 70 centimetres from the average sea level to the bottom of the canal, an approximately 6 cm protective layer of MAPEGROUT T60S* was applied using stainless steel mesh (measuring 10x10 calibre 5).

The mesh had to be "guided" into position to prevent expansion as the product was setting

(chosen to withstand tidal action and the aggressive effects of water) and also to act as a grout-carrier support helping to prevent damage due to bumps and bangs.
