by Nicolò Marchetti, Lorenzo Nigro, Hamdan Taha, Francesco Nigro, Tiziano Cerulli *

The archaeological expedition L involving Rome's La Sapenzia University and Palestine's Department of Antiquities which was restarted in Tell es-Sutlan in the spring of 1997, has led to the discovery of the ruins of fortifications and buildings from the ancient city of Jericho, dating it to the 2nd and 3rd centuries BC. All of the areas covered by the dig have yielded very important data. Right from the start, the project has concentrated on the study of the urban structure of this extraordinary city, renowned as the world's oldest thanks to its astonishing 10,000 year history. 40 years on from the end of the last dig, the ancient city of Jericho (Tell es-Sultan or "Hill of the

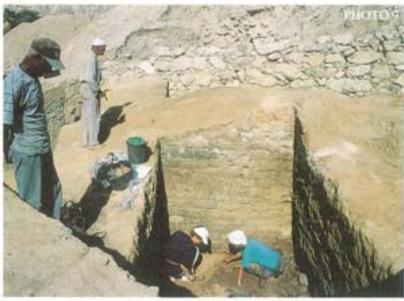
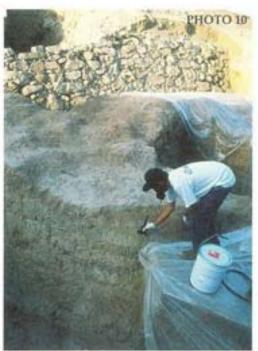
Photo 7, reconstruction of Jericho approximately 1900 BC. The first rampart is seen in white with the (still unconfirmed) area E gate, while the lower city around the spring is green. Photo 8, the megalithic wall dating from 1600 BC at the base of the second defensive rampart in area A. Photo 9,work in progress. area A, excavation of the layer with the large collapsed 1700 BC building. Photo 10, restoration and reinforcement of the great brick tower belonging to the fort in area A., 1800 BC. Figure A, original untreated brick. Figure B, original treated brick. Note the silica "bridges". Optical microscope imaging courtesy of Mapei R&D laboratory.
