The Ducal Palace of Sassuolo

Avantgarde technology and in-depth chemical analysis of the original building materials resulted in a superb restoration that enabled this splendid monument to be opened to the public.

Restoring the floors: a winning collaboration

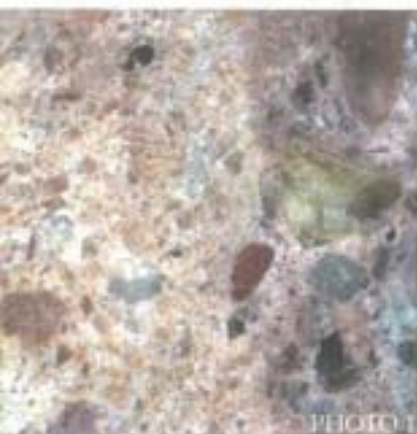
Photo 1
A "collar" 0.2 to 0.3 mm thick composed predominantly of calcium carbonate is visible on the surface of the terracotta tile. The collar is caused by lime in the mortar bed that migrates into the body of the tile itself and subsequently carbonates

The mortar's state of preservation was determined by the soluble salt content which turned out to be very low, indicating that it had held up well. The mortar was a system originally composed of common lime mixed with primarily siliceous aggregate and "reactive silicates", e.g. clay. It developed its mechanical strength through a chemical reaction, the carbonation of the common lime, a process which occurred over the course of centuries. This long span of time, however, allowed the lime to penetrate approximately 200µ into the

tiles before carbonating, forming a rich surface "collar" of carbonate that caused the area where the mortar interfaced with the tile to shift to the inside of the tile itself, thus weakening it. Common lime, even if mixed with "pozzolanic" materials, damages the structure of terracotta if it is not quickly converted into calcium carbonate.

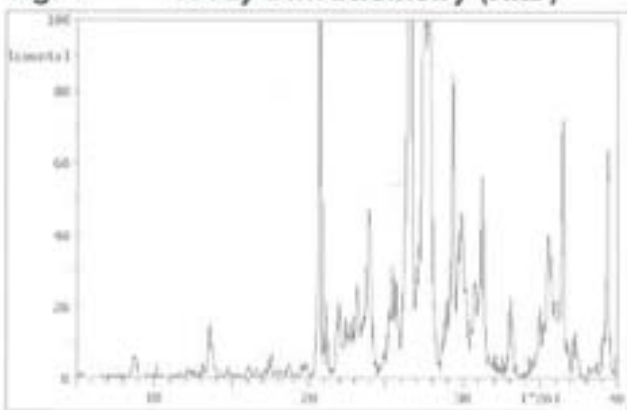
Fig. 1 X-ray Diffractometry (XRD)

The analysis shows the presence of quartz, sodium and potassium feldspar, diopside and small amounts of calcite, along with traces of the original clay (illite), confirming the predominantly silicate nature of the terracotta

The tiles analyzed showed they were composed primarily of silica with a low calcium carbonate content, a composition very similar to that of modern materials. The chemical analysis data showed they were similar to tiles fired at high temperatures with a "vitrified" body. The low amount of salts contained in the tiles was also an indication of a good state of preservation. This scientific investigation into the nature of the original materials enabled precise indications to be given as to the selection of products to be used for the restoration.

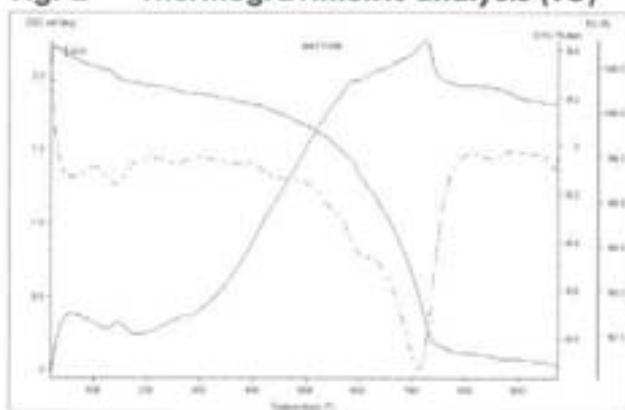
Fig. 2 Thermogravimetric analysis (TG)

This analysis also confirms the siliceous matrix of the terracotta which is approx. 6% calcite. (Data and photos courtesy of the Mapei R&D Laboratories Milan - Italy)
