VITTORIO EMANUELE II ARCADE

The mosaic floor of the “drawing room” of Milan has been brought back to its antique splendour

The mosaic floor of the Vittorio Emanuele II Arcade in Milan has been brought back to the original splendour, created in the second half of the nineteenth century by the architect Giuseppe Mengoni.

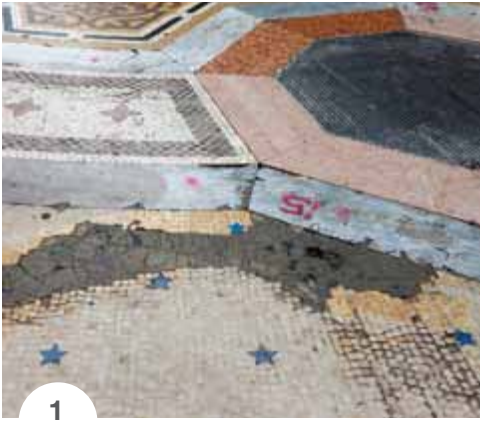
Photos 1 and 2. The flooring prior to restoration work.
Photo 3. After removing the inserts and the damaged areas, EPORIP was applied and the gaps were rebuilt with MAPEGROUT T40.

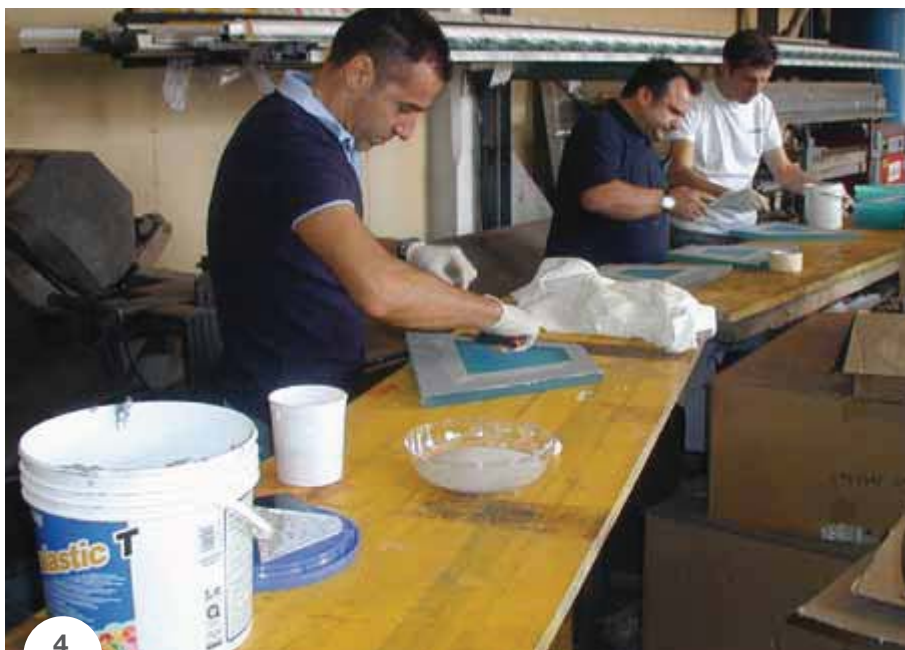
Photos 4 and 5. Where possible, the inserts were repaired in the workshop. The petals in the insert were bonded with KERALASTIC T.

The 25 mm thick Plexiglas petals in the inserts were bonded with KERALASTIC T two-component, high-performance polyurethane adhesive with no vertical slip, which also guarantees that the whole system remains watertight. The petals were then sealed with MAPESIL AC pure, anti-mould, acetic silicone sealant, with BioBlock® technology, for movements up to 25%.

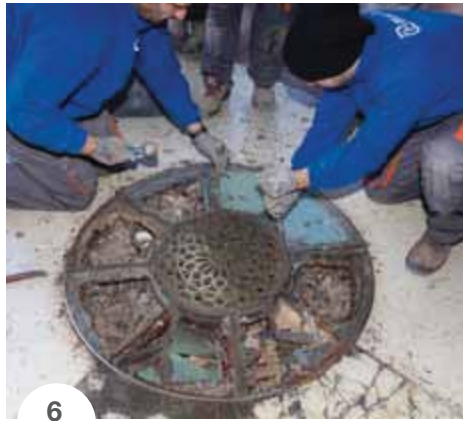
The inserts were completely deformed due to the stresses in the flooring and concentrated loads from passing vehicles. Beside, the flooring around them suffered from water infiltrating into the areas under the Arcade.

Photo 6. The inserts before the restoration work.

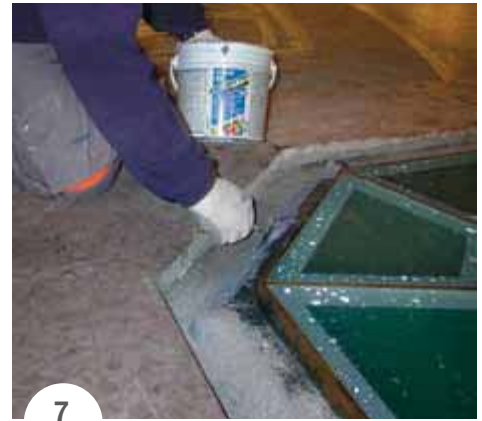
Photo 7. The restored insert placed and fastened with ADESILEX PG1 RAPID.

After completing the inserts in the workshop, each one was placed in position and bonded with ADESILEX PG1 RAPID two-component, rapid-setting thixotropic adhesive for structural bonds. All the edges of the metal frames were fastened in place so that there was a

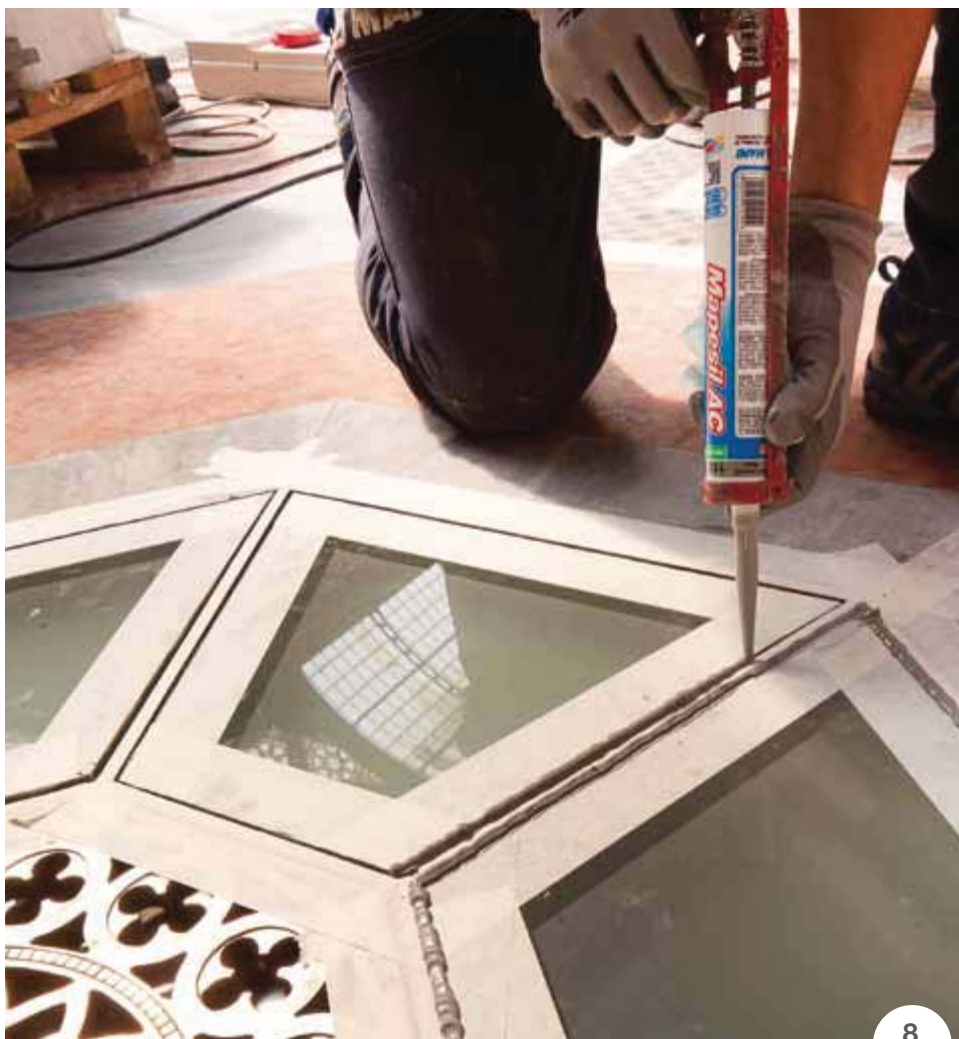
Foto 8. The inserts' joints were sealed with MAPESIL AC.

In this case too, the petals' joints were sealed with MAPESIL AC.

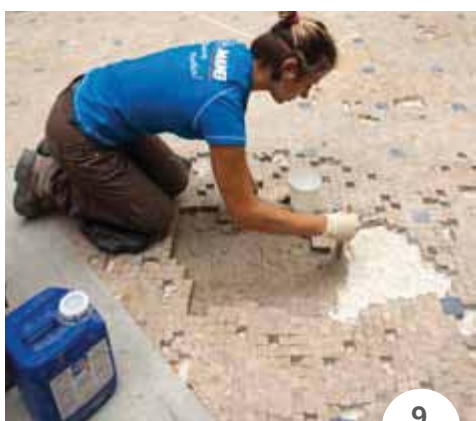
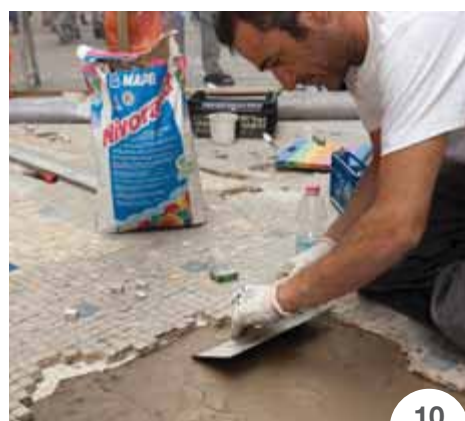
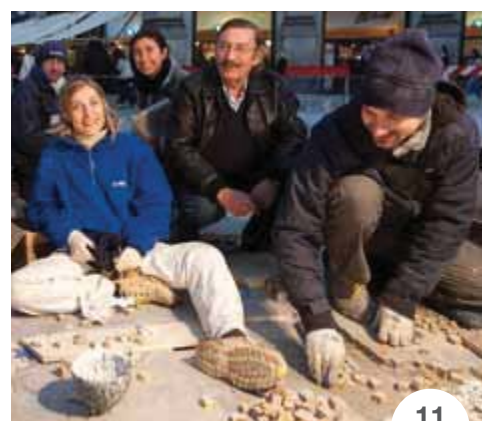
Photos 13, 14 and 15. EPORIP and MAPEGROUT SV FIBER were used to restore the mosaic of the Bull, damaged by the weather and pedestrian use. The tiles were installed with KERAPOXY.

First, around the healthy areas in the original flooring, EPORIP epoxy adhesive was injected to make a monolithic bonding of the damaged substrate. The substrate was repaired over the EPORIP layer while it was still fresh using MAPEGROUT SV FIBER quick-setting and hardening, fibre-reinforced, hi-flow cementitious mortar with stiff steel fibres. Using this system, work could be carried out very quickly, even in bad weather.

The mosaic representing the bull, considered a lucky charm on which every year thousands of people leave their mark, deserves a special mention. To prevent vibrations damaging the Bull, the mosaic was framed and then carefully removed using tiny grinders to remove the tiles. First EPORIP was applied and then, after waiting the proper time, the substrate was repaired with MAPEGROUT SV FIBER quick-setting and hardening, compensated-shrinkage hi-flow mortar, especially suitable for repairing concrete and fixing drains, man-holes and urban architectural fittings in place. The bull was then installed using KERAPOXY two-component, high-performance, anti-acid epoxy and adhesive with no vertical slip for laying and grouting ceramic tiles and stone material. The adhesive was applied on the back of each tile before placing them in position on the installation bed. The following morning, a few hours after the repair work had been completed, the bull was ready for use once again.

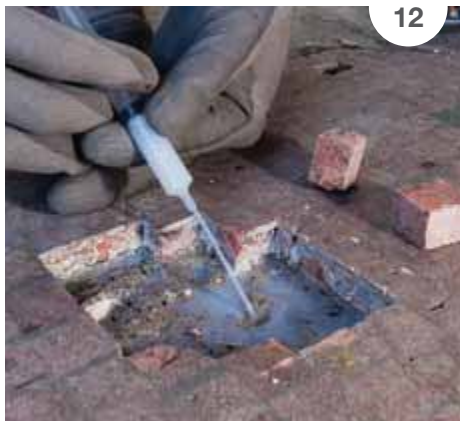
12

Photo 12. Localised consolidation of the flooring with PRIMER 3296.

The first operation was to obtain sufficient load-bearing capacity and strength in the substrate without damaging the entire flooring. PRIMER 3296 consolidating and anti-dust primer in water dispersion, with micro-particles of acrylic polymers and good penetration capacity, was applied, therefore, in the areas with poor mechanical strength.

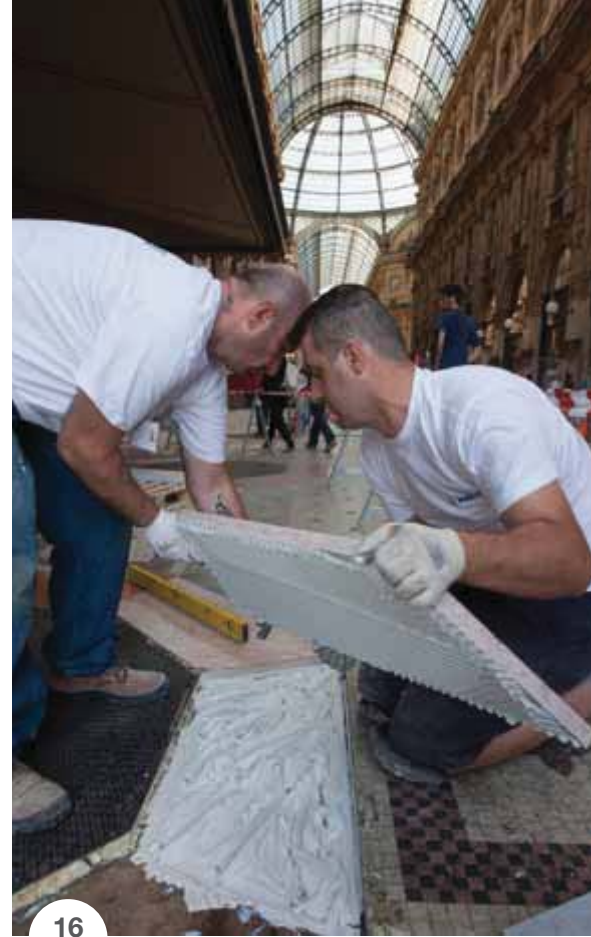
16

Photo 16. Installing the marble slabs with white ELASTORAPID.

from PLANICRETE synthetic latex rubber to improve the mortar's adhesion and strength. In other areas, where the thicknesses would allow, the marble was installed directly on the concrete substrate using white ELASTORAP-ID. All the expansion joints created around the perimeter of the inserts were sealed with MAPESIL LM.

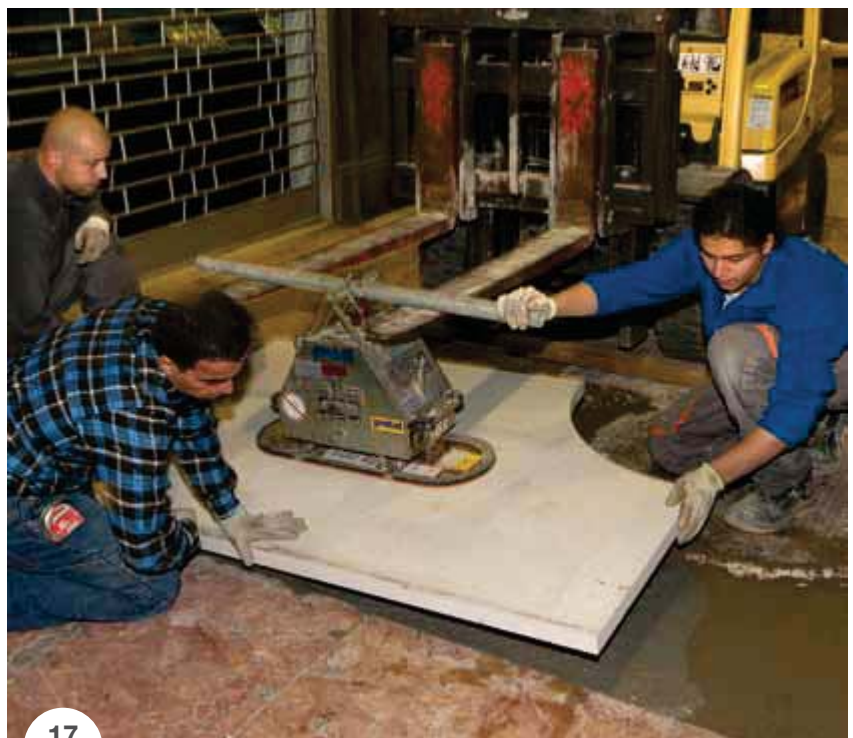
17

Photo 17. In the porticoes adjacent to the arcade, the marble slabs were re-positioned using MAPESTONE TFB 60 where the gaps were 10-15 cm thick. Where it was possible to install the slabs directly on the concrete substrate, ELASTORAPID was used.

Once the damaged part of the marble had been removed, if the gaps to be filled were as thick as 10-15 cm, the slabs were put back in place using MAPESTONE TFB 60 (pre-blended mortar with high compressive strength and good resistance to de-icing salts and freeze-thaw cycles, exposure class XF4, for installation screeds for architectonic stone flooring) after applying a layer of bonding slurry made

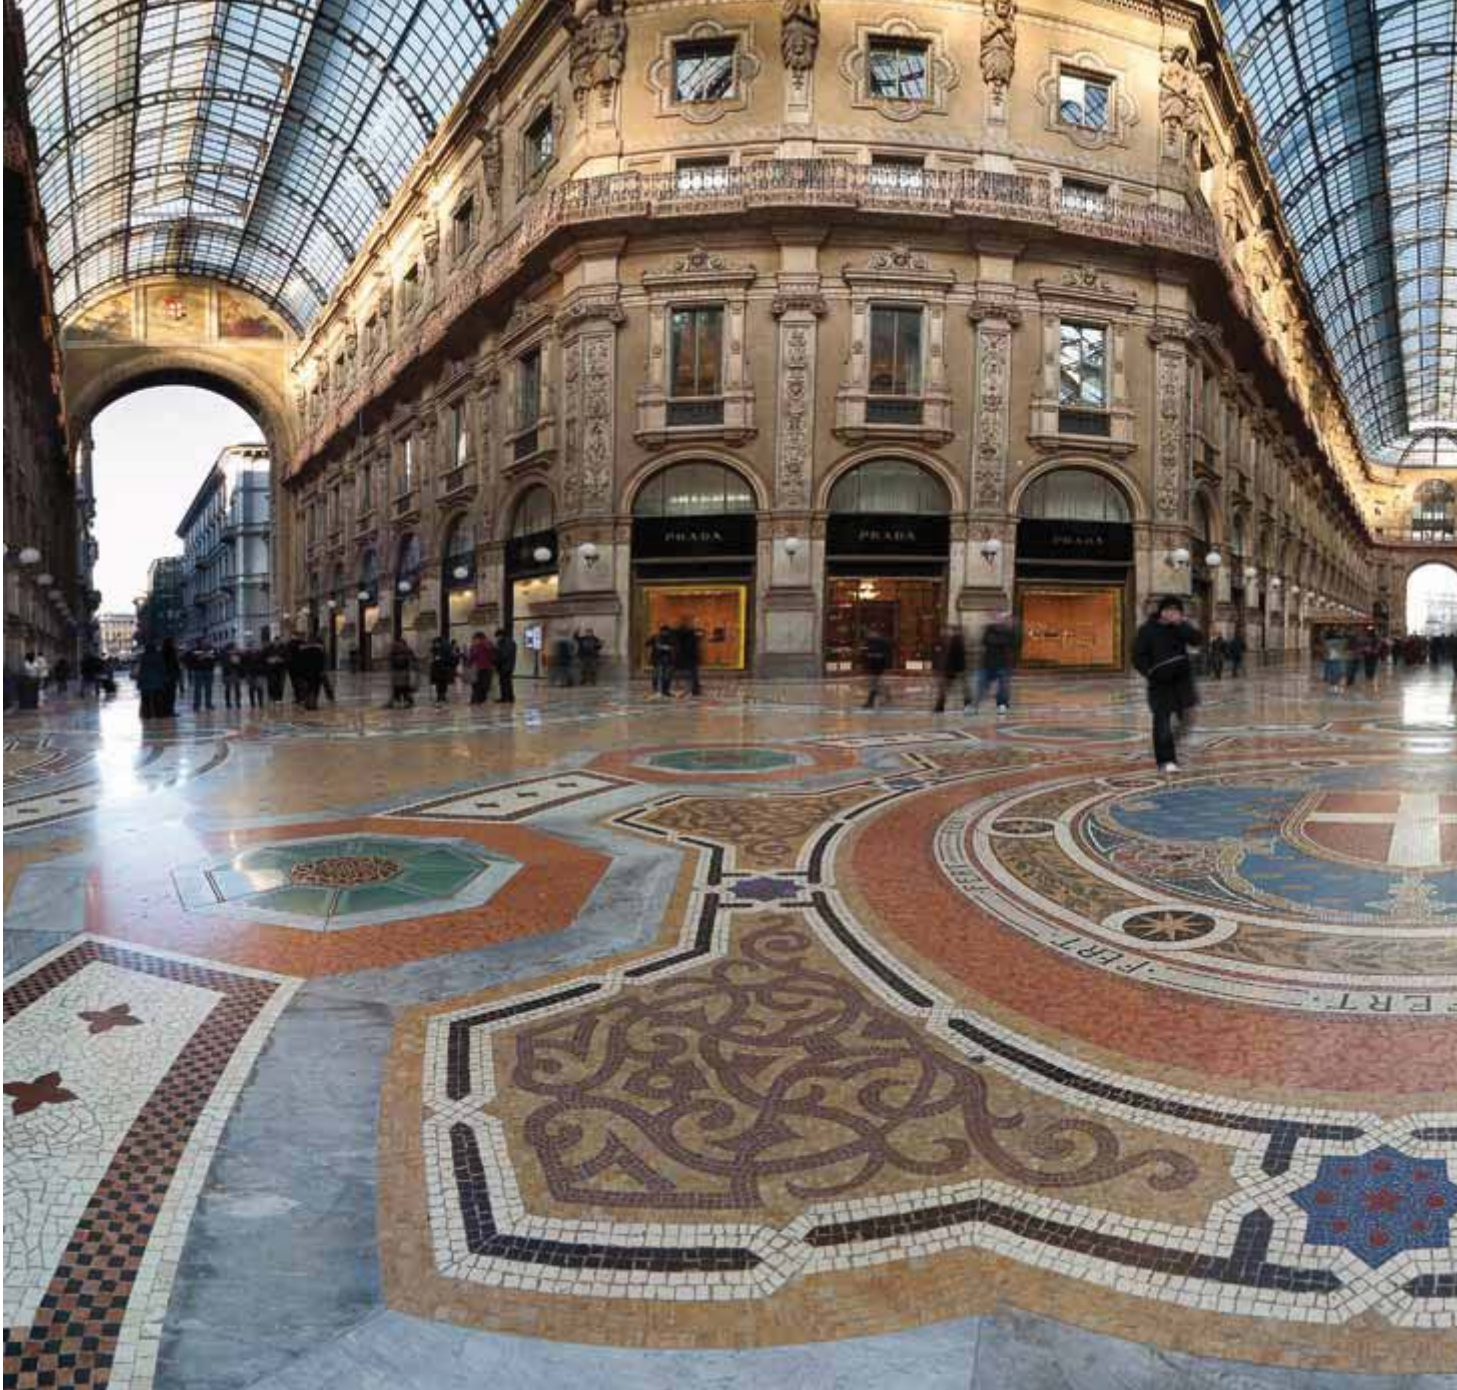
Above. View of the Arcade after completion of the works.
