SEALANTS BEAT THE BIG CHILL

Repairing expansion joints in the screeds of a frozen foods warehouse took special hi-tech products, a few precautions and an ingenious stratagem.

Project: Frigoriferi Del Nord
Trezzano Sul Naviglio, (Milan) Italy

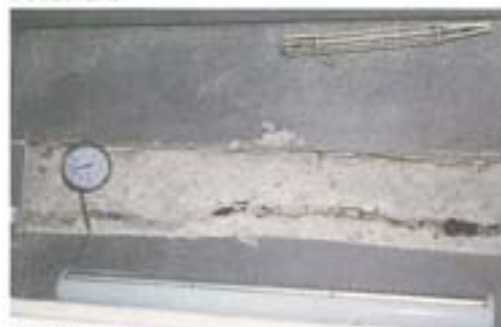
Under such extreme conditions materials themselves undergo molecular transformations, in that they become rigid and fragile. At the Frigoriferi del Nord fragility was exactly the problem that had to be solved. The heavy loads of

merchandise transported on forklifts in the intense cold formed cracks along the expansion joints in the concrete floor (Photo 2). Making the repairs required a product that could bond strongly to the concrete, yet withstand the heavy warehouse traffic over time despite the extremely low temperatures. For this reason epoxy resin products were used that retain their physical and mechanical performance characteristics, permanently sealing the cracks in the joints.
