## In a tunnel heading for Genoa

**The Ferriere motorway tunnel needed to be restyled to quickly cover up signs of ageing. This was done with the help of MAPEGROUT GUNITE.**

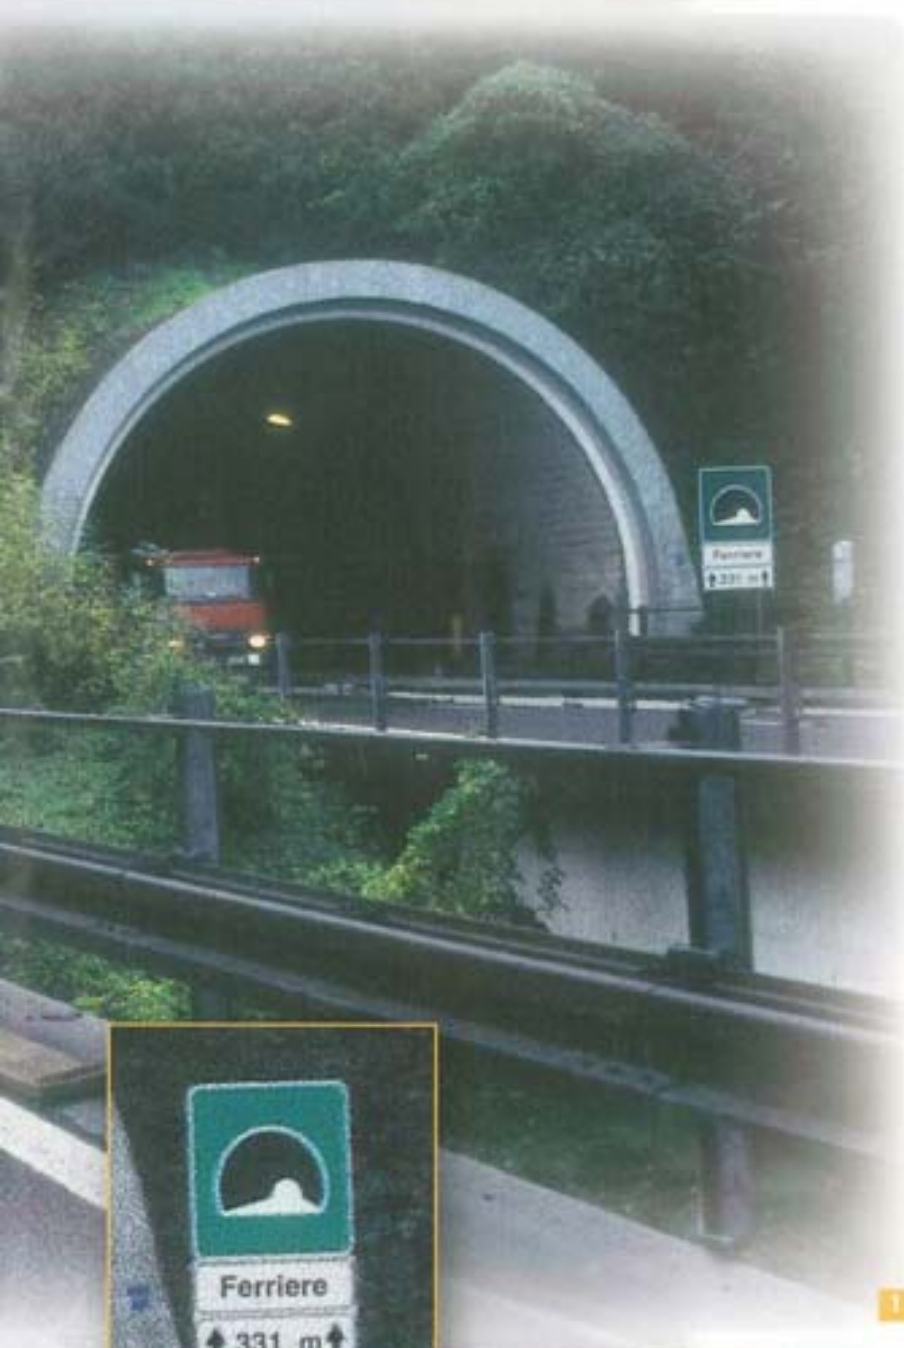
*Photo 1.*  
The outside of the Ferriere Tunnel along the section of A12 motorway near Carrodano.

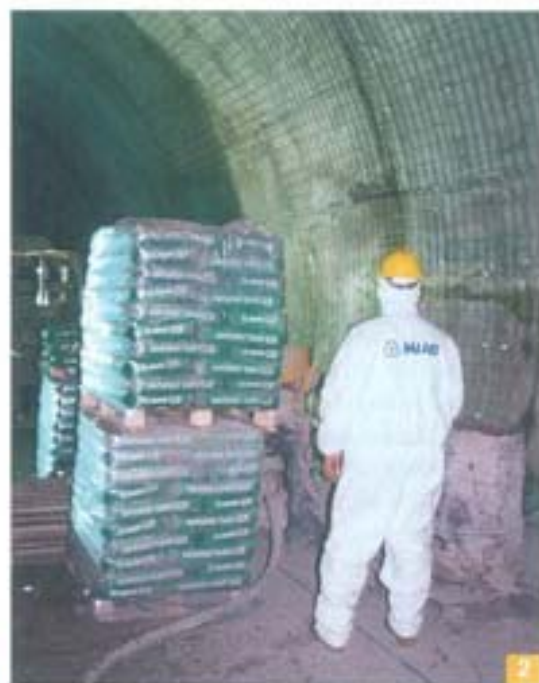
Photo 3. Technicians busy spraying on Mapegrout Gunite. You can clearly see the electrically welded steel mesh forming the frame for the plaster made from Mapegrout Gunite. The product was applied using a rotary pump directly supplied by bags of dry product hydrated when emerging from the hose.

Mapei products for underground constructions have been used both for building new works and repairing old ones, as in the case of Ferriere Tunnel. To carry out this work – applying a covering surface with a nominal thickness of 35 mm, reinforced with an electrically welded mesh – Mapei suggested and supplied MAPEGROUT GUNITE® premixed grout, used for covering concrete tunnels, repairing damaged bridges, hydro works, reservoirs, and industrial structures. MAPEGROUT GUNITE®'s high mechanical properties make it ideal for structural repairs, that can be carried out up for thicknesses of up to 40 mm per coat without using fixed formworks. Composed of hydraulic binders, microsiliates, selected aggregates and special additives, the product is applied by means of a special dry mix spray machine on solid, dirt-free, rough surfaces that have been previously saturated with water. The product has undergone rigorous testing to assess and certify its high mechanical resistance to compression and flexion and its absolute waterproofness. For work on Ferriere Tunnel, MAPEGROUT GUNITE® was sprayed on using a special Ocmer rotor pump (mod. "0cm-030 compact"), fed directly with bags of

This particular method, used quite often when working with large surfaces, allows high daily work rates: in the case of Ferriere Tunnel estimated at about 500 m<sup>3</sup> of coated surface-a-day, split over two daily shifts. This kind of work rate is particularly appreciated and in demand for works carried out along motorways, since it limits traffic flow problems, such as having to change lanes or long queues during rush hours. This also explains why the work on Ferriere Tunnel was carried out in almost record time, no more than 80 calendar days, equal to 60 work days. For instance, the MAPEGROUT GUNITE® was applied in less than 20 days and the approximately 600 tons of product used on-site were "worked" at a rate of 30 thousand kilograms-a-day, with peaks of 2000-2500 kg/hour. MAPEGROUT GUNITE®'s strong points are not just the way it serves its purposes, but also its easiness to use, which reduced the amount of natural "waste" product (i.e. the material bouncing off the surface onto the floor), and the improved appearance of the finished surface, which is smoother than previous applications using other products.

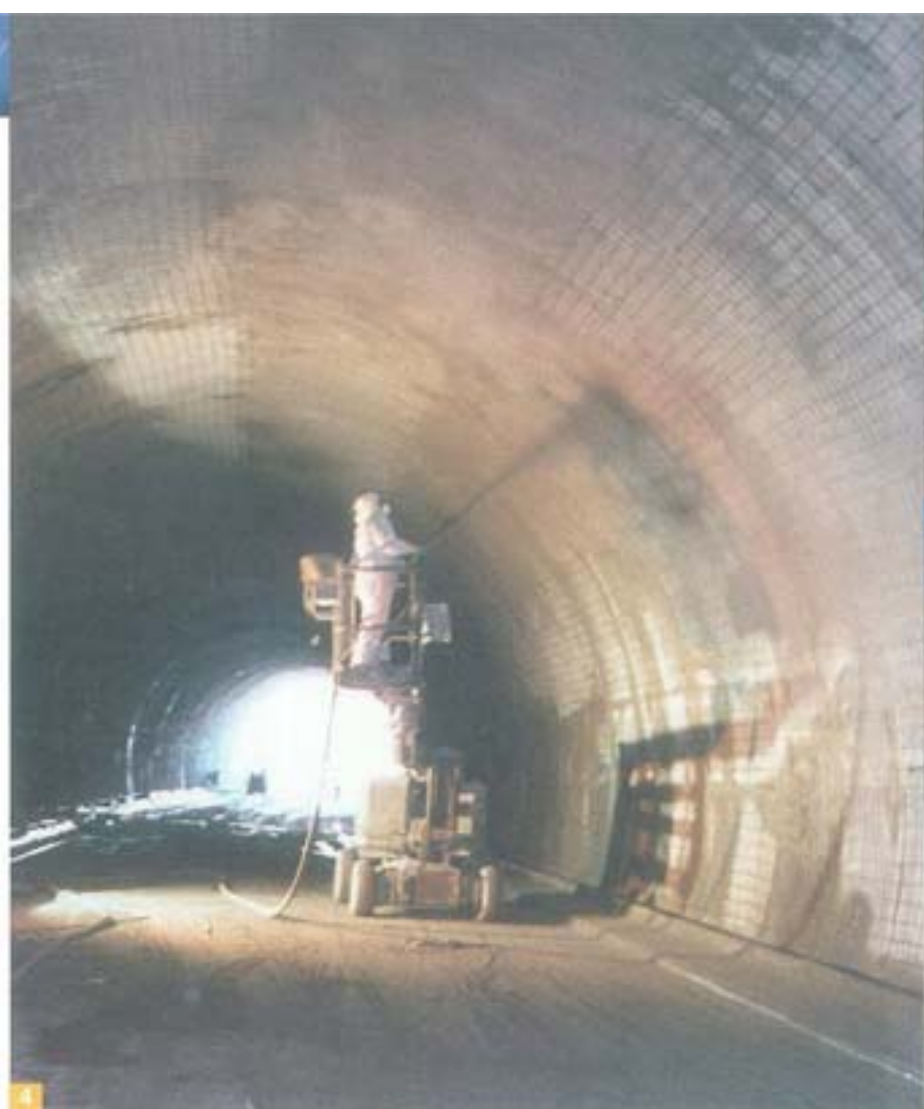
Photo 4.  
The tunnel's coating surface was carefully cleaned with water before spraying on Mapegrout Gunite.

done was to spray-clean the tunnel's coating surfaces to get rid of any dirt or dust that had formed down the years (grease, smoke marks etc.), accretions formed by dripping and running water of varying intensity, and bits of loose concrete that might break off at any moment and cause accidents. After cleaning, which perfectly exposed the intrados of the basic coating, the real state of the tunnel became clear, showing gaps in the concrete, damage and cracks where the various rings are attached and near the quoins, as well as clearly indicating where the running and dripping water was located.

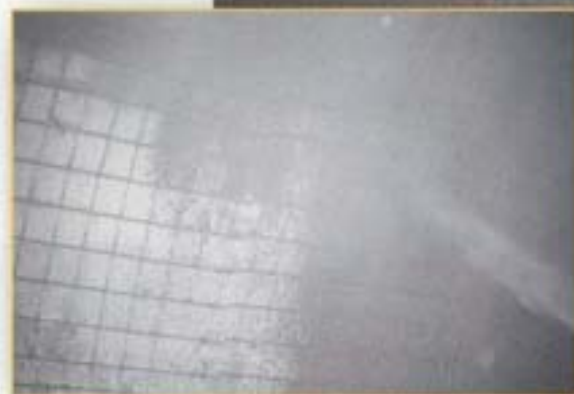
Photo 5.  
The spray method, starting with dry product, allows the kind of fast work rates required when operating on roads. In this case, the work was carried out in almost record time; no more than 60 work days.
