Monte Bianco Tu

For a year now, the Monte Bianco Tunnel has been restored to its irreplaceable role as a communications route between Italy, France and the whole of north-eastern Europe beneath the tallest peak in Europe.

Repair Work

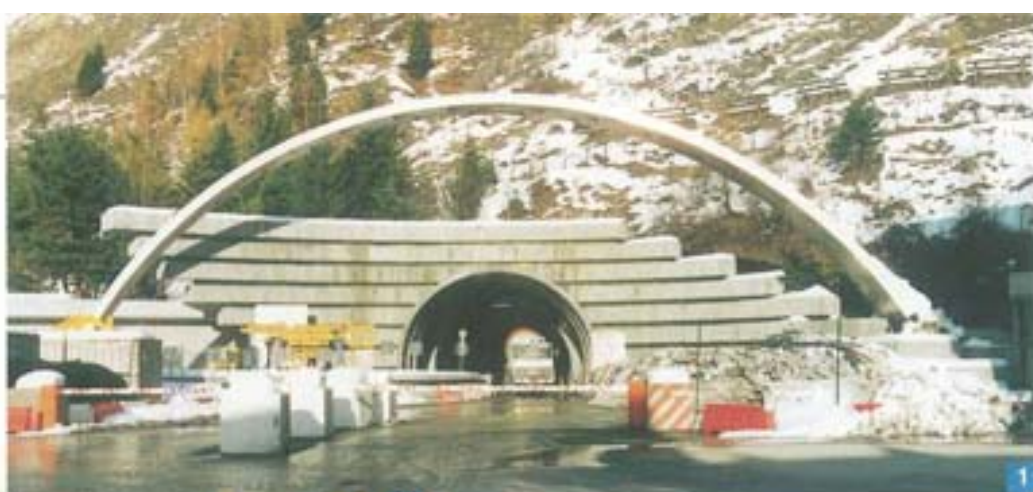
1

Photo 1. The entrance to the tunnel while the works were going on.

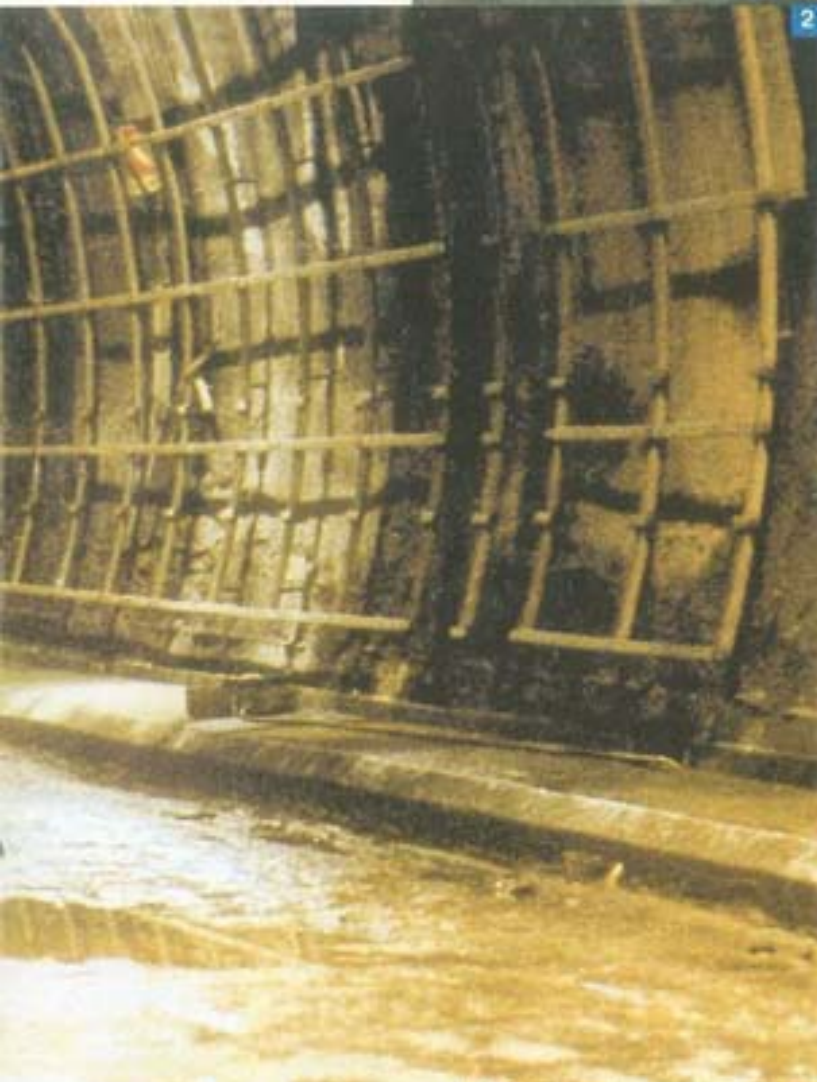
2

Photo 2. Two technicians study a section of the Monte Bianco Tunnel rebuilt after a fire. Cutting-edge systems and technology were used to rebuild the tunnel to make it as safe as possible. (The photo is taken from Sette no. 26, 28th June 2001; our thanks go to the magazine for letting us use it).

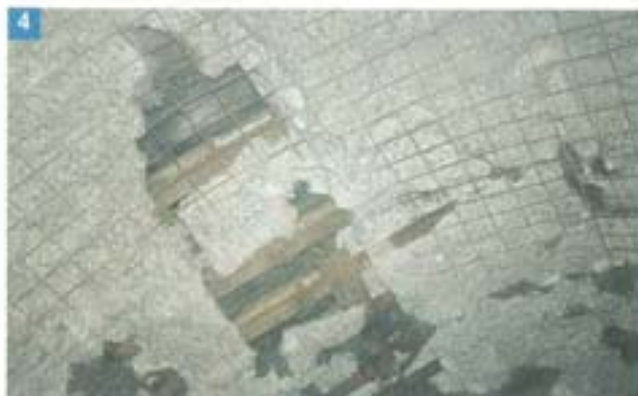
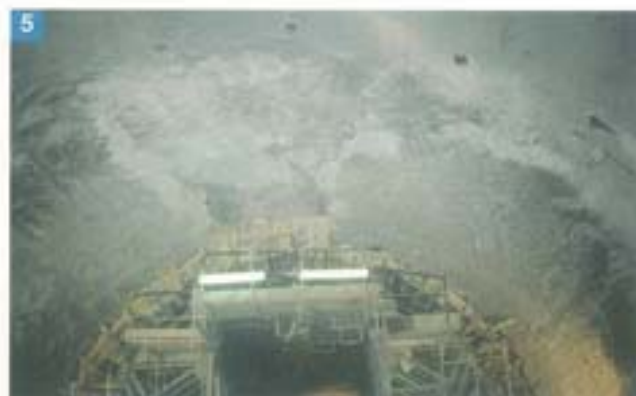
Photos 4 and 5.
After carefully analysing the state of the tunnel, the concrete surfaces were water-scrubbed to remove the layer of concrete damaged by the fire and reveal the reinforcing bars.

After assessing the state of the tunnel, work began on cleaning the concrete surfaces using a water-scrubber to remove the layer of concrete damaged by the fire and also seriously jeopardised by all the water that flooded in. The thickness of the concrete removed depended on the amount of damage and the need to restore the tunnel to a height of 4.30 metres near the walkways. In some areas this meant removing all the lining. The need to remove either part or all of the concrete lining meant Mapei

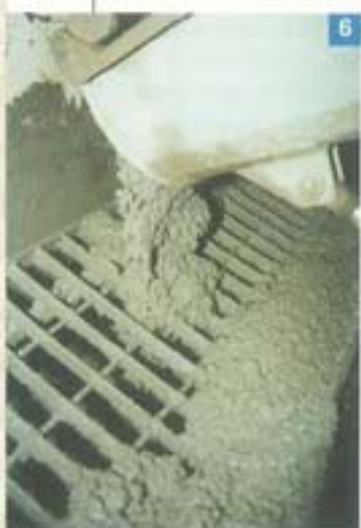
Photo 6.
Two different admixtures, MAPEFLUID N200 and MAPEFLUID X404, were used to obtain a durable and highly fluid concrete ideal for spraying on the surfaces.

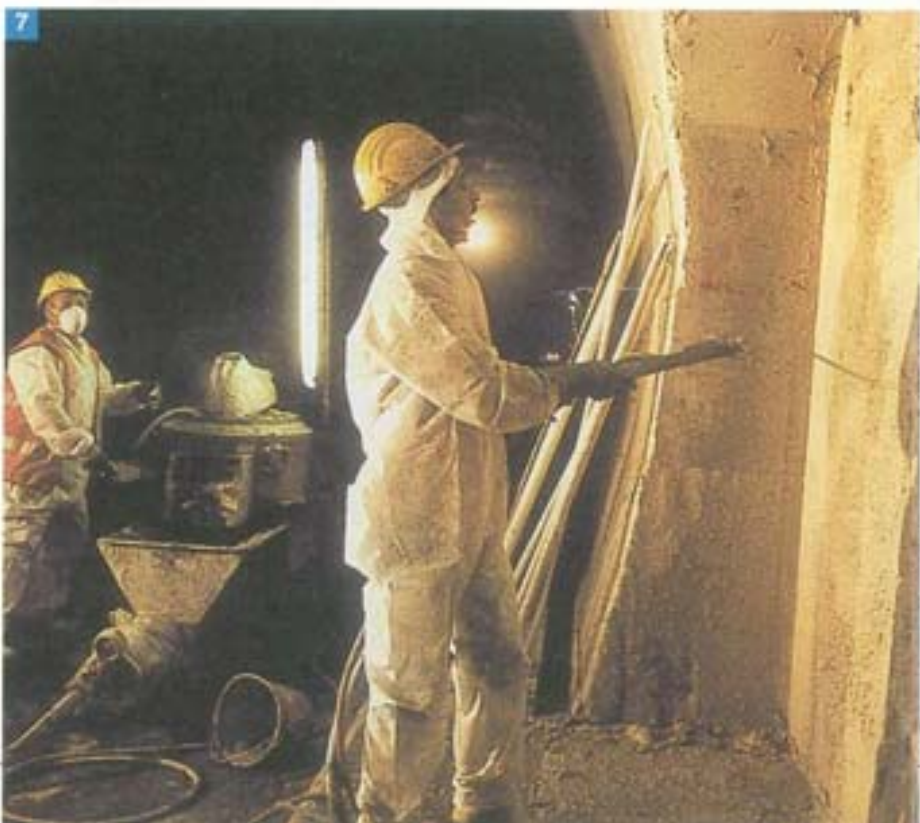
Photo 7.
The picture shows MAPEGROUT BM being sprayed on to repair the concrete.

The air-supply channels placed beneath the road surface in the new project were converted into safe exit routes, and MAPEGROUT BM*, a two-component cementitious mortar with low modulus of elasticity, was used for repairing the concrete involved.

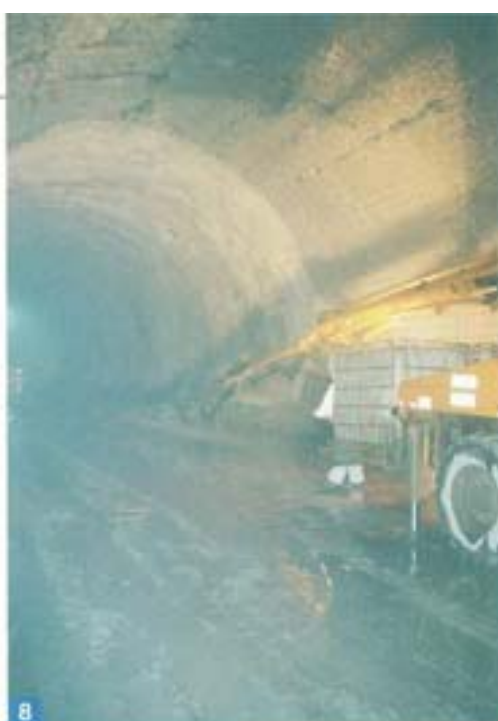
Photo 8.
An application of concrete set more quickly using MAPEQUICK AF100.

These are alkali-free setting accelerators for making concrete with high mechanical strength that ensure safe excavations in order to apply permanent linings. MAPEPLAST SF*, a microsilica-based powdered compact admixture with pozzolanic action, was added to the basic mix to make the concrete harder wearing. After spraying, the tunnel was re-profiled by another layer of cast concrete made even more fluid by adding MAPEFLUID X404* and MAPEFLUID IF328* hyperplasticisers, used in winter to make the concrete set and harden more quickly.

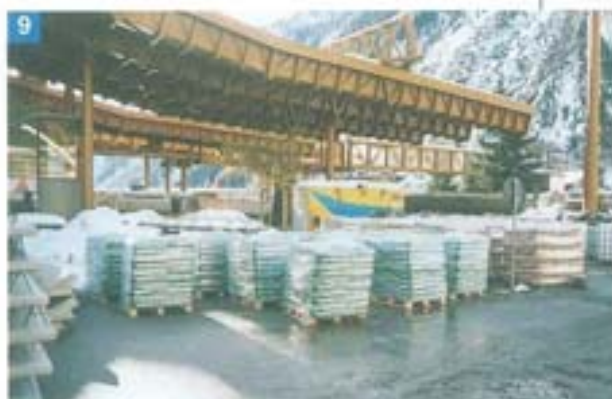
Photo 9.
Mapei products stored on the building site near the tunnel entrance, also open in winter.

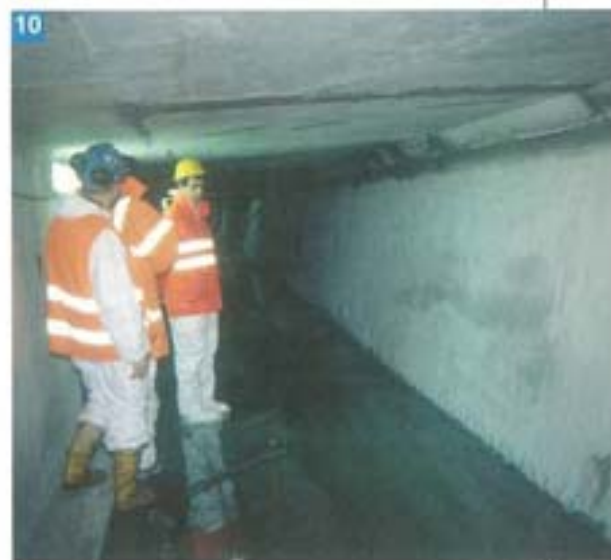
Photo 10.
MAPEGROUT BM, a two-component cementitious mortar with low modulus of elasticity specially designed for repairing concrete, was used on the tunnel.
