BALCONY

facing

reconstruction

Campello condominium, Chivasso (Turin)

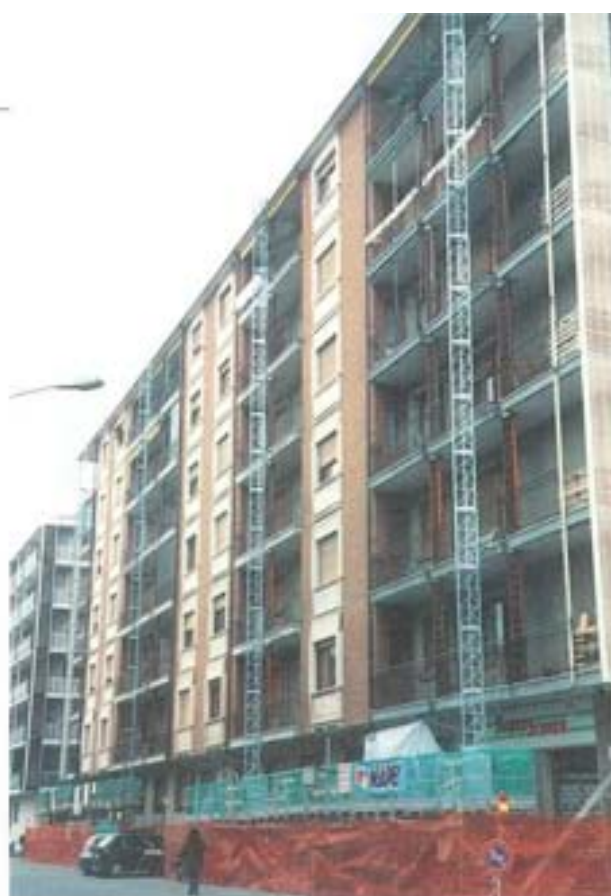
PHOTO 2

At the end of all of this, ELASTOCOLOR was applied to brighten up the façade and, most importantly, create a highly effective protective barrier against the destructive action of atmospheric agents (photo 2). "In short, we can safely say that the products used in the renovation of the balcony facings and stairwell façades were very satisfactory and lived up to our expectations very well," said architect Giuseppe

When the work on the balconies was finished, treatment of the façades of the courtyard stairwells began. This involved renovating the damaged areas and painting the façade, which was in a much better condition than the balcony facings. The walls were first hand-cleaned using brushes and putty knives. After this, any damaged parts were removed given that there was widespread and dangerous deterioration. The treatment of these surfaces followed the same pattern as the balconies, except that MAPEFER was not used because there were no reinforcing rods. Having carefully cleaned the surfaces, a good layer of MAPEGROUT THIXOTROPIC was applied, followed by MAPEFINISH which not only covered the MAPEGROUT but also any small imperfections present in the plasterwork.
