Conservation of a masterpiece of modern architecture: Mapei systems for renovating and restoring the exterior of the Guggenheim Museum in New York with a LEED-certified project

Solomon R. Guggenheim Museum, New York (USA)

Work: repairing reinforcement rods; restoring numerous sections of damaged concrete surface; waterproofing and protecting outside concrete surfaces

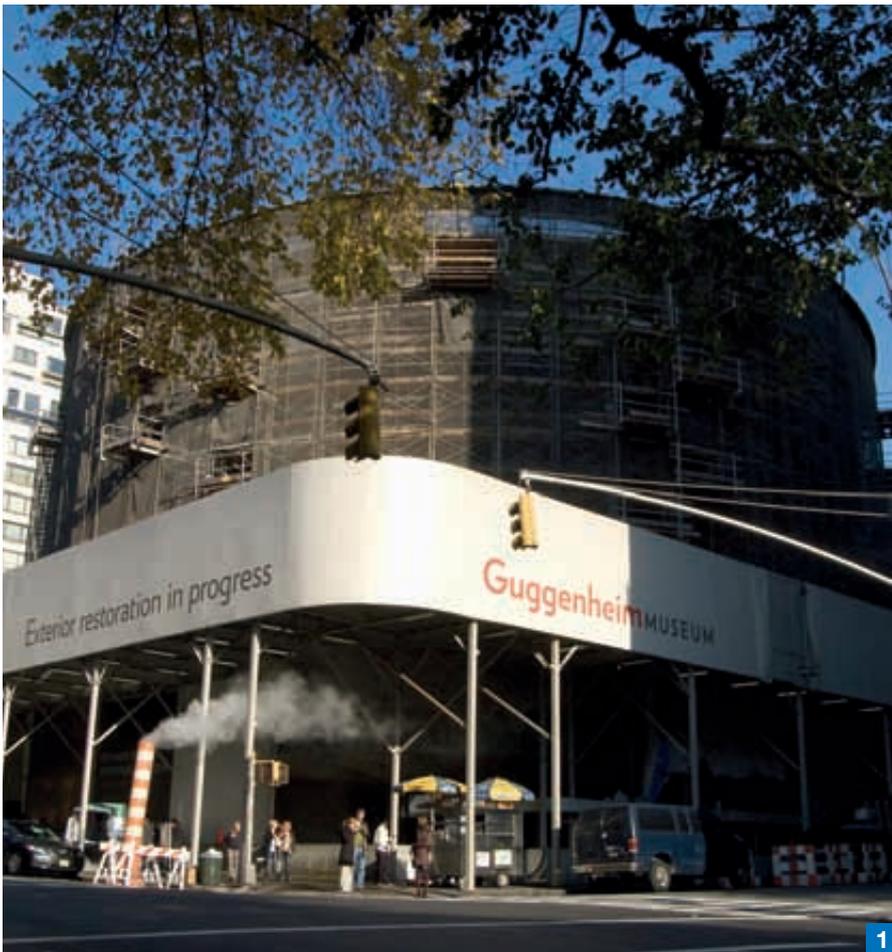
Photo 1.
2007: renovation works begins at the Guggenheim Museum.

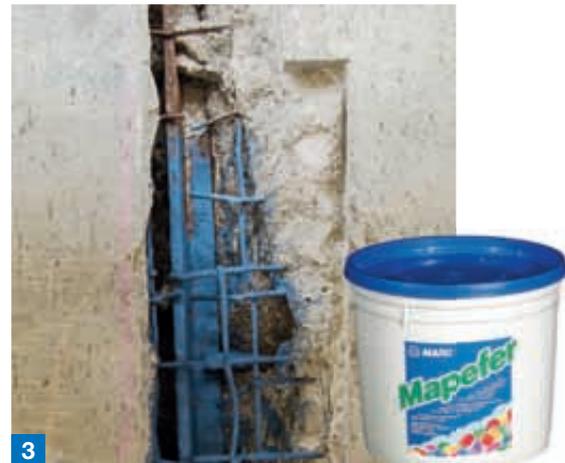
Photo 2.
2007: analyses of the damaged areas and cracks in the outside surfaces of the building.

Due to the particularly innovative construction method, which included a total lack of expansion joints in the building holding the Guggenheim Museum, right from the very beginning cracks began to appear. Down the years, oxygen, together with water and aggressive agents, penetrated into the cracks and brought about a gradual corroding of the reinforcement rods. This, in turn, led to rust forming on the ironwork and, consequently, the iron surface deteriorating and damaging the overall structure.

After the company commissioned to carry out the work removed the various layers of finishing that had been applied to the outside surfaces of the building over many years, ICR technicians and structural engineers drew up a map of the cracks present, making a distinction between those subject to movements (and which subsequently

developed into expansion joints) and those caused by shrinkage of the concrete. It was obvious that the different types of cracks had to be treated using different operating methods. More generally speaking, Mapei was asked to deal with the building's structural problems.

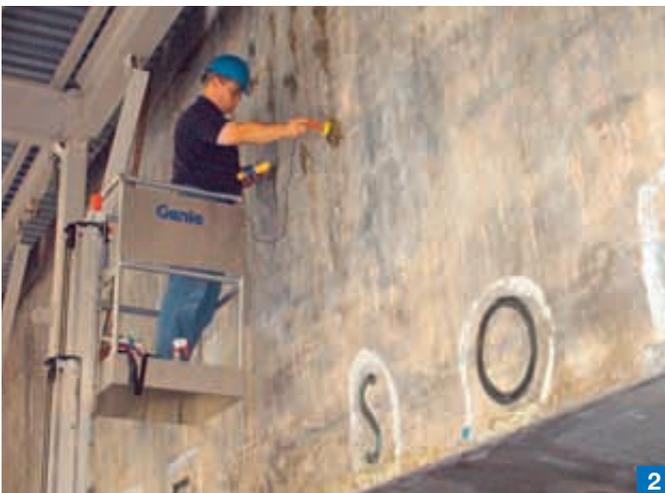
Photo 3.
2007: reinforcement rods protected using MAPEFER 1K.

MAPEFER 1K, a one-component, corrosion-inhibiting, cementitious mortar

was applied to the reinforcement rods after they had been cleaned, to ensure a re-alkalising protection and prevent dust formation.

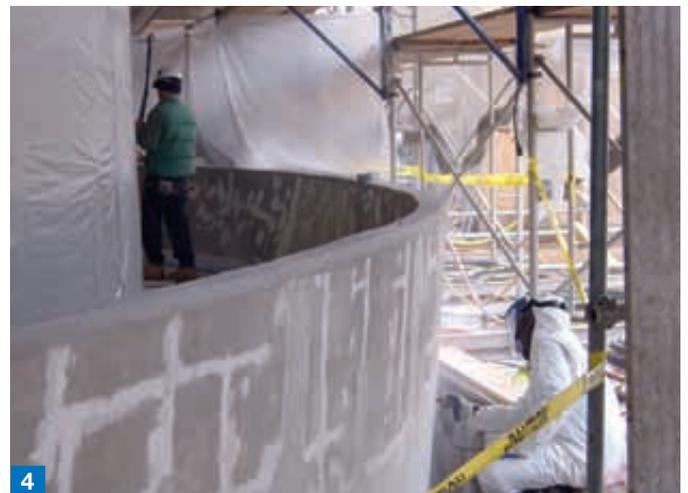
Photo 4.
2007-2008: repairing of certain sections of the Museum's circular outside facade using PLANITOP XS mortar.

After the MAPEFER 1K had dried, numerous sections of damaged concrete were repaired using PLANITOP XS, a special normal-setting, one-component, thixotropic mortar manufactured in Mapei Corporation's plants and marketed in the Americas by the Mapei Group's North-America subsidiary.

Unlike conventional mortars used for repairing concrete structures, PLANITOP XS can be used in thicknesses of 0-10 cm per layer, without having to apply several different layers, thereby saving on application time. This product offers high workability and extended open time. These features allowed the restorers to easily recreate the original forms of the building with great success and reshape any imperfections in the substrate, as suggested by the designers.

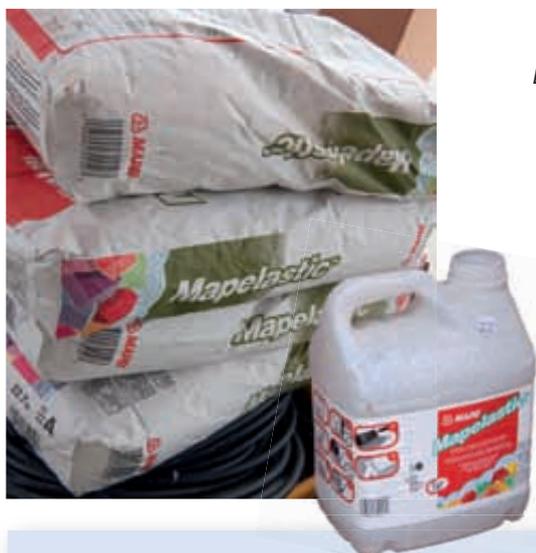
Photo 5.
2008: spraying
ELASTOCOLOR.

In some cases cracks subject to smaller movements were sealed using ELASTOCOLOR RASANTE SF, a fibre-reinforced elastomeric undercoat with high filling properties and admixed with fine sand.

For this reason it was decided to use ELASTOCOLOR RASANTE, a fibre reinforced filling undercoat applied using an airless spray. After drying, ELASTOCOLOR RASANTE forms a smooth coating, which, thanks partly to the fiber content, follows any expansion substrate without cracking.
