# MAPEI AND THE TEATRO ALLA SCALA THE ART OF WORK

**the Teatro alla Scala reopens after 912 days of work  
renovated and restored**

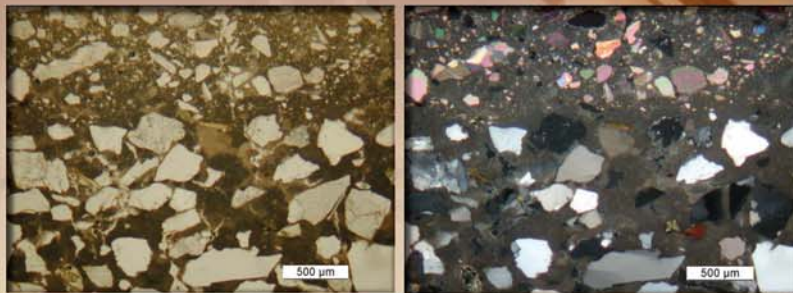
The sectional radiographic analysis of the plaster and of the underlying layer of render, observed at 1 Nicol, shows how the interface between the plaster (on the left) and the render (on the right) is indicated by the different grain size of the aggregates (larger in the render) and by the different colour of the matrix. In the second section, observed at 2 Nicols, the interface between the plaster and the render is indicated by the variation in the nature of the aggregates, which are mainly carbonated (calcites) in the plaster and silicates in the render (quartz).

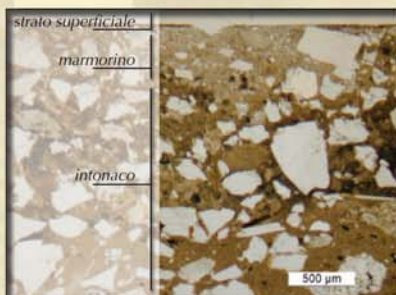
Sectional radiographic analysis of sample 1-01 (IN): the notes to the side indicate the 3 layers (surface layer, plaster and render) which make up the sample. This image allows the particle size and form of the aggregates which make up the render and plaster to be assessed, as well as the thickness of the layers.

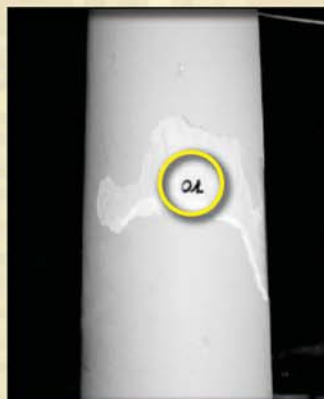
Position of where sample 1-01 was taken.

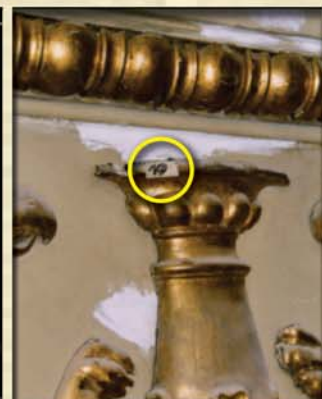
Sample 19 was taken in a point where the decorations were probably the original ones from the start of the 19<sup>th</sup> century.

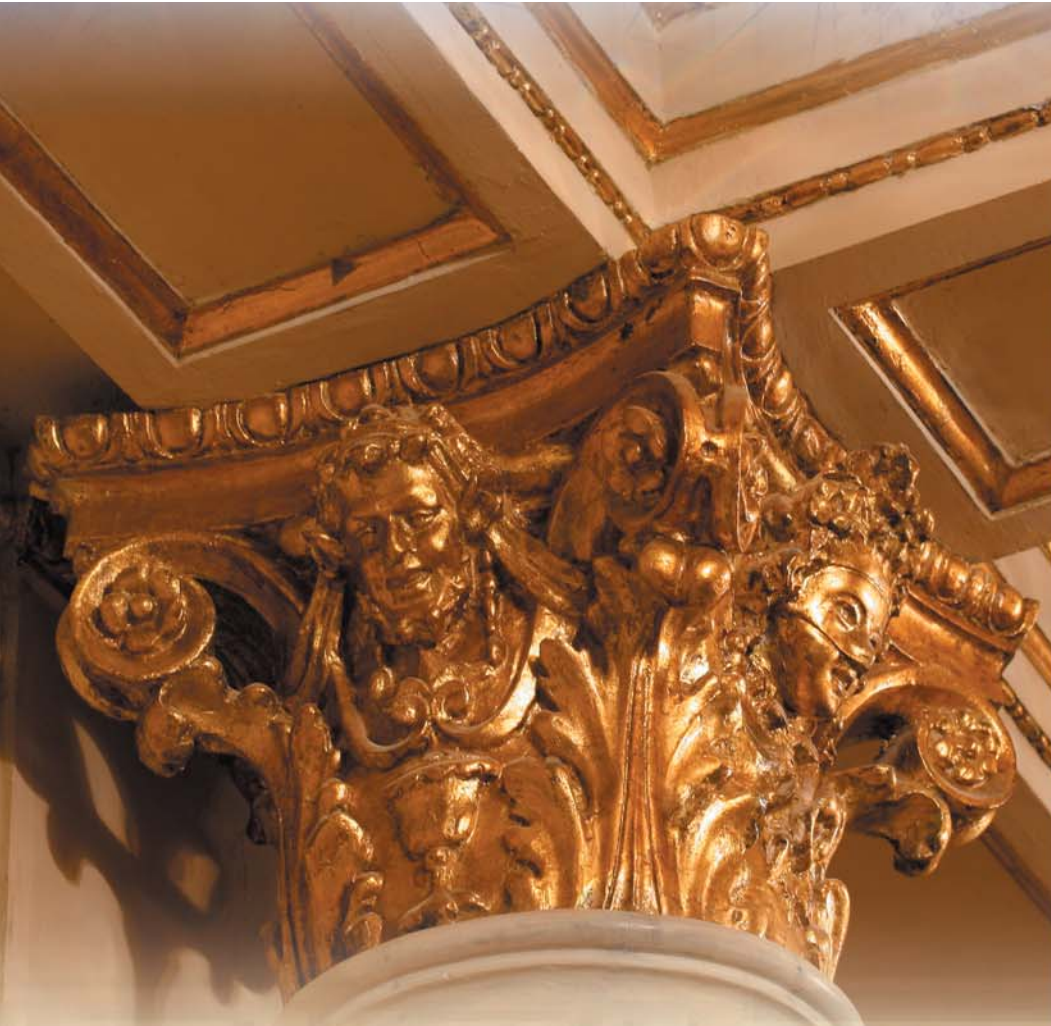
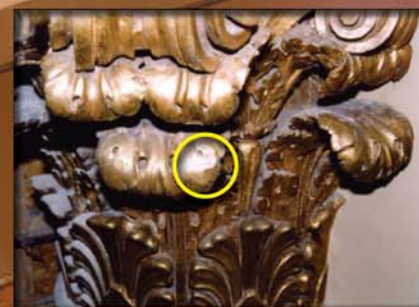
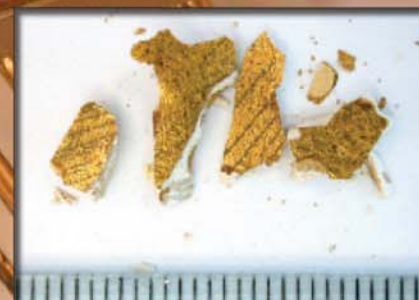
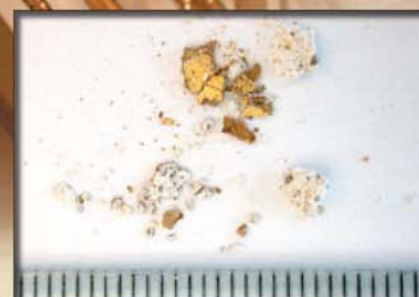
*The sample of a fragment of surface gold-leaf showed that there was also an older layer.*

The sectional radiography analysis led to establishing that the most antique and, most likely, the original gold-leaf was carried out using pure gold or using an iron/copper alloy. On the other hand, the most recent repairs were carried out using copper/zinc alloys (brass). Also, the quality of the gold leafing was characterised according to whether the model on which it was applied was one of the original ones from 1830 in papier-maché, or one dating back to a more recent, post-war rebuild based basically on gypsum mouldings. Similarly in this case, the chemical-physical analysis demonstrated that it was of fundamental importance to define the most suitable technique to bring the decorations back to their original splendour.

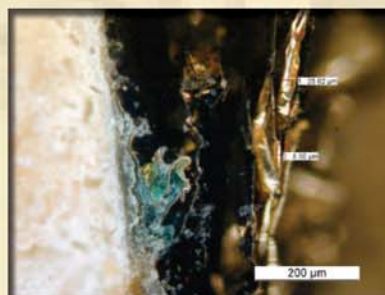
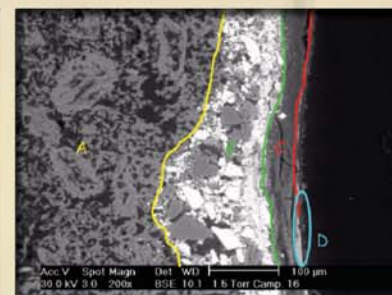
*A basic chemical analysis of the various layers was carried out using an electron microscope, with the corresponding EDS images obtained in the Mapei R&D laboratory.*

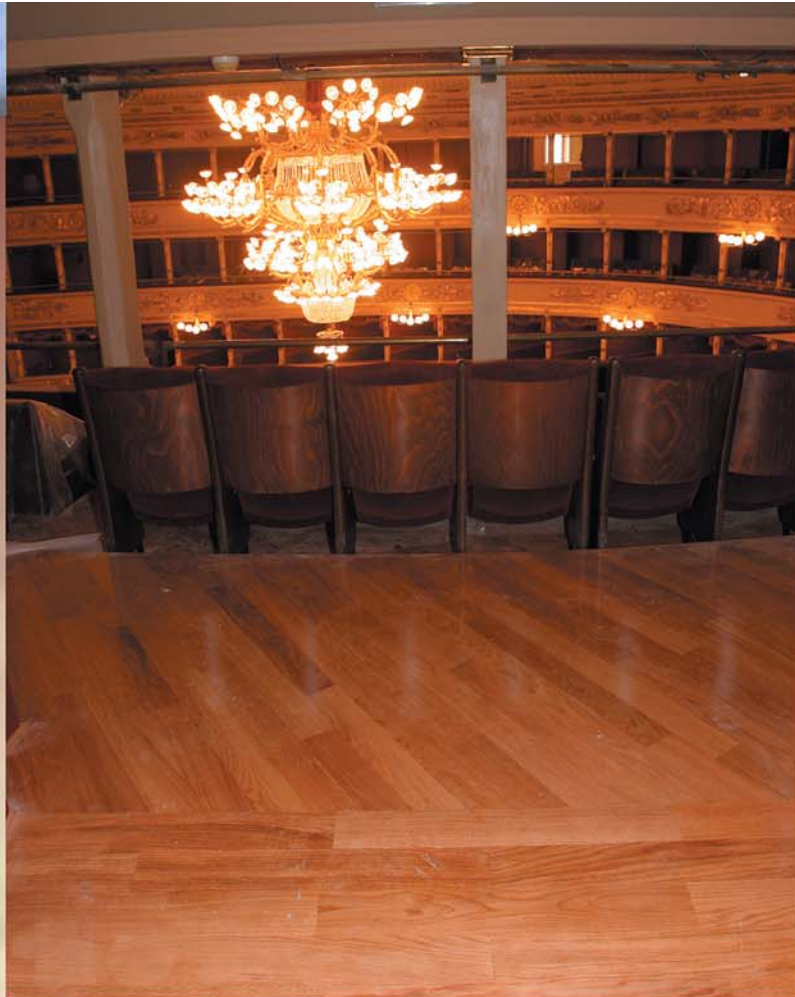
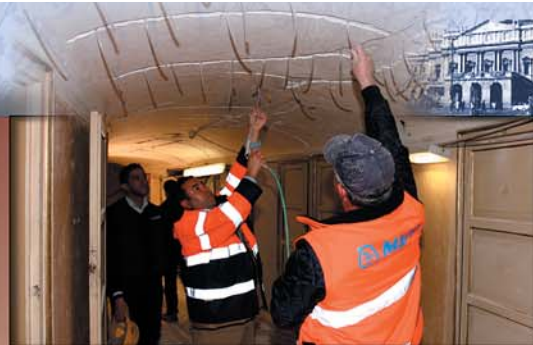
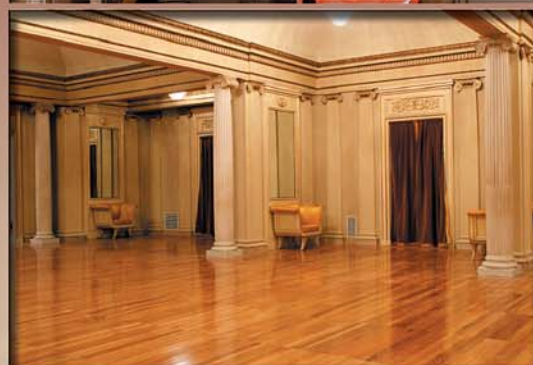
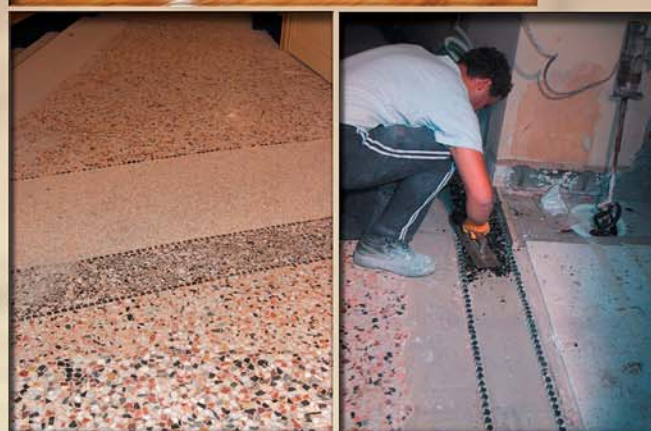
### CONSERVATIVE MAINTENANCE OF THE EXISTING TERRACOTTA FLOORS AND LAYING OF THE NEW ONES

The surface of the existing terracotta floors, which had inevitably been ruined by normal use over the years, were brought back to their original splendour by a thorough cleaning process using KERANET. The new terracotta flooring was laid using KERAFLEX high-performance adhesive.

In the monument area in particular, removal of the surface layers of the paintwork in the corridors leading to the boxes, which, after careful analysis, was found to be acrylic-based, was carried out using PULICOL, specially modified in this case to cater for both the poorly-ventilated work environment in which it was used, and to render it sufficiently thixotropic.

The skimming layers which had been applied over the original terracotta tiles, on the other hand, were removed both mechanically and with the use of KERANET, an acid-based product which is particularly suitable for removing traces of cement, lime, efflorescence, residues of cementitious adhesives and grouts. In the areas where the original terracotta tiles were irreparably damaged, new ones were laid using KERAFLEX, a high-performance adhesive which is classified as C2TE according to Standard EN 12004.

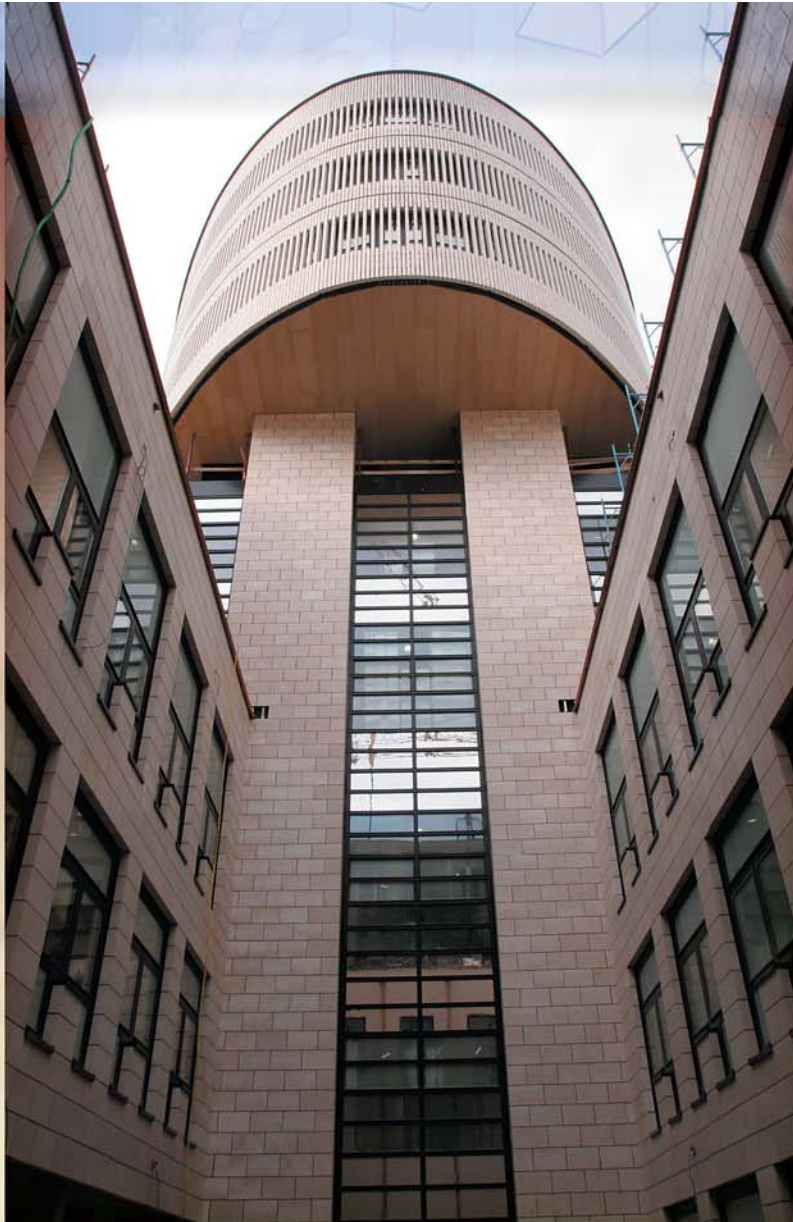
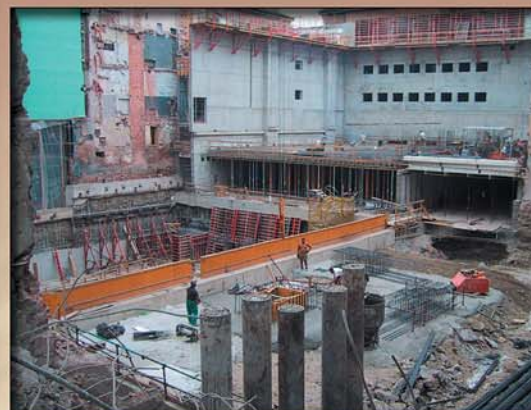
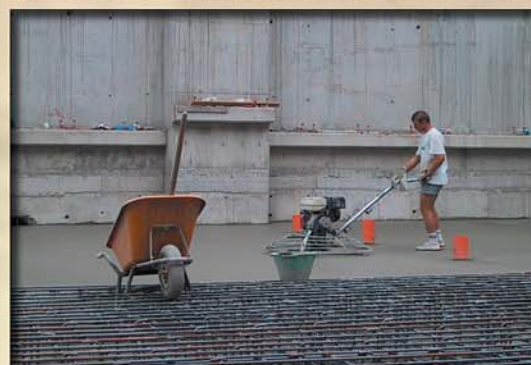
When the new structures of the ellipsoid dome and the stage tower were constructed (designed by the architect Mario Botta), the quality of the conglomerate employed for the foundations and restraining walls proved to be of particular importance. In this phase, Mapei offered their experience to the building company and the concrete manufacturer involved, to optimise the composition of the cement conglomerate. The concrete, prepared using nanostructure admixes from the DYNAMON range, was the solution chosen to meet the customer's requirements regarding waterproofing, durability and the low amount of heat generated.

Mapei's support was also important in the sector involving the finishing of internal surfaces, recommending the most suitable system for waterproofing the canteen and showers by using rigid and flexible protection products (IDROSILEX PRONTO and MAPELASTIC), and also the most suitable adhesives for the various types of floor coverings laid in the ellipsoid dome. High performance, flexible adhesives were used (KERAFLEX MAXI, class C2TE according to Standard EN 12004) for laying the porcelain and klinker floors.

To avoid the onset of both warping and staining, a quick-setting and hydration adhesive (GRANIRAPID, class C2F according to Standard EN 12004) was used for laying the slabs of Botticino marble. Finally, to make sure that the wooden slats were laid correctly and securely, ULTRABOND P902 2K proved to be the most suitable choice.

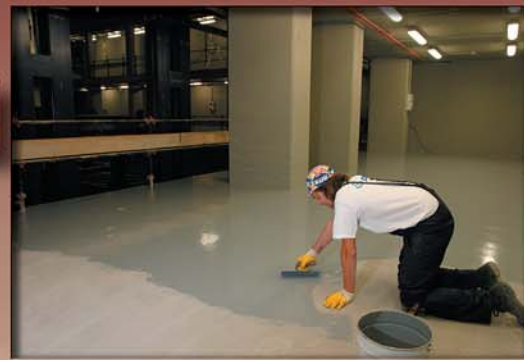
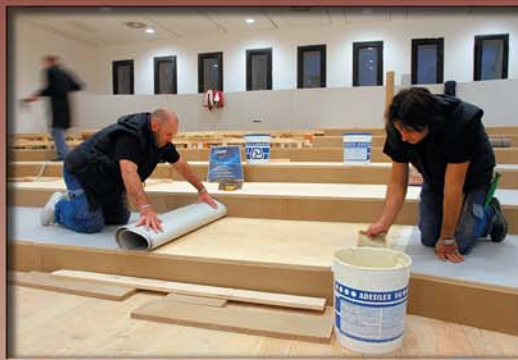
In the Stage Tower area, apart from installing the screeds with the same materials and techniques as those used in the monument area, and laying the klinker floor tiles by using KERAFLEX MAXI (KERACOLOR FF was used for grouting the joints), Mapei's assistance was also required to define the materials and operational techniques for the service corridors and walkways. In these areas, to obtain a floor covering which was particularly resistant to abrasion caused by the rigours of the service loads, the best solution was found to be the solvent-free, multi-layer epoxy system MAPEFLOOR SYSTEM 31. Finally, in the rehearsal rooms, where PVC sheets were to be used, an universal acrylic adhesive in water dispersion, ADESILEX V4, was employed, to guarantee the functionality of the floor throughout its entire period in service.
