Loyola University Medical Center - Chicago, IL

Proper Surface Preparation Ensures Durable Floor Covering Installation

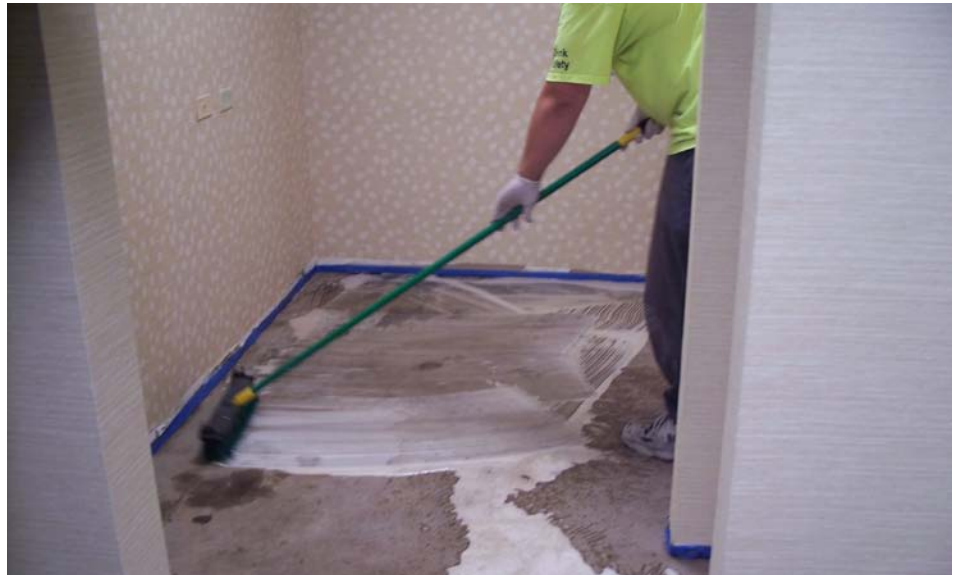
On Day 1, the first area was prepared using the Planiprep SA material, a powerful, water-based stripping solution designed for preparing nonporous or chemically contaminated concrete surfaces (see photo upper right). Planiprep SA chemically etches the surface of clean concrete, promoting excellent adhesion for the subsequent application of Planiprep ET.

capped with Planiprep ET, an ultra low-viscosity, two-component, penetrating 100%-epoxy treatment. Planiprep ET penetrates deeply into the prepared concrete surface, strengthening it and creating a suitable surface for direct application of all MAPEI adhesives that are approved for use on nonporous substrates. When used with Planiprep SA, Planiprep ET provides subfloor moisture emission control up to 12 lbs. (5,44 kg) and 92% relative humidity (RH) without the need for shotblasting the concrete surface.

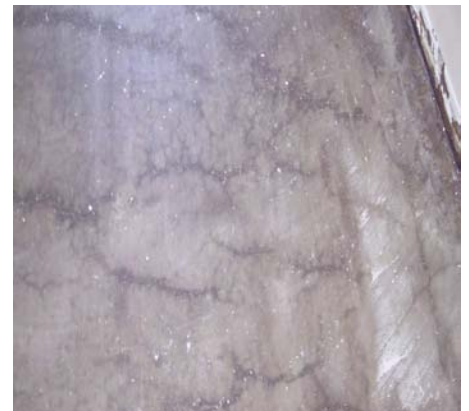
A hospital renovation project at Loyola University Medical Center in Chicago, Illinois, ran into some difficulty when a post abatement vinyl plank installation began to fail in occupied patient corridors. The initial installation was repaired once, but this repair failed a second time due to what appeared to be exposure to remaining abatement chemicals (see photo of subfloor issue on lower right).

Destructive analysis of the failed areas revealed cracks in the substrate where presumably the abatement chemicals remained following the abatement procedure. Mechanical preparation of the substrate, and the cracks, was not possible as the hospital was an occupied environment, and both noise and dust were primary concerns of the hospital.

The subsequent layer of 100% solids epoxy used in the replacement floor covering not only isolated the abated substrate, but it also sealed off the cracks where the abatement chemicals presumably remained.
