MAPEI: A Role Model for Emergency Prep

by Anita Burton, Editor

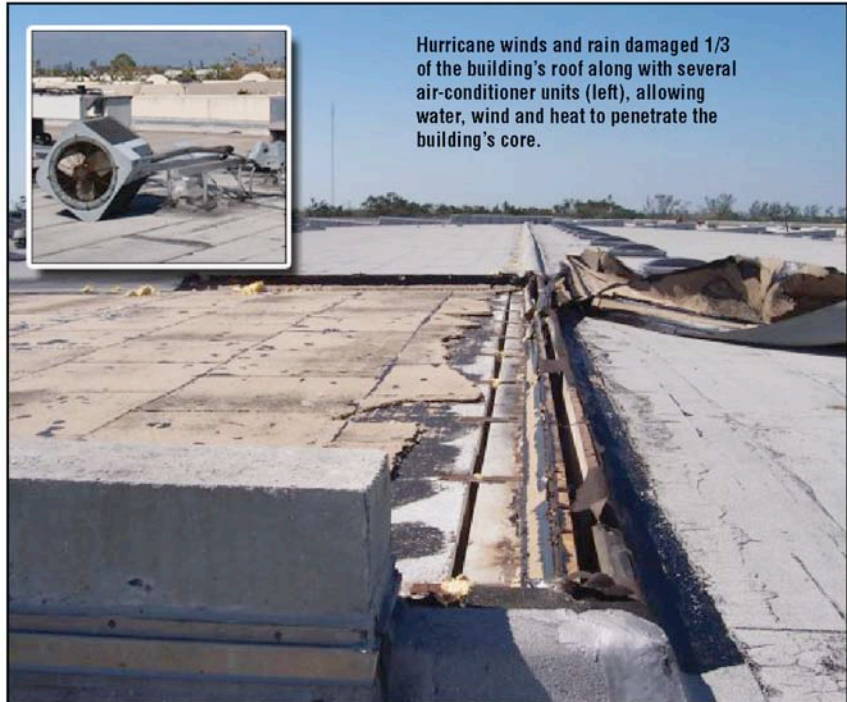
Hurricane winds and rain damaged 1/3 of the building's roof along with several air-conditioner units (left), allowing water, wind and heat to penetrate the building's core.

Having known for days that Wilma was on its way, MAPEI took precautions to evacuate staff at its two-story corporate office. When Wilma hit, her winds and rain managed to peel off about one-third of the building's roof, allowing water and wind to penetrate the building core.

At the same time, Wilma's winds tore the side panels from 20 rooftop air-conditioning units, causing massive heat infiltration and significant damage to MAPEI's computer server (the heat buildup actually melted two hard drives!).

Because of the roof damage, water saturated the entire upper floor, drowning 20,000 sq. ft. (2,323 m²) of insulation and acoustical ceiling tiles. After becoming wet, acoustical tiles became the weight and consistency of oatmeal, causing the ceiling to buckle, fall, and then coat and ruin computers, office furniture and personal valuables. Water damage shorted out ceiling cable wires throughout the building, knocking out phone and computer accessibility, requiring IT to completely rewire the internal system. Water that saturated and ruined carpeting on the upper floor eventually leaked through to similarly damage the lower floor's acoustical ceiling tiles and carpet.

- 2 MAPEI's insurance company brought in Disaster Services Incorporated to address such immediate remediation needs as removing wet and damaged carpet, ceiling tiles and insulation.
- 3 Walls were tested for moisture to avoid the potential of mold. Tests revealed that moisture was present from ground level up to 18 inches (46 cm) on one side of the building. Wherever moisture was found, the drywall was cut out 4 feet (1,23 m) high. Once the drywall and carpets were removed, a bleach solution was sprayed to help prevent mold.
- 4 An electrical contractor was hired to help stabilize and recover electrical power throughout corporate building.

- 5 Two hot-air generators were set up to pump generous loads of hot air through polyethylene tubes into the building's walls, to dry out the remainder of the building and prevent mold development.
- 6 Once the building was dry, a mold-testing company was hired to test for mold in the areas where moisture was previously discovered. Thanks to the quick reaction, final results revealed no presence of mold.

When your own building needs a facelift, it helps if you're a player in the construction industry. Specialized contractors were called in to deal with critical roofing repairs, electrical wiring, gutting and reconstruction of several offices, yet much of MAPEI's efforts centered on reconstructing the upper- and lower-level flooring surfaces.

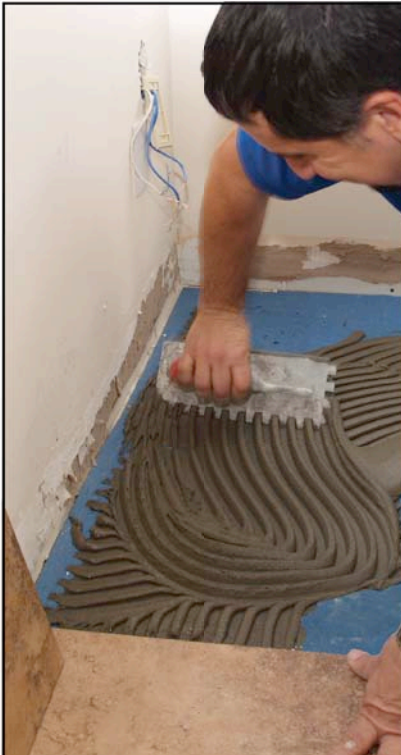
Granirapid flexible mortar system was used to install 20,000 sq. ft. (1,858 m²) of porcelain tile on the building's upper level.

C) Challenge: To install 20,000 sq. ft. (1,858 m²) of porcelain tile on the upper level of the building requiring a fast-track, flexible, rapid-curing mortar system.

Solution: Install tile using MAPEI's *Granirapid®* premium rapid-setting, flexible polymer-modified mortar system developed with High-Hydrated Cement Technology (HCT™) to build high, early mechanical strength. *Granirapid* is formulated from a shrinkage-compensated technology that allows medium-bed, high-build capacity for large-format tile.

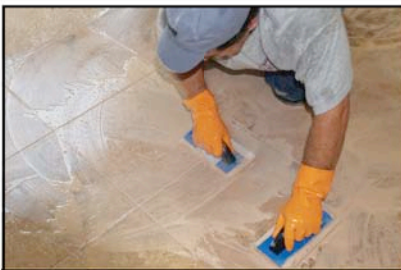
Kerapoxy chemical and stain-resistant grout was used to grout 35,000 sq. ft. (3,252 m²) of porcelain tile throughout the building.

Solution: Grout 35,000 sq. ft. (3,252 m²) of porcelain tile using *Kerapoxy®* chemical and stain-resistant 100%-solids epoxy mortar and grout. Ideal for fast-track installations, *Kerapoxy's* easy water cleanup and fast-setting properties allow foot traffic within 24 hours.

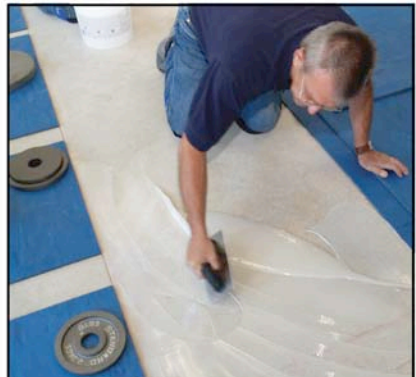
Ultrabond G21 polyurethane-based adhesive was used to install large-format rubber tile in MAPEI's employee gym.

Solution: Use *Ultrabond® G21* solvent-free polyurethane adhesive, designed for extreme indoor and outdoor installations. *Ultrabond G21* aggressively adheres all types of floor coverings and many difficult-to-bond-to substrates. MAPEI's fitness enthusiasts can now enjoy exercising in a more durable and contemporary-looking environment. 🏋️
