RESISTING SULPHATES

The Piedicastello tunnel on the Autobrennero motorway was repaired with the use of special mortars and modified spraying machines.

Piedicastello Tunnel (North Tube) - Trento (Italy)

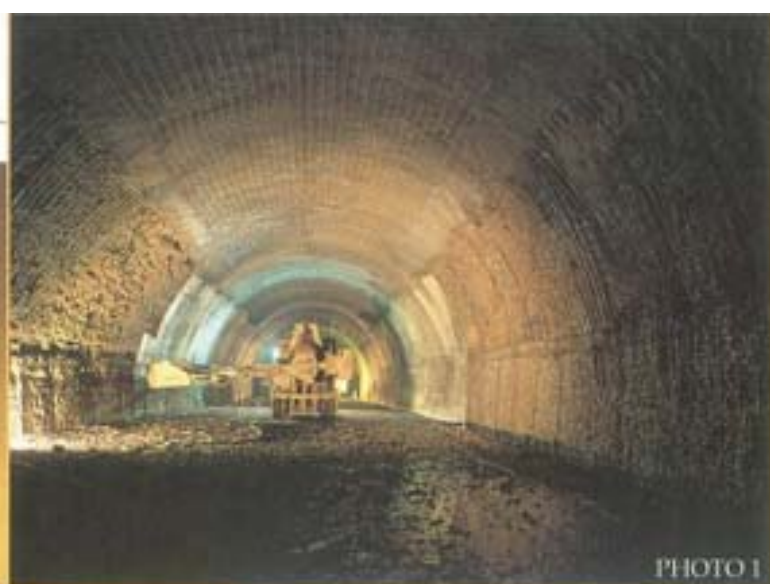
PHOTO 1

After having dismantled the existing supports and having secured the whole length of the tunnel with iron rods, the process of high pressure hydro-demolition to remove the damaged concrete began (photo 1). Luca Manuelli, surveyor of Mosconi S.r.l. of Edolo (TN), the company that carried out the concrete hydro-demolition, explains how "the hydro-demolishing was carried out using a pressure of 1,250 atmospheres on one pump, and 1,350 atmospheres on a second pump, removing on average approximately 8 cm of concrete (a total of 1,400 m³ of concrete). The water used was then recycled and purified with a special

Hydro-demolition was particularly advantageous in this application as it speeded up the operation, was completely free of vibration (and thus did not affect the other tunnel or the overlying rock mass), and enabled the technicians to remove only the damaged concrete while maintaining the existing reinforcement intact.

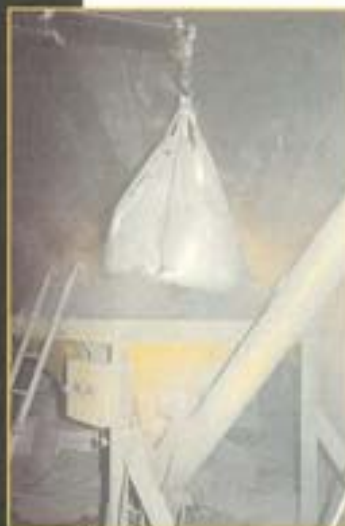
The main causes for the deterioration in the concrete were the combination of infiltrations of water rich in soluble salts, especially sulphates, along with freeze-thaw cycles around the tunnel entrances and carbon dioxide and sulphuric anhydrite emissions. Detailed investigations on the state of conservation of the

- the Piedicastello tunnel did not have any severe construction defects;
- although cracks were present, the concrete in the internal section of the tunnel was good quality. The surface concrete had deteriorated with the damage affecting a layer of between 5-25 cm deep over the surface;

The basic criterion adopted to restore the tunnel involved repairing and waterproofing the outer surface and improving the interaction between the lining and the rock mass. The Brennero Motorway Authority opted for a "shell" type intervention by cortical hydro-demolition of the lining, and restoring

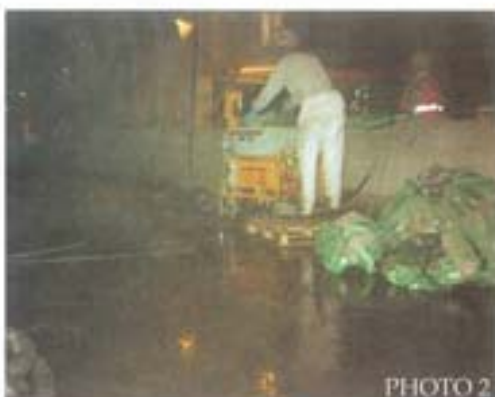
PHOTO 2

After this phase, the crown was repaired after having first installed a reinforced welded net held up with over 3,000 4.50-m long anchor bolts. The tunnel was then remodelled by reconstructing the thickness with layers of MAPEGROUT T60, a single-component sulphate-resistant fibre-reinforced thixotropic grout (photos 2, 3 and 4).

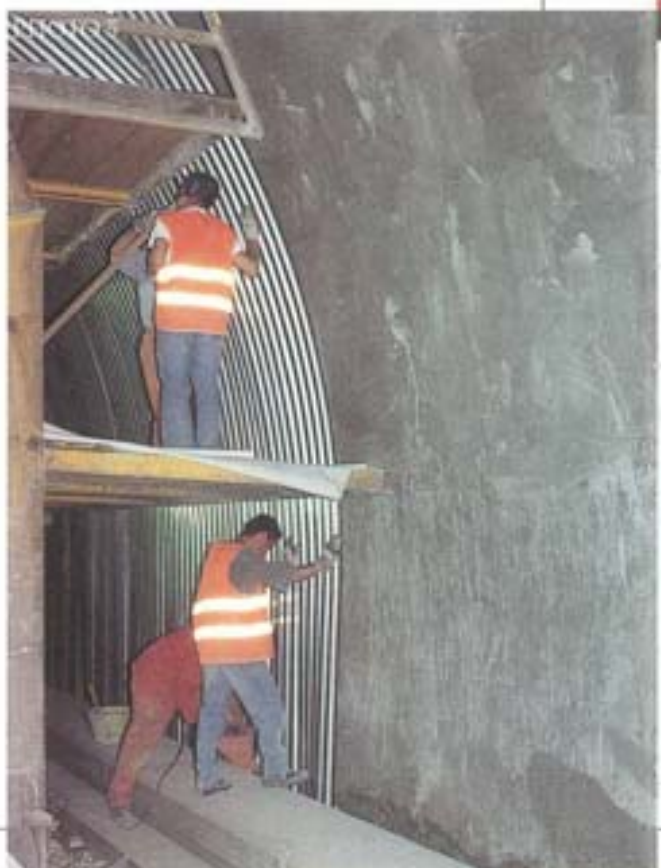
Finishing consisted in lining the tunnel walls with fretted stainless steel plates, sound-proof padding and non-reflective aluminium panels (photos 5 and 6).
