A13 Bologna-Padua motorway (Italy)

Bridge over the River Po along the A13 Motorway

THIS BRIDGE BUILT AROUND 50 YEARS AGO WAS THE FOCUS OF IMPORTANT STRENGTHENING AND REPAIR WORK

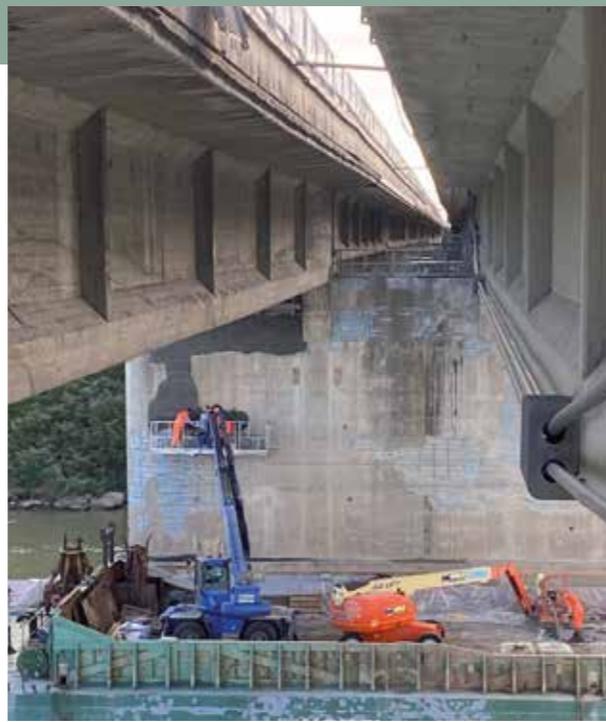
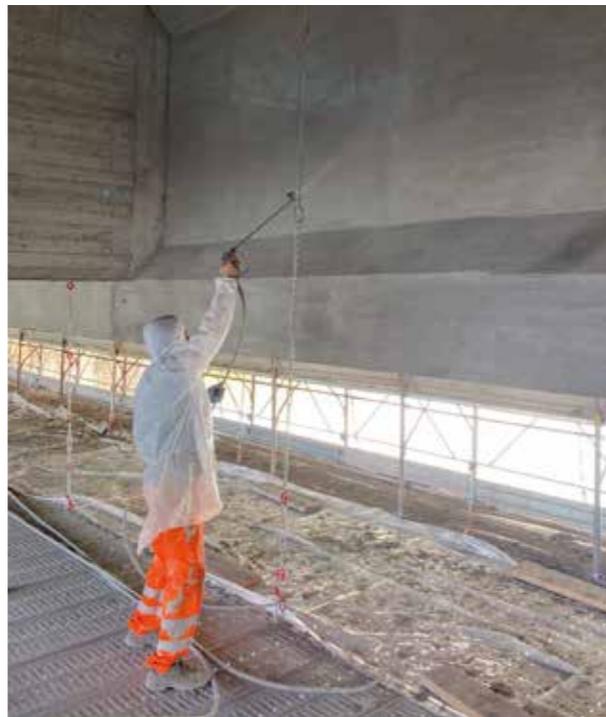
The bridge underwent a refurbishment and concrete repair intervention that made use of MAPEGROUT EASY FLOW GF, MAPEGROUT HI-FLOW B2, and MAPEGROUT LM2K.

After strengthening the deck, the concrete surfaces were finished with MAPECOAT E23 epoxy primer and MAPECOAT PU 33 polyurethane resin-based, flexible coating.
