Oroville (California)

OROVILLE DAM SPILLWAY

MAPEI PRODUCT HELPED TO STRENGTHEN A DAM'S STRUCTURE AND SAVE A CITY

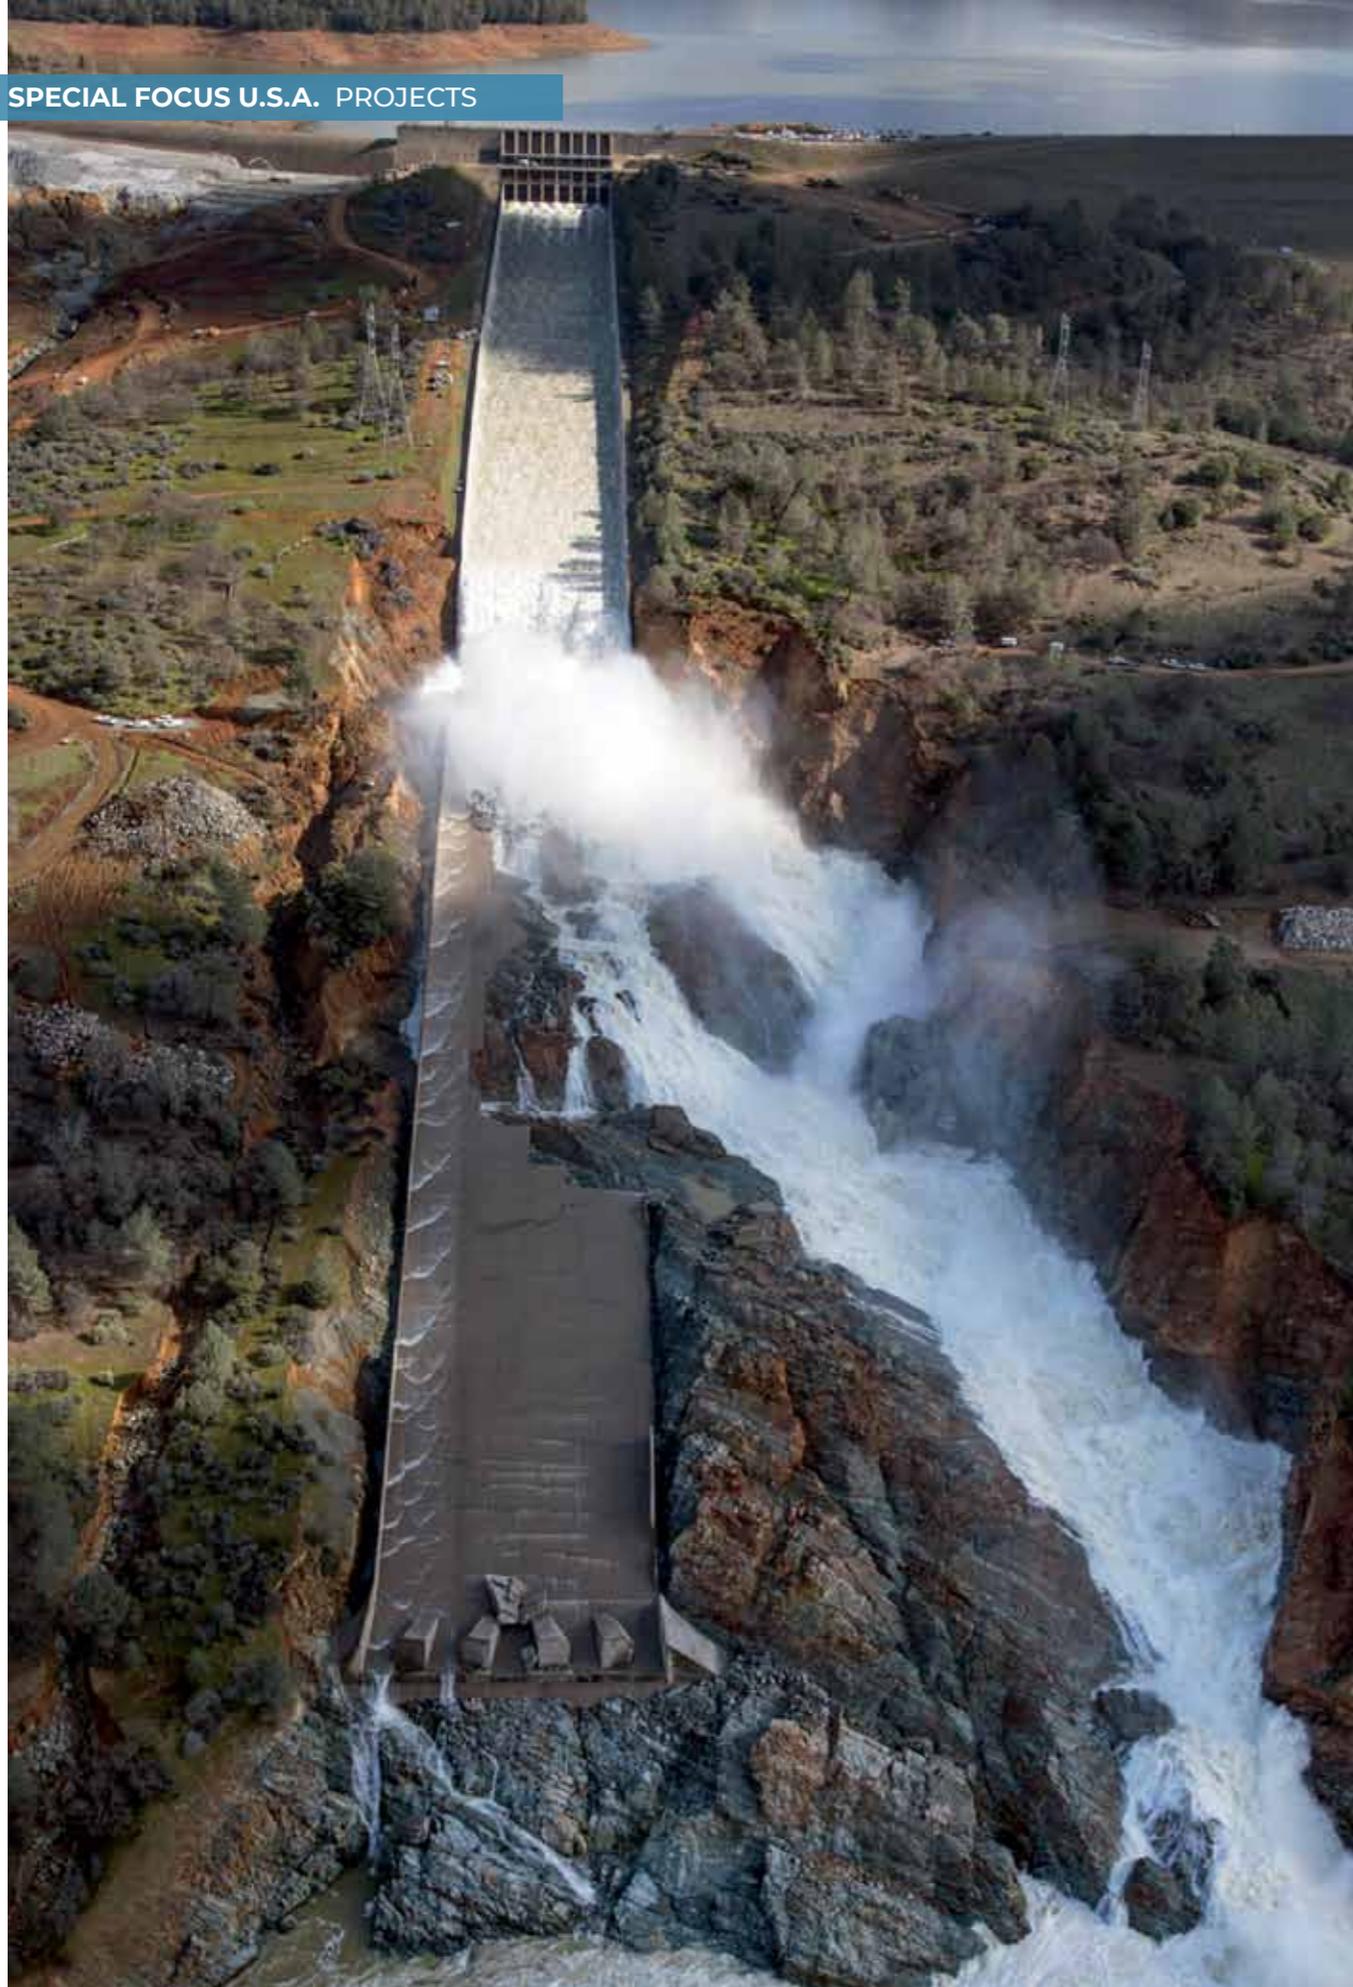
RIGHT. In operation since 1968, the Oroville Dam is an earth-fill embankment dam just east of the city of Oroville, California, in the scenic Sierra Nevada foothills.

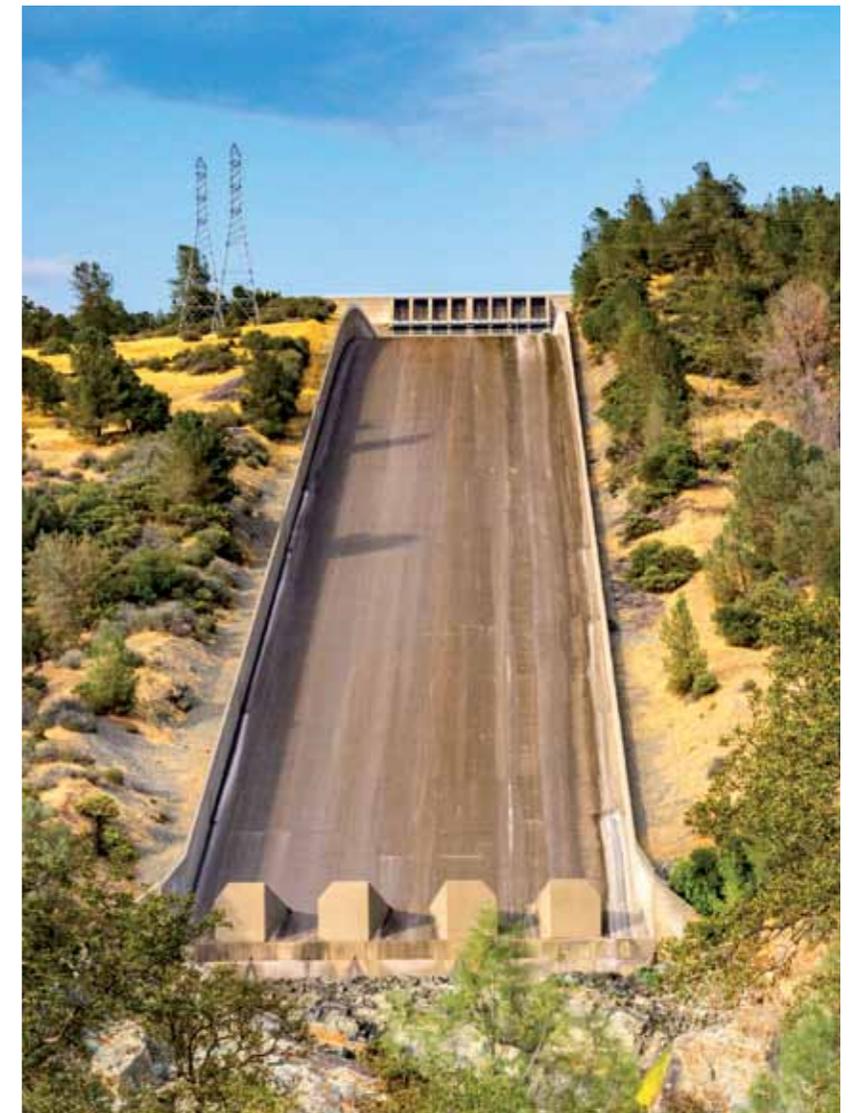
LEFT. On February 7, 2017, as the rain water continued to pour down, California state engineers noticed concrete erosion on the flood-control spillway at the Oroville Dam in California. Strengthening and repair work was completed thanks also to PLANIGROUT 755.

The specifications called for the installation of about 8,000 pieces of no. 10 rebar on the spillway to reinforce the heavily eroded structure. "Each piece of rebar was sized between 4.57 and 7.62 m in length," Dyer said. PLANIGROUT 755 is a one-component, non-shrinking, cementitious grout. This product is manufactured and distributed on the U.S. market by Mapei Corp. (its counterpart on the international market is called MAPEFILL). The product was excellent for use as non-shrink grout for rebar placement. About 8,000 cores were drilled. Rebar was then placed into the cores.

"We pumped PLANIGROUT 755 in to fill the voids between the pieces of rebar and the outer wall of the core," Dyer said. "We used about 16,000 bags of 22.7-kg product during the entire project."

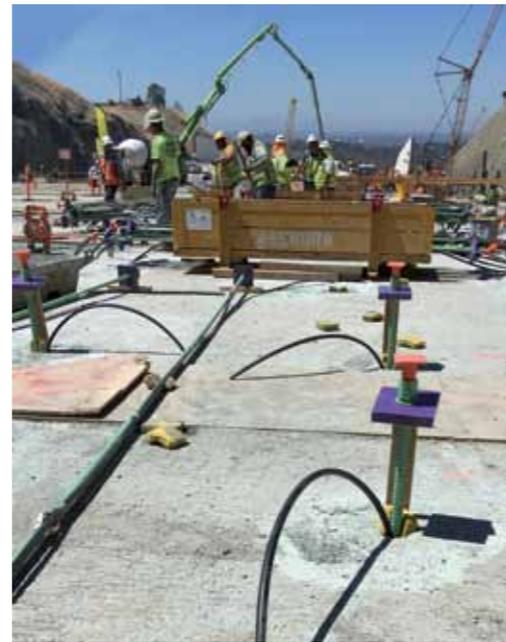
ABOVE. PLANIGROUT 755 was pumped in to fill the voids between the pieces of rebar and the outer wall of the core.
