Brindisi (Italy)

CHURCH OF SAN PAOLO EREMITA

EFFECTIVE AND LONG-LASTING PRODUCTS FOR THE RESTORATION AND CONSOLIDATION OF A CHURCH BADLY DAMAGED BY THE PASSAGE OF TIME

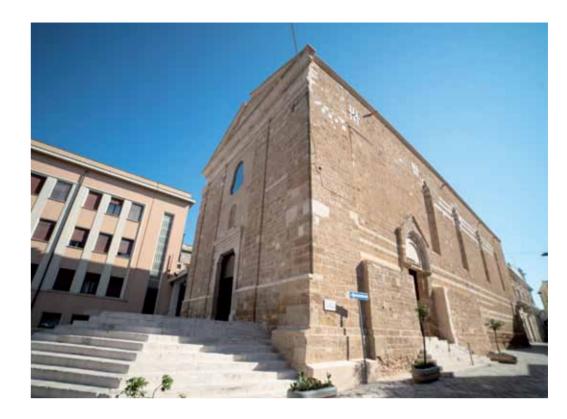
1. MAPE ANTIQUE F21

was injected through

small tubes using low-

consolidate the stone

pressure pumps to

structure

MAPE-ANTIQUE F21 binder was used to consolidate the stone structure and limestone vaulted ceiling of the church. This is a cementfree, salt-resistant product made from lime and Eco-Pozzolan used to make super-fluid, volumetrically stable slurries and was injected in

the structure by using low-pression
