Milan (Italy)

Aquilonare Sacristy in Milan Cathedral

A COMPLEX RESTORATION INTERVENTION ON THE PORTAL, THE MARBLE FLOORS AND THE FRESCOES BY CAMILLO PROCACCINI

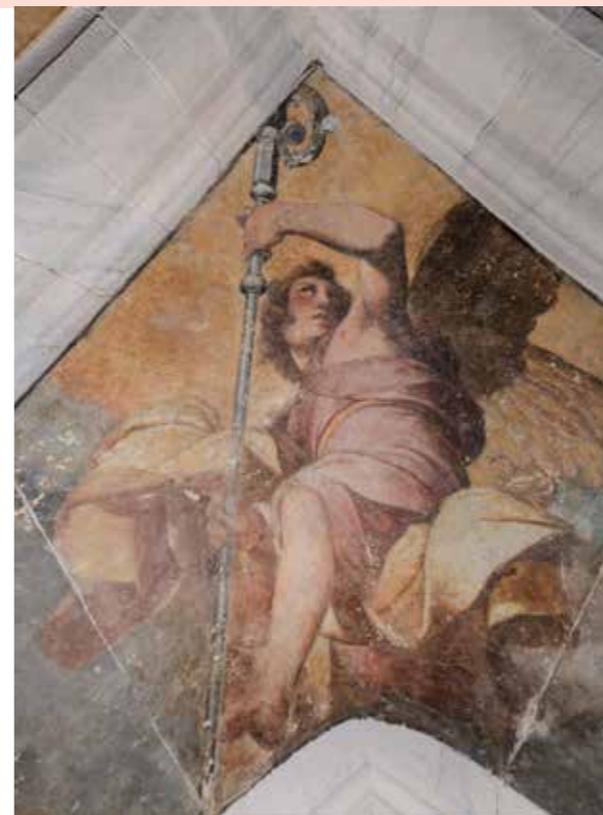
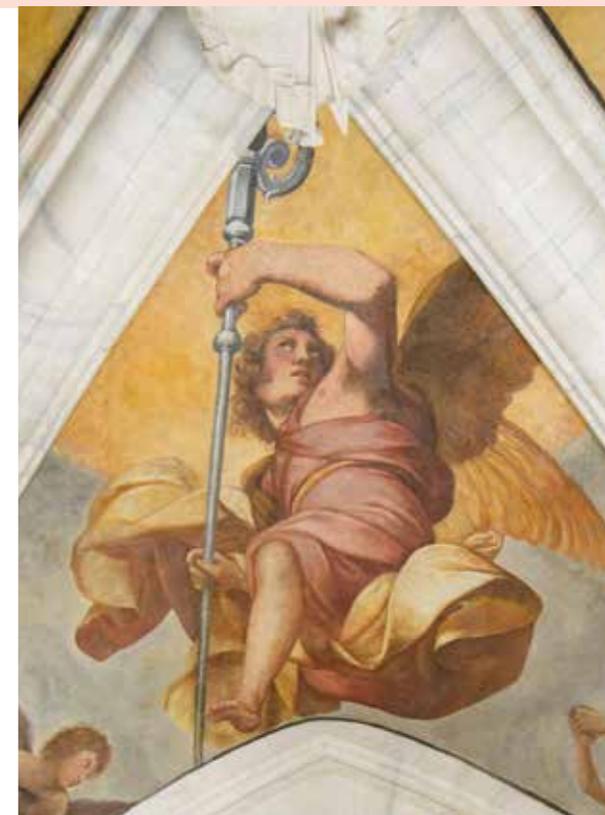
ABOVE. A rib of the Aquilonare Sacristy before (left) and after (right) the completion of the restoration intervention.

While restoring the frescos, the company also restored the marble ashlar, especially the ribs of the two cross-vaulted ceilings and the two large, central keystones. The marble elements had become completely blackened by an extremely compact, thick layer of dust, smoke and particulate matter. The joints between the ashlar had been sealed in the 1970s with conglomerate made from sand, marble powder and dark pigmented epoxy resin to match the colour of the blackened marble, which was applied in large quantities and spread roughly over the surfaces so that large portions of the marble ashlar were also covered. The cleaning phase consisted of repeatedly applying meerschaum and arbolcel compresses with ammonium carbonate and, due to the sheer thickness and toughness

of the layer of dirt, they were left in place for several days. Removing the grouts from the joints proved to be much more complex and time consuming. Heat and hand and power tools were used and gave an excellent result.

The joints grouted with cementitious mortar were cleaned by the specialised craftsmen from the Veneranda Fabbrica del Duomo and then filled with MAPE-ANTIQUE ALLETTAMENTO cement-free, natural hydraulic lime-based mortar. They were then coloured, a little at a time, to blend them in with the various shades of the marble. This mortar was chosen for its chemical-physical and elastic-mechanical compatibility with the properties of the mortar originally used and is also resistant to soluble salts, so does not suffer "attack" by soluble salts present in the structure from previous restoration works using cementitious mortars.

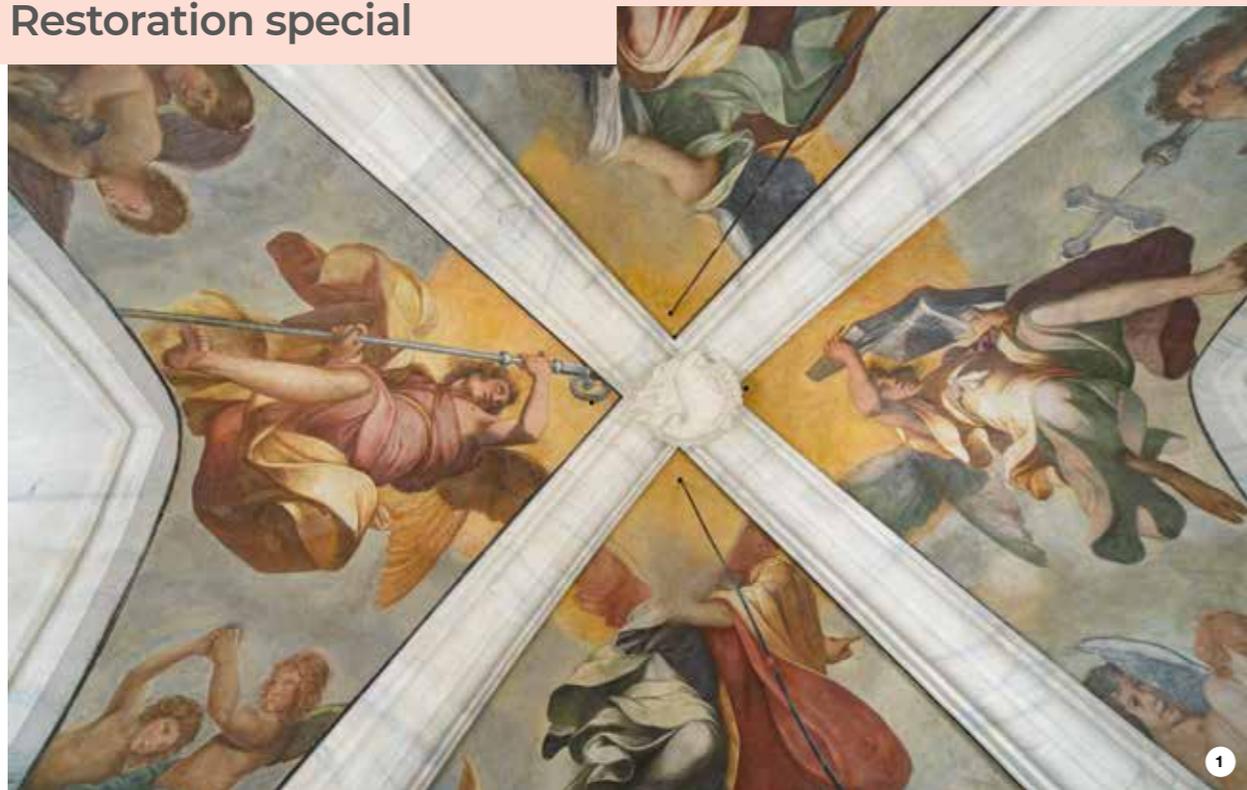
1. The frescoes on the canopies of the west bay after restoration.
2. Application of the CONSOLIDANTE 8020 mix on the frescoes on the canopies.
3. Re-establishing the adhesion of the frescoed surfaces with MAPE-ANTIQUÉ F21.

After pulling off the frescoes in the 1960s, they were bonded to very thin canvas with caseinate (casein and lime putty) which, over the years, had lost its bonding power, with serious consequences for the stability of the colour; the missing areas were patched up with pieces of canvas and then covered with tempera applied directly on the canvas without any base grout. After pulling off the frescoes, the original render had been demolished and then rebuilt using cementitious render. The frescoes, which at this point were attached to canvas, had then been repositioned on the new render using contact adhesive but were not laid flat and large blisters and creases appeared in the canvas. Over the years, the adhesive lost its properties and the frescoed canvases started to detach from the render, putting the stability of the entire feature at great risk.

After removing all the dusty and crumbling material and then laying on a thin layer of wash paper, the restoration

company (Centro di Restauro di Paola Zanolini e Ida Ravenna) proceeded to detach the frescoed canvases and, once they had been taken down to ground level, the adhesive was removed from the back of the canvases using sprayed water and an iron. All the portions of fresco then had a new canvas backing applied and the layer of wash paper was removed. Then, skilful, expert hands restored all the frescos which were later bonded back to the ceiling in their original position using ULTRAMASTIC 5, a special ready-to-use, white paste adhesive. The joint lines between the different portions were filled and blended in by carefully painting them to mask the joints. The method adopted to reintegrate the paintwork meant that small and medium-sized areas of missing paintwork could be touched one by one, while the larger areas were blended in with the colours of the fresco around them without carrying out any further repair work.
