Milan (Italy)

Giorgio Gaber Theatre

GRAND REOPENING 22 YEARS AFTER ITS CLOSURE. MAPEI'S CONTRIBUTION TO THE RESTORATION WORKS IN THE INTERIORS AND EXTERIORS

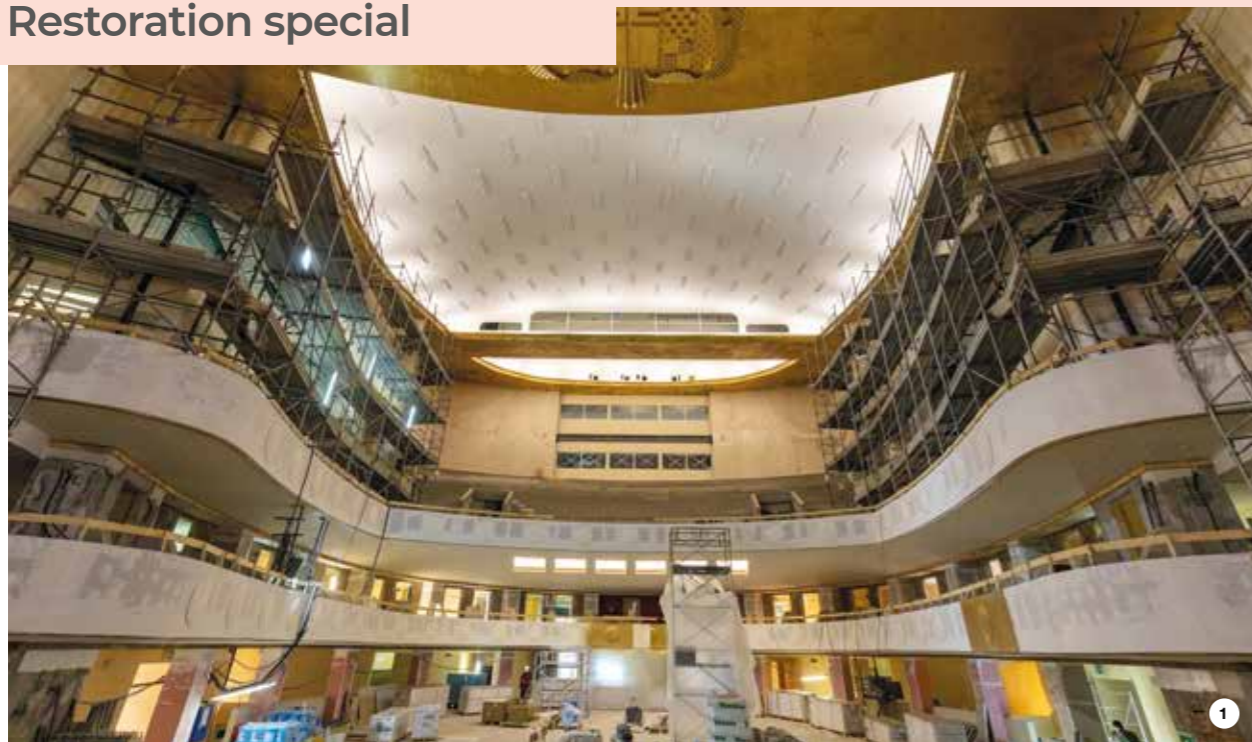
1. The interior of the theatre during the restoration. The gold leafing on the vaulted ceiling was also restored.
2. A view of the layers of paint that were found on the golden finish of the vaults.
3. The walls in all the corridors, stair wells and stalls were finished off with SILEXCOLOR MARMORINO.
4. Before applying the render and skim coat, the masonry was consolidated by applying a coat of PRIMER 3296.

From an interior aesthetic and architectonic point of view, the new features included the restoration of the imitation gold leafing, the vaulted ceilings in the gallery and the cornices running along the sides covered with five layers of paint, the gypsum sculptures in the foyer on the first floor, the "ears" on the vaulted ceiling of the stalls and gallery and the restoration of the original colours. Conservative restoration work was also carried out on the render and on the stone surfaces of the historic façade. "Milan yellow", the historic colour used to identify the most important buildings in Milan, was re-proposed.

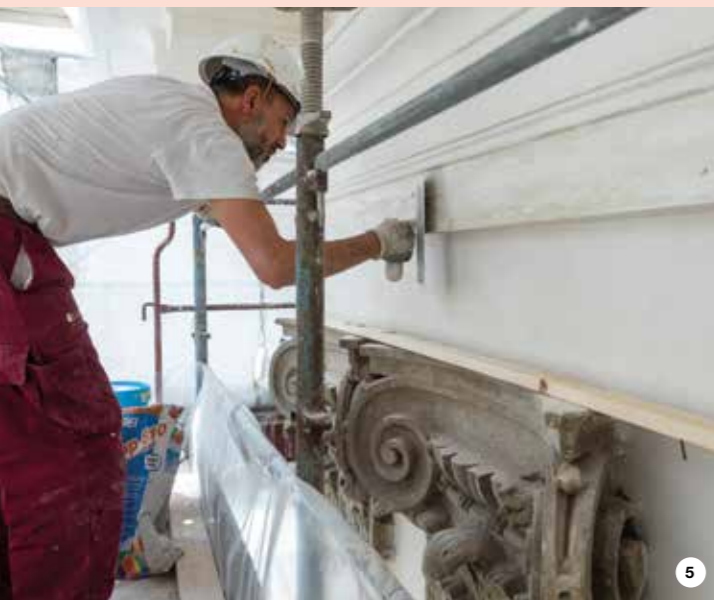
5. PLANITOP 510 fine-textured, lime-cement skimming mortar was applied on the external surfaces before painting them. When the render was made of lime, the product chosen was MAPE-ANTIQUÉ NHL ECO RASANTE CIVILE fine-grained, breathable, smoothing and levelling mortar.

- Restoration of damaged and deteriorated render was carried out by firstly applying MAPEWALL INTONACO BASE natural hydraulic lime-based base render. Then, after skimming the surfaces with PLANITOP 510 fine-graded, lime-cement based skimming compound, the surfaces were painted with SILEXCOLOR BASE COAT and SILEXCOLOR PAINT in the colour shade chosen by the Works Direction.
