Palermo (Italy)

Enel head offices

CONCRETE REPAIR AND NEW COATINGS
FOR THE RENOVATION OF THE FAÇADES

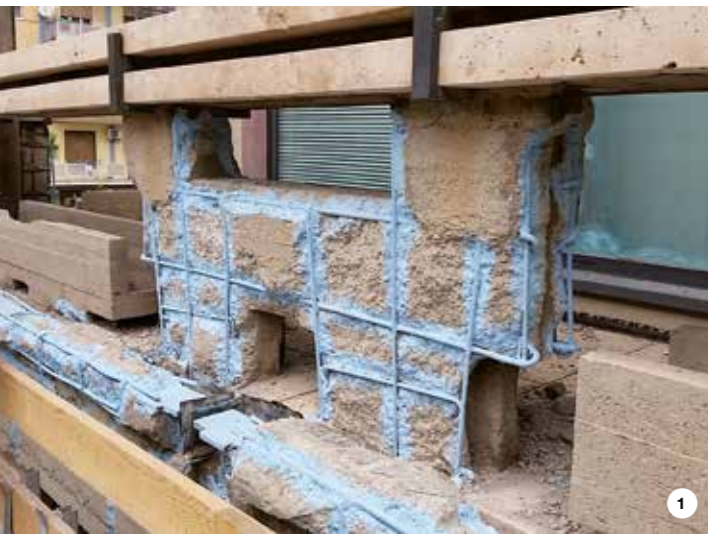
1

1. The damaged rebar was protected by applying by brush two coats of MAPEFER 1K corrosion-inhibiting cementitious mortar.

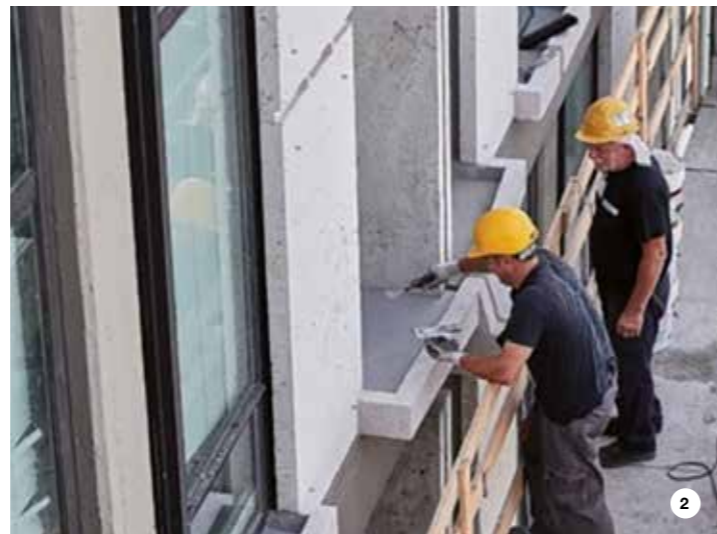
2

2. The deteriorated concrete ledges were repaired with MAPEGROUT 430 pre-blended, normal-setting, fibre-reinforced, thixotropic cementitious mortar.

Work was carried out on the deteriorated areas in the protruding part of the ledges by reintegrating the gaps and missing parts in each element to restore them to their original shape, consolidating the existing deteriorated parts and, lastly, treating the elements with protection and finishing systems. After demolishing all the crumbling and unstable areas and any parts of the concrete that had become detached, brushing the rebar by hand and then cleaning all the surfaces, the rebar was passivated by applying by brush two coats of MAPEFER 1K one-component, corrosion-inhibiting cementitious mortar. The deteriorated concrete structures were then repaired by applying MAPEGROUT 430 pre-blended, normal-setting, fibre-reinforced, thixotropic cementitious mortar with a trowel.

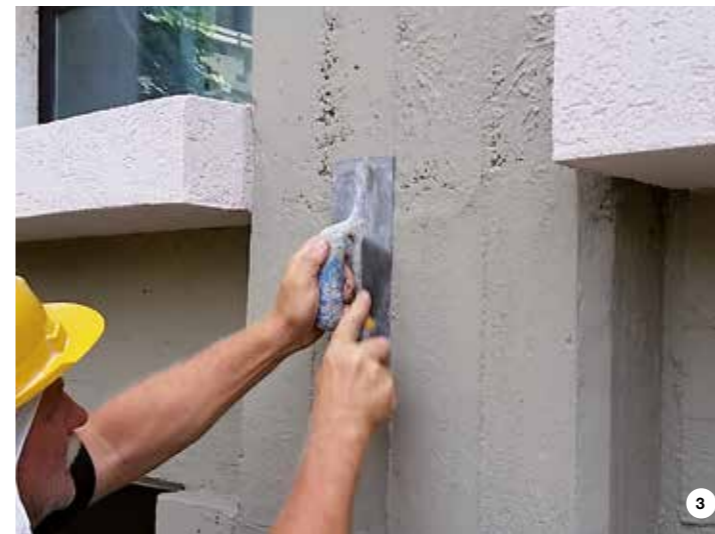
3

3. The concrete surfaces of the ledges were skimmed with PLANITOP 210 water-repellent, normal-setting, fine-grained cementitious mortar.

The surfaces were skimmed with PLANITOP 210 one-component, water-repellent, normal-setting, fine-grained cementitious skimming mortar.

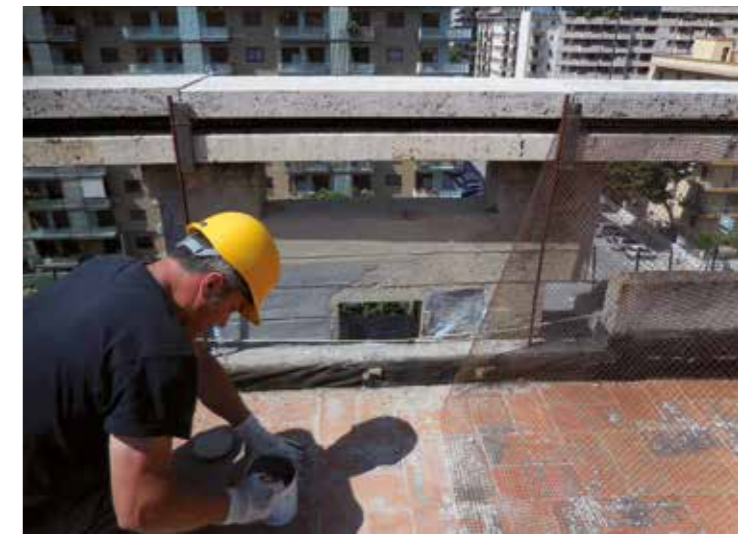
4. On the balconies, the rebar was again treated with MAPEFER 1K and MAPEGROUT 430 was chosen to repair the deteriorated elements.

a protective coating and finish. As with the previous case, after brushing the rebar and cleaning the surfaces, the rebar was protected with MAPEFER 1K and MAPEGROUT 430 was chosen to repair the deteriorated elements.
