THE CHURCH OF THE NATIVITY IN BETHLEHEM

HIGHLY RELIABLE MATERIALS AND TECHNIQUES EMPLOYED FOR STRENGTHENING AND RESTORING WOODEN STRUCTURES

Restoration work on the Church of the Nativity in Bethlehem – one of the most popular sites for pilgrims visiting the Holy Land – started in September 2013 and is still in progress.

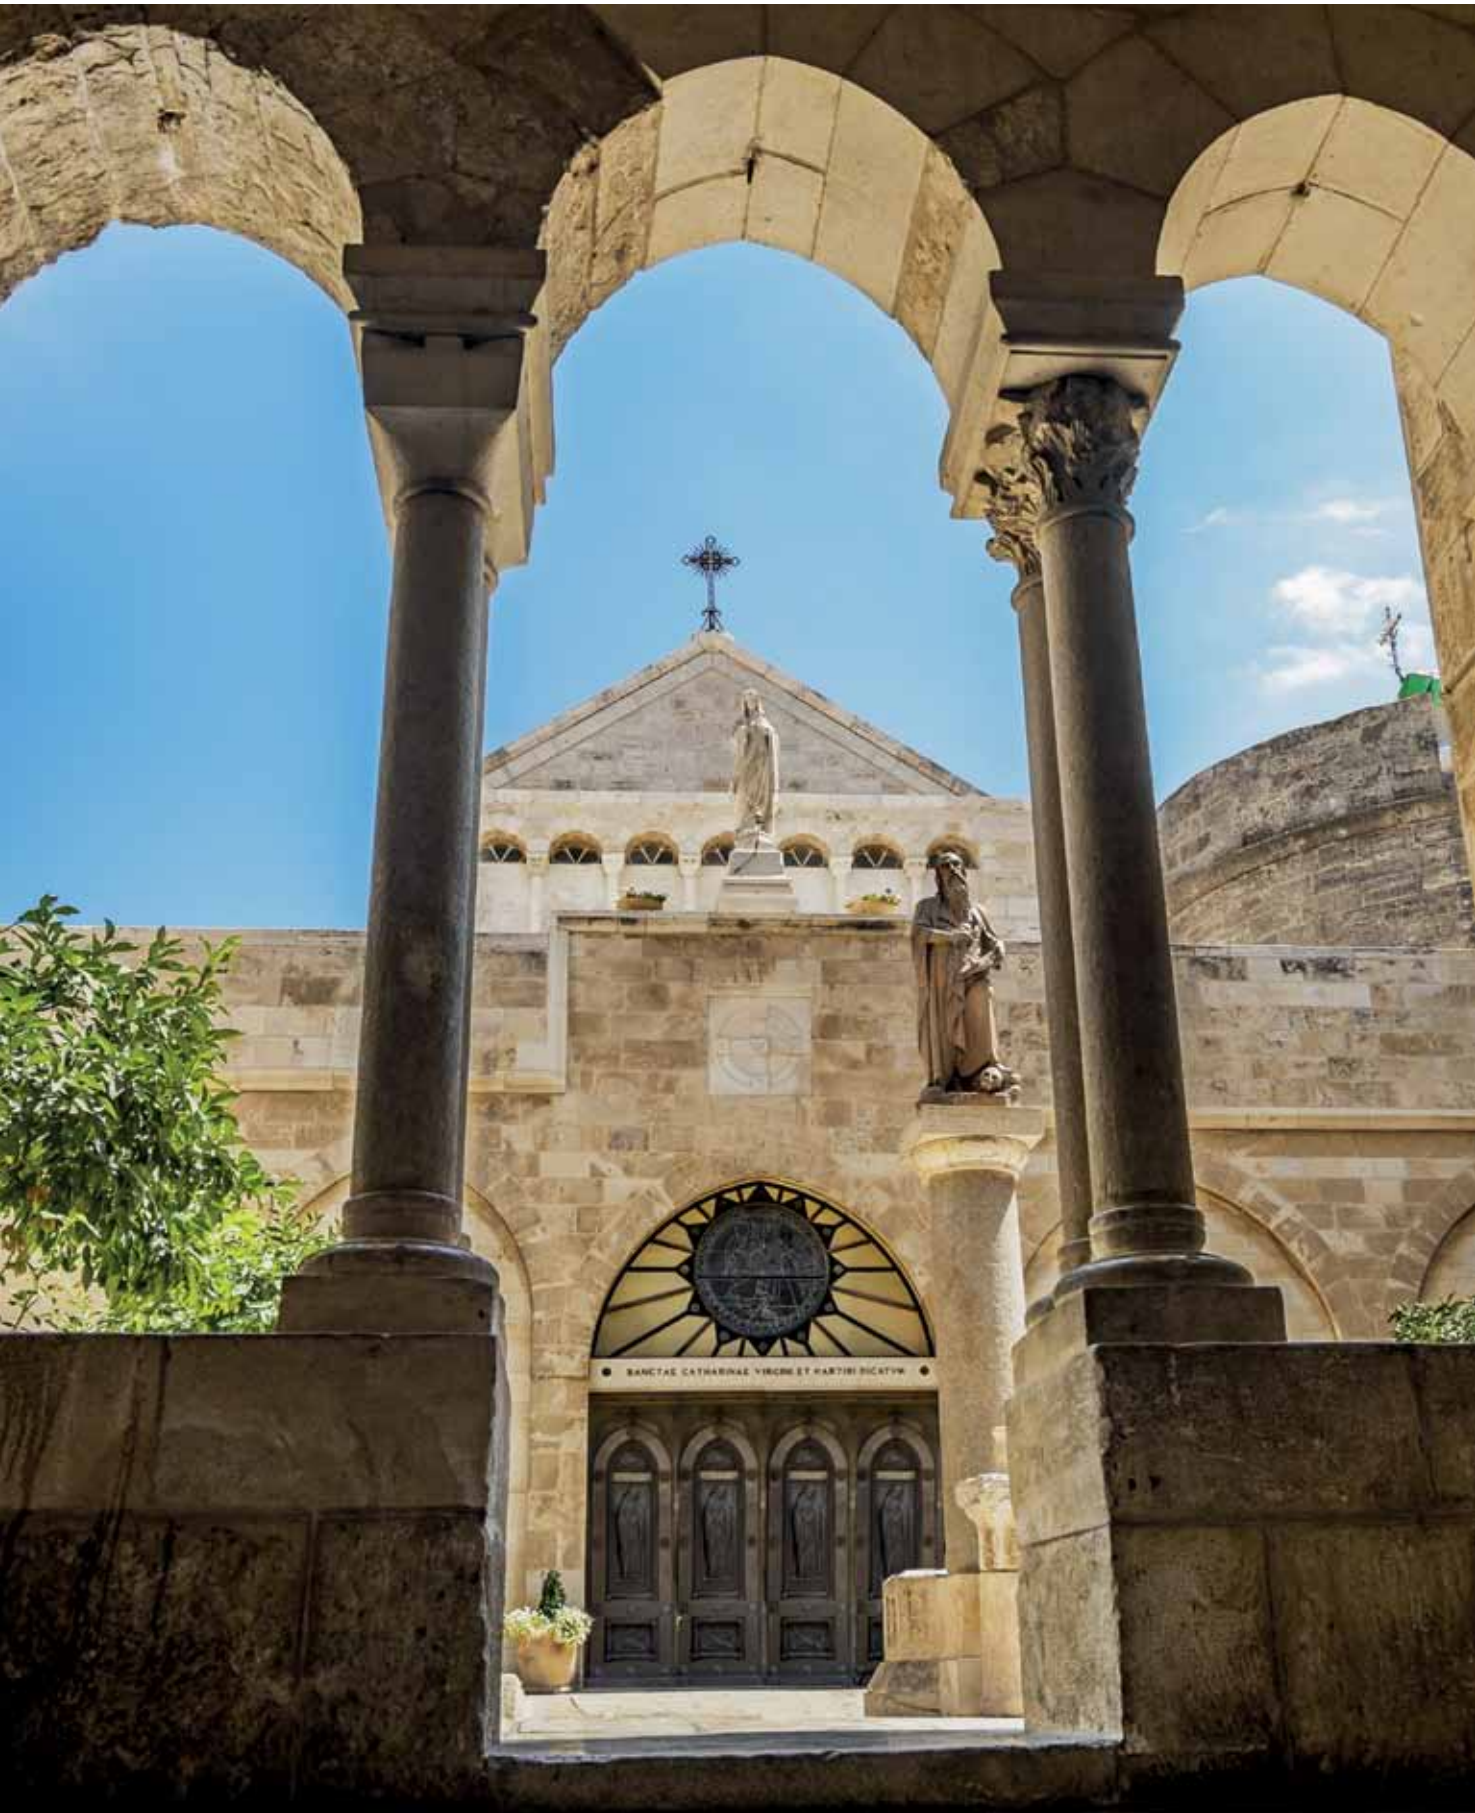
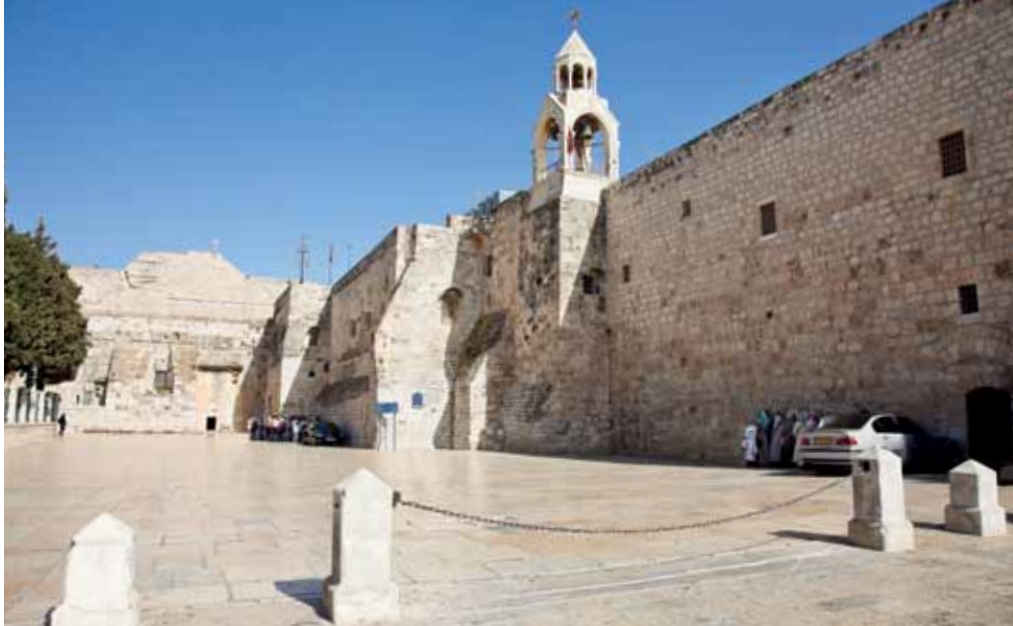
PHOTOS 1 and 2. The Church of the Nativity before and after the restoration of the roof.

lected following an international tender, signed a contract to carry out the restoration and conservation work on the roof by restoring the physical and mechanical functions of the timber roof structure and replacing 2,000 m² of lead sheeting on the roof.

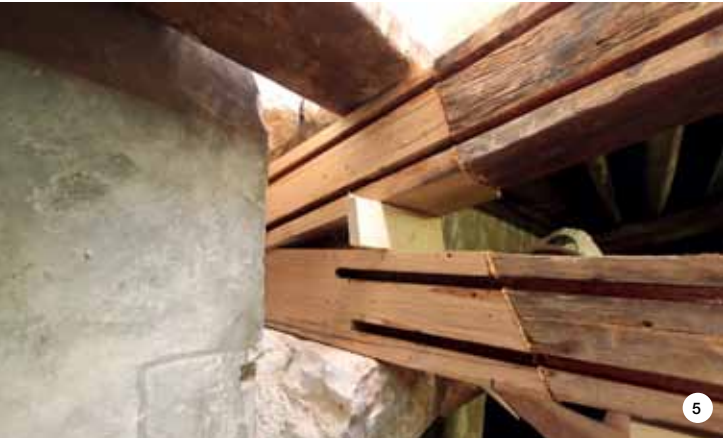
5

PHOTO 5. In the first phase of the restoration works the wooden surfaces were impregnated with MAPEWOOD PRIMER 100.

The results were only obtained after impregnating the surfaces with MAPEWOOD PRIMER 100, an epoxy impregnator in water dispersion used to consolidate wooden structural elements damaged by fungi or woodworms. This product is specific for

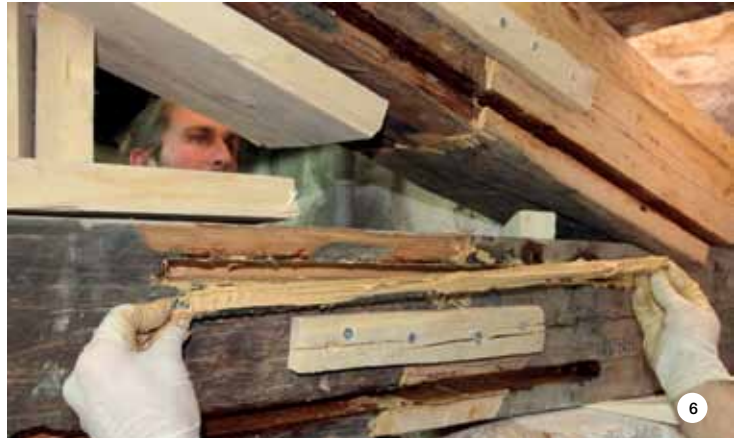
6

PHOTO 6. MAPEWOOD PASTE 140 was chosen to bond the wooden structures and the connector rods.

Following the analysis, which was carried out by comparing the results of the monitoring campaign by LegnoDoc Srl from Central Italy and the samples taken, the product chosen to bond the wooden structures and the connector rods of an appropriate diameter inserted into the structures was MAPEWOOD PASTE 140 two-component, thixotropic epoxy adhesive. This product is the ideal solution for repairing timber beams and truss by anchoring metal bars to them, because it hardens without shrinking and forms a paste with exceptional bonding properties, high levels of tensile and flexural strength and a flexural modulus of elasticity that ensures a sound structural joint is formed.

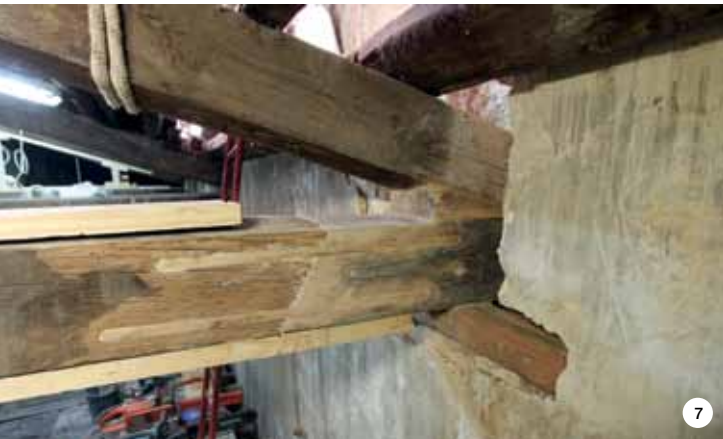
7

PHOTO 7. The wooden structure before finishing.

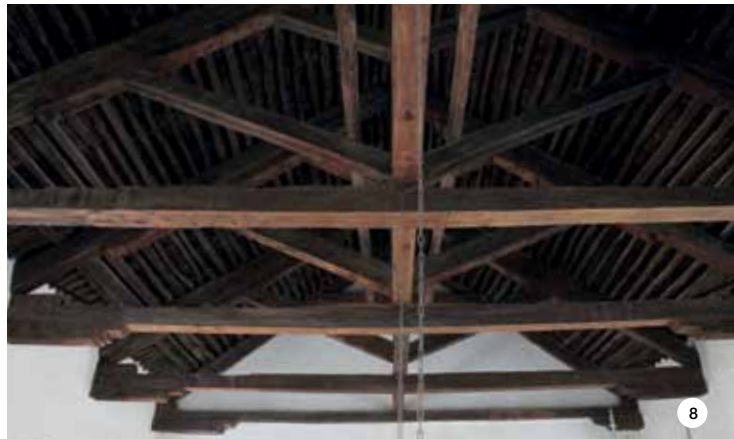
8

PHOTO 8. At the end of the restoration works the colors of the wooden elements were brought back to their original splendor.

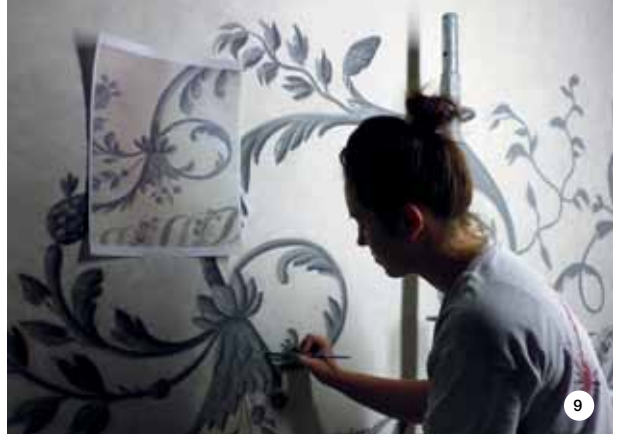
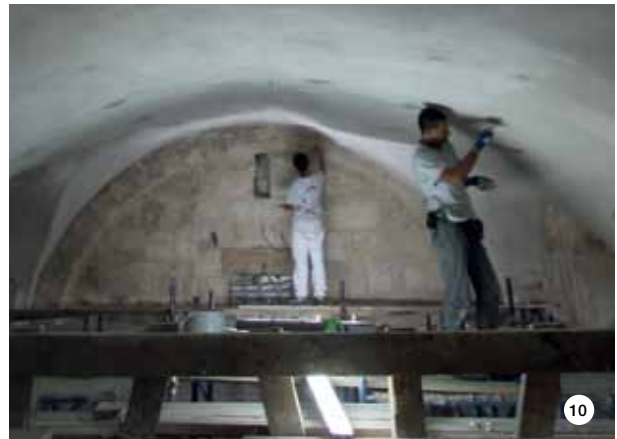
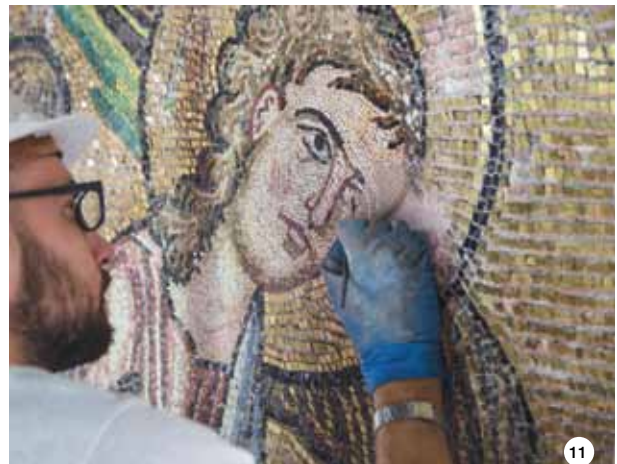
PHOTO 9, 10 and 11. The restoration works also involved wall mosaics.

A highly articulated, targeted plan of action was adopted to restore the mosaics on the walls and to repair and consolidate widespread areas with MAPE-ANTIQUÉ F21 superfluid, salt-resistant, fillerized hydraulic binder, where some of the tiles had become detached from the substrate. It also included the interventions to consolidate the surface of the glass tiles suffering from scattering, remove the deposits damaging the tiles and to carry out repairs on the missing areas.

The result is to have given a new voice and dignity to the mosaic decorations, which before the intervention had been severely compromised by seepage and, even more importantly, had become mute and degraded by the dark veil which hung over them.
