TAKING SHELTER IN THE DOCK

The renovation work on the out-fitting wharf at the Sestri Ponente shipyard testifies to how an analysis of the conditions causing deterioration of concrete and choosing specific products are vital in re-establish quality and durability.

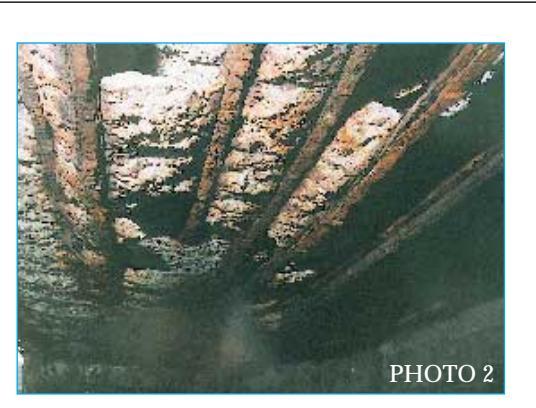
considerably better built. In both cases though, the inner surface of the girders and the concrete slabs were in bad condition. The concrete reinforcement rods were completely exposed and corrosion had reduced the section substantially (photo 1 and 2).

After having thoroughly analysed the problem and laid down all the parameters for the reconstruction project, the technical department decided to remove the layer affected by hydrodemolition in order to remove the chlorides that had penetrated the concrete over the years. The task called for a two-pronged approach: first, the removal of loose and deteriorated parts with electrodemolishers, second, high pressure hydroscaring (2,000 bar, 25 litres per minute) all surfaces. The use of high pressure hydrodemolition was especially
