Different kinds of bridges, DIFFERENT KINDS OF REPAIRS

Different technology and different products employed to restore two bridges over the River Duero: one in concrete and one in stone.

Bridges on the River Duero, located along the stretch between Peñafiel and Pesquera de Duero (Valladolid – Spain).

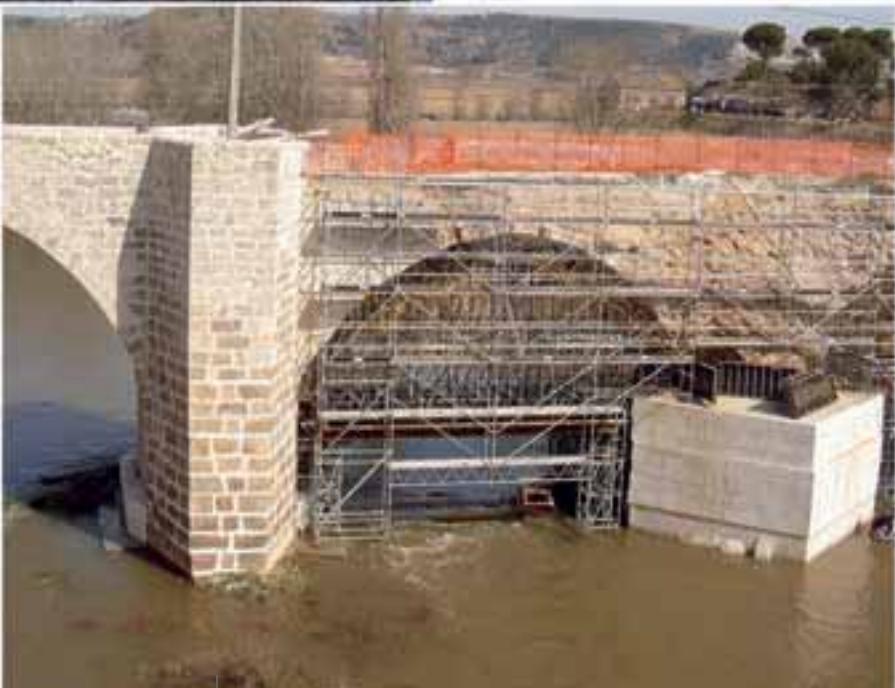
Further damage was also found by the technicians, with cracks in the columns which support the arches, no sealant between the stones in various portions of the masonry work and cracks in the vault of some of the arches, which had

provoked detachment of a number of blocks of stone.

salts. The cracks in the vaults of the arches were repaired using MAPE-GROUT T40* thixotropic mortar and pointing was again carried out using MAPE-ANTIQUÉ LC* binder.

MAPE-ANTIQUÉ I* hydraulic binder was then injected to consolidate all of the arches, except the two central ones. MAPE-ANTIQUÉ I* is used to consolidate by injection and fill cavities, cracks and internal porosity in ancient stone and brick structures. The day before the binder was injected, the internal structure to be consolidated had to be thoroughly soaked with water, using the same holes which had been drilled ready for injecting the
