CONCRETE STRUCTURE RENOVATION  
IN THE SLAG DROP ZONE  
OF MITTAL STEEL PLANT IN CRACOW

DATE: 06-2011

INTERVENTION BY MAPEI: REPAIR AND STRENGTHENING WORKS OF CONCRETE STRUCTURE IN THE SLAG DROP ZONE (MITTAL STEEL)

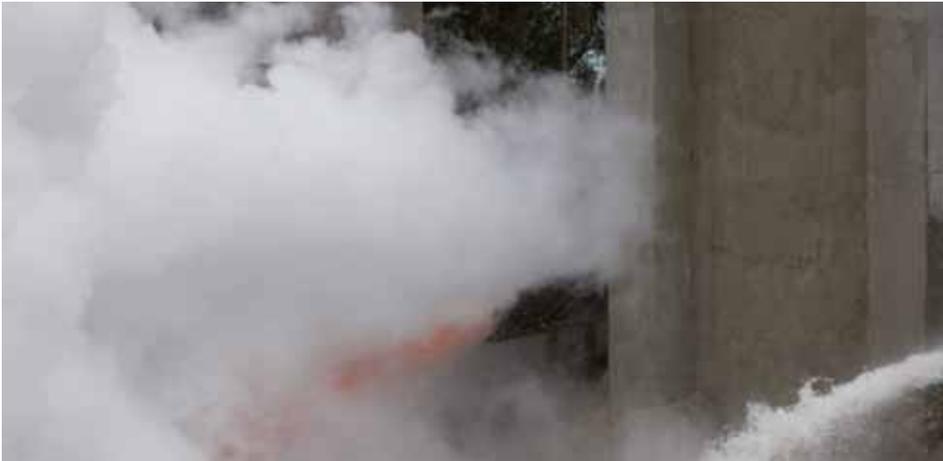
Slaking slag process.

Photograph above represents the slaking slag process. During the slaking we have to face huge amounts of vapor and the installation's construction is therefore exposed to huge thermal shocks. It is based on concrete structure and developed with poles and crane beams and four commanding booths. During the use only temporary repairs of the construction elements were executed. Intensive exploitation, without extensive renovation led to construction's withdrawn from use in 2009, the decision was taken by the Bureau of Technical Inspection. The same year, the construction repair, renovation and protection works concept's elaboration was commenced. In the designing phase the Mapei Technical Assistance was asked to collaborate in the concrete structure renovation technology development. The first step was to execute an adequate inventory of damages and construction's technical condition. The construction was divided to two load zones, depending on the influence of temperatures fluctuation and on conditions in which it has to operate. In the zone I, the machines with permanent contact with vapor, released during the slaking found their place. The damages in this case were major.
