# 2011

## **ICRI Project Awards**

Cooling Tower Strengthening and Rehabilitation

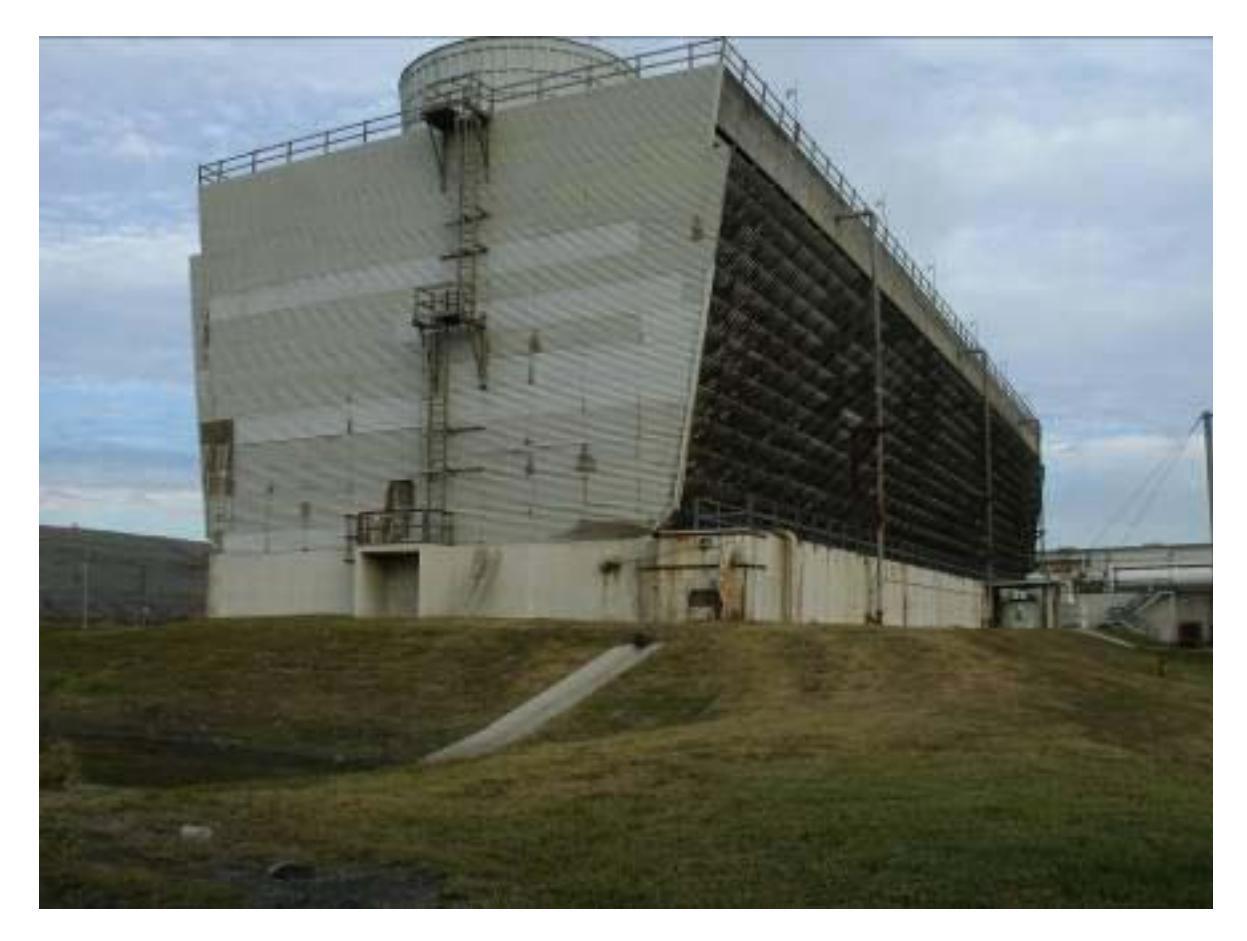
If problems can surface just from airborne debris, imagine the impact that broken pieces of concrete could have on a system should pieces break off of the structure and get caught in the exchanger. As mentioned above, with restricted water flow and equipment malfunctioning, shut downs can occur. Not to mention the overall stability of the structure as the steel reinforcement corrodes, spreading rapidly through the concrete like cancer through a body.

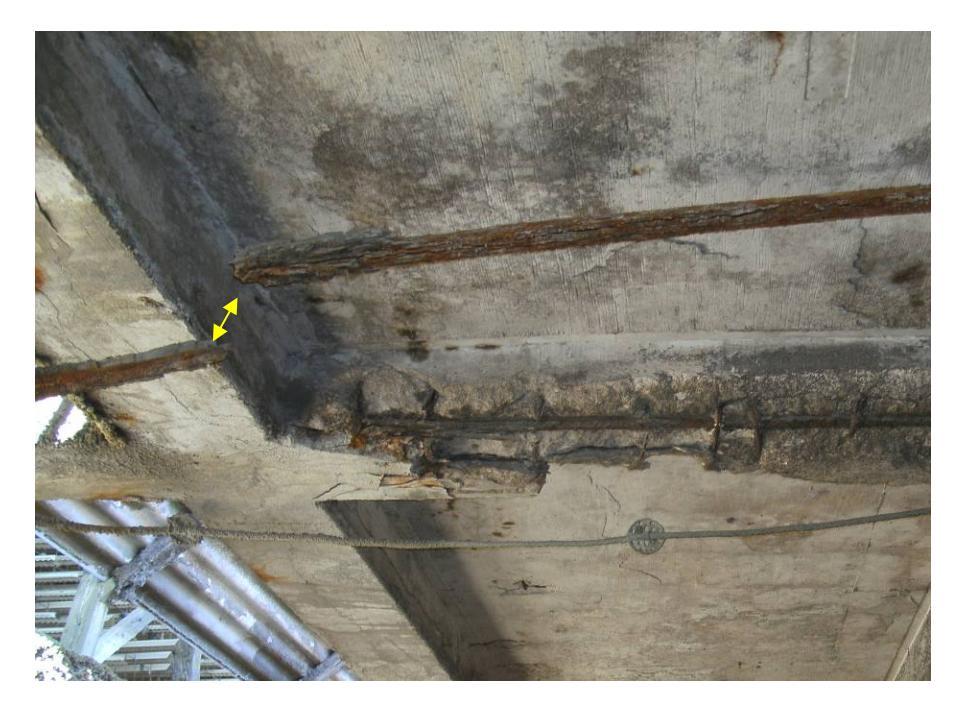
The corrosion was so severe under the walkway it caused all 8 of the 1-3/8" diameter steel tie-back rods to corrode completely off. This allowed the retaining wall to shift, opening large cracks in the corner of the structure.

The first area to address was the southeast corner of the retaining wall that supported the 255 foot walkway. With the steel tie-backs corroded off and the large cracks within the wall it was imperative to strengthen this area prior to proceeding with repairs to the walkway above or the inside of the narrow water flumes. After repairing the spalls and cracks, both the inside and outside areas were wrapped with CFRP to secure the structure.
