The Abbey of Tiglieto

Italy's first Cistercian settlement has been subject to careful architectural restoration which had been carried out respecting the appearance of the original building.

Abbey of Santa Maria di Tiglieto – Tiglieto (Genoa, Italy)

Restored: 1998

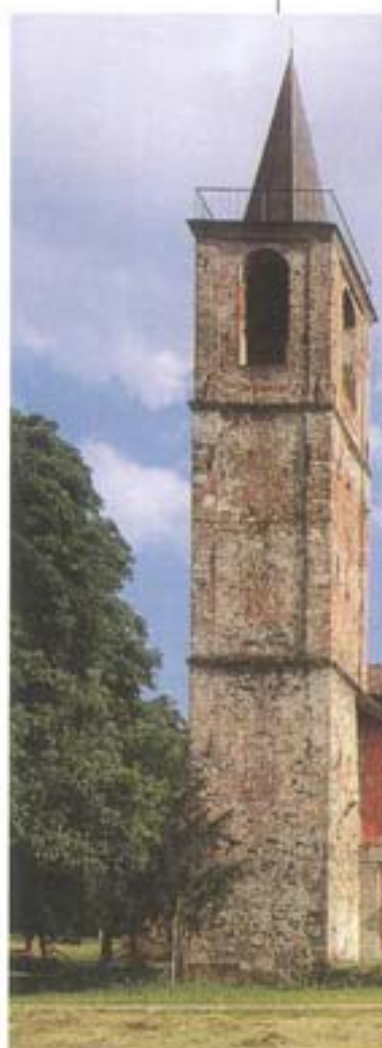
PHOTO 11

Without doubt the Medieval-17th-century bipolarity is a special characteristic of the Tiglieto building; the conservation for future generations of this duality reflects the effort to preserve the building's authenticity (photo 11 and 12).
