# TAKING SHELTER IN THE

The renovation work on the out-fitting wharf at the Sestri Ponente shipyard testifies to how an analysis of the conditions causing deterioration of concrete and choosing specific products are vital in re-establish quality and durability.

# DOCK

Sestri Cantiere navale, Gruppo Fincantieri  
Sestri Ponente (GE)

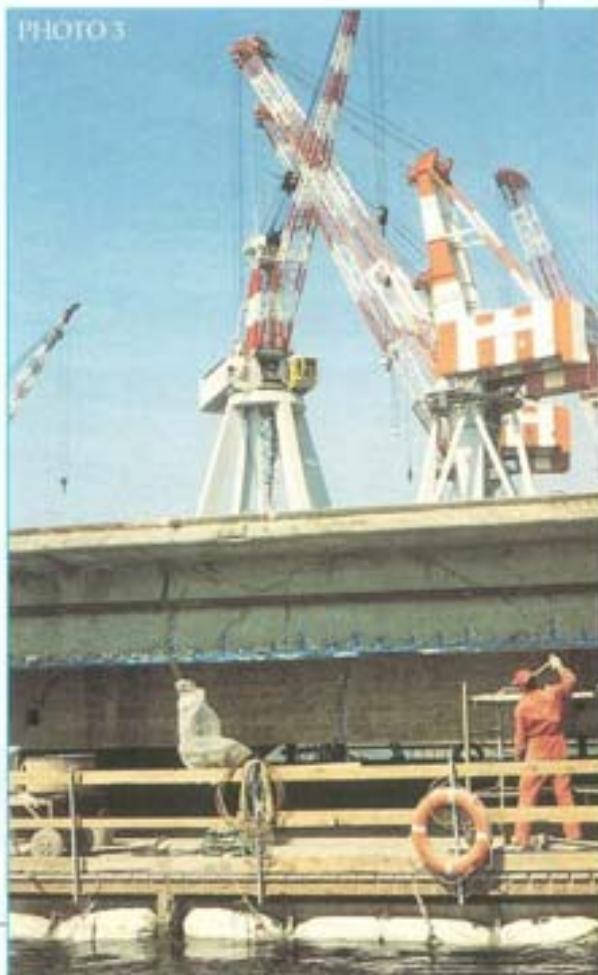
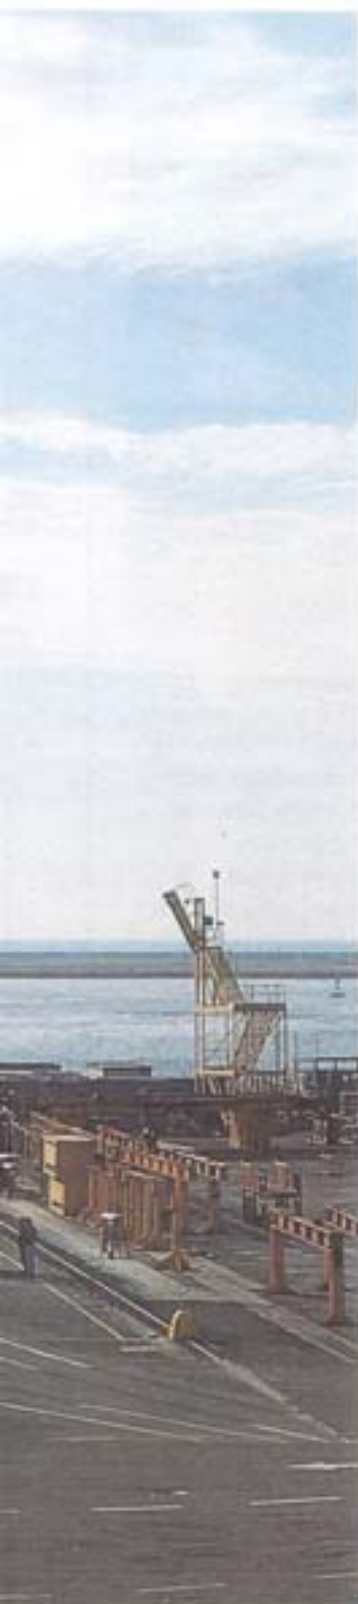
considerably better built. In both cases though, the inner surface of the girders and the concrete slabs were in bad condition. The concrete reinforcement rods were completely exposed and corrosion had reduced the section substantially (photo 1 and 2).

effective in some sections of the beams' inner surfaces. It revealed a higher degree of deterioration than expected, and fragments of concrete 7-8 cm thick were removed, exposing the steel reinforced framework.

After having thoroughly analysed the problem and laid down all the parameters for the reconstruction project, the technical department decided to remove the layer affected by hydrodemolition in order to remove the chlorides that had penetrated the concrete over the years. The task called for a two-pronged approach: first, the removal of loose and deteriorated parts with electrodemolishers, second, high pressure hydroscaring (2,000 bar, 25 litres per minute) all surfaces. The use of high pressure hydrodemolition was especially

MAPEFER - a mortar based on polymers in water dispersion, cement binders and corrosion inhibitors - was brushed on the reinforcing rods (photo 3 and 4). Besides being an effective corrosion inhibitor, MAPEFER also improves adhesion of the concrete. The concrete was then reconstructed using MAPEGROUT MS, a pre-mixed micro-silicate-based fibre-reinforced thixotropic mortar (photo 5, 6, and 7).
