Mapefloor™ CPU: Contractor Repair Instructions

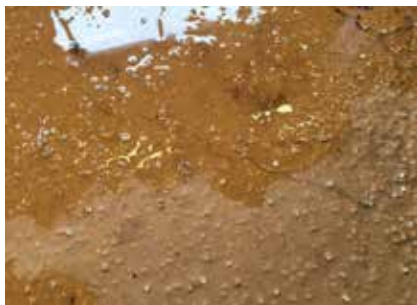
Surface cracks: The cause for cracks on the surface may be the lack of or undersize of anchorage grooves, which cause curling of the screed and its fracture as traffic moves over it. Routinely inspect the existing coating for reflective cracks, or cracks occurring directly over underlying cracks or joints. Remove any unbonded

coating along the length of the crack. Tape over the edges of the intervention area. Rout out the crack with a rotary disc, clean the crack walls with a solvent and bevel the edge of the bonded coating alongside the crack. Caulk the joint with a

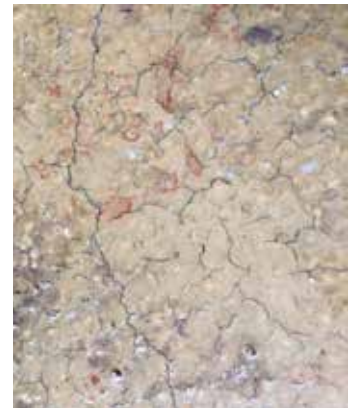
Surface crazing: The most probable cause of surface crazing is the modification of the mixing ratio of Part A, Part B, Part C and *Mapecolor™ Paste*, which results in inadequate product performance. This crazing allows possible penetration of liquids into the screed and eventually into the substrate. Repair by shotblasting, milling or scarifying the surface and reapplying a properly mixed *Mapefloor CPU* coating.
