The Charles Bridge in Prague

An ancient and picturesque monument withstanding damages and floods

The Repairing Interventions

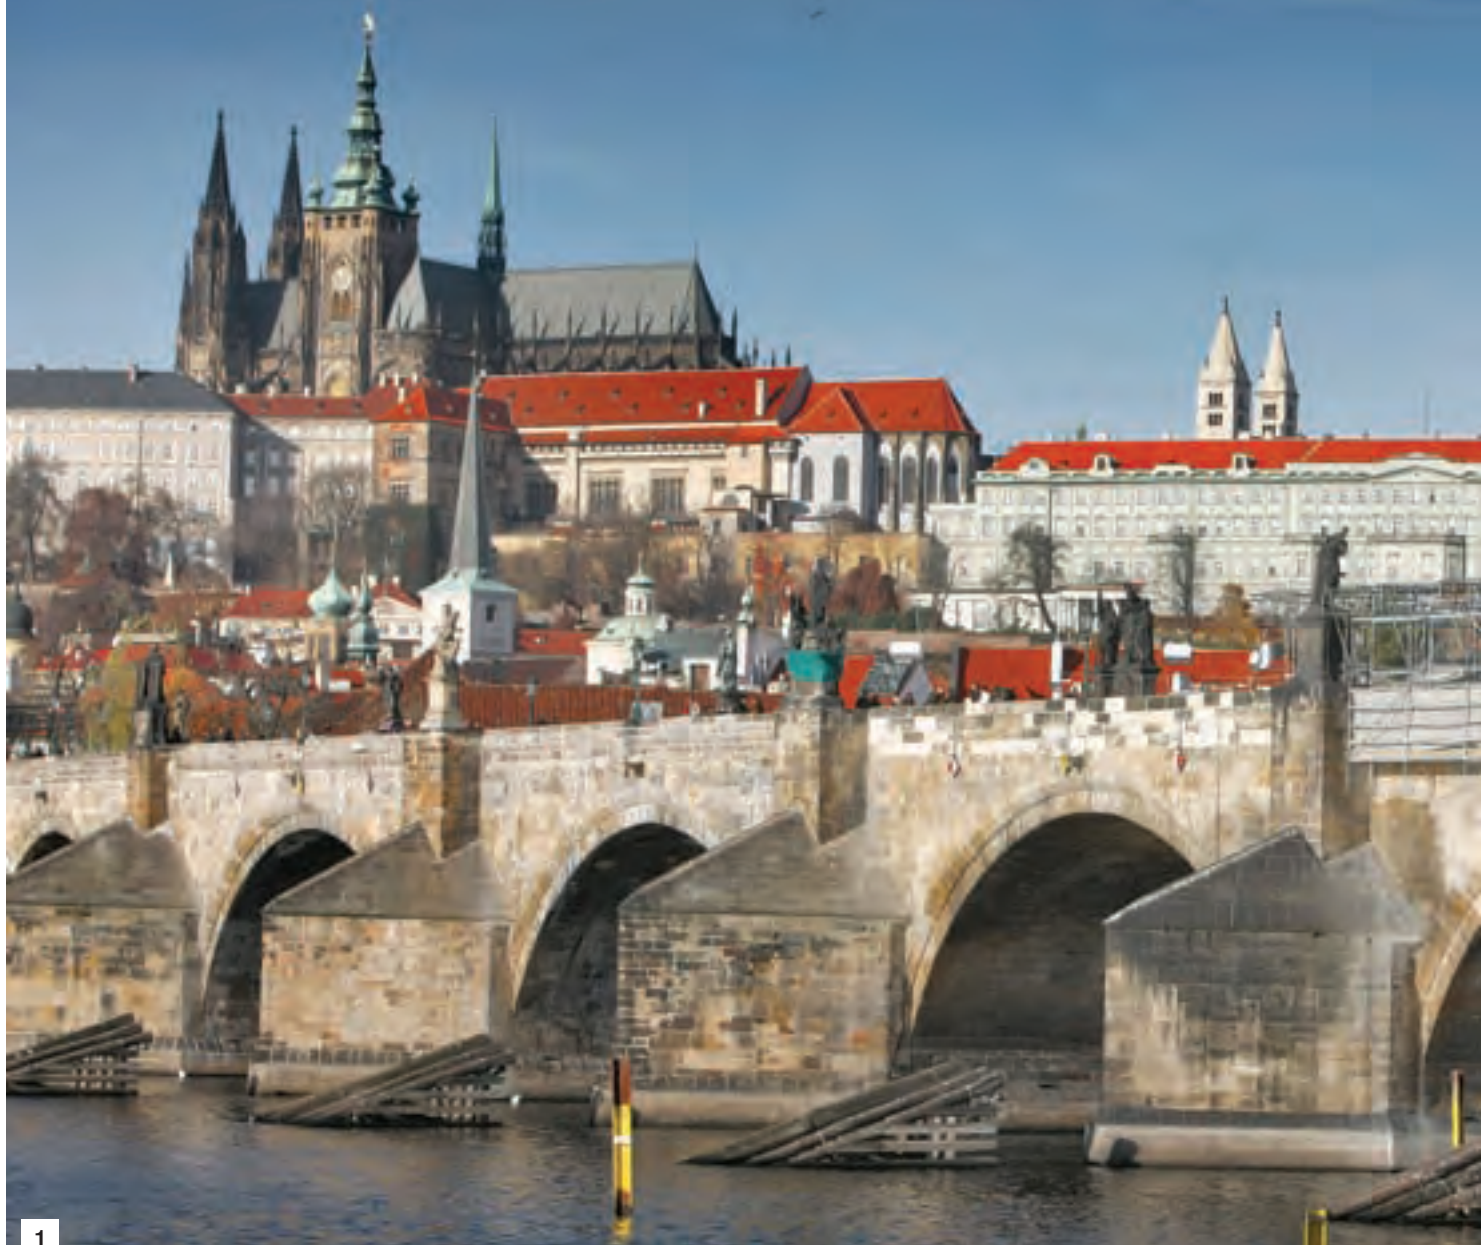
Photo 1. View of the Charles Bridge during the restoration works. On the background, Prague's Castel and Cathedral.

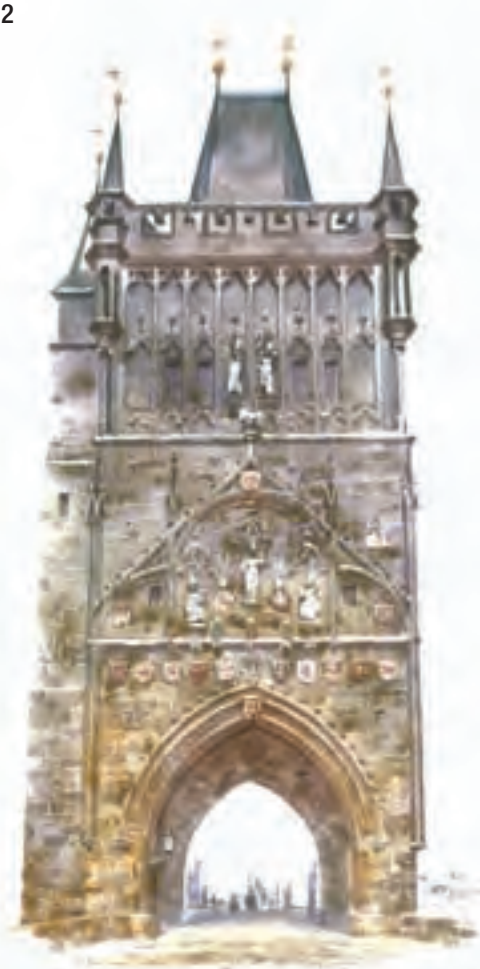
Photo 3. The Charles Bridge is made of blocks from different types of sandstones which make the framework and were carefully analysed. Damaged sandstone blocks were changed in the whole bridge cladding.

Damaged sandstone blocks were changed in the whole bridge cladding. The previous bituminous surface created in the 1920s was substituted by split granite strips. The bridge was intended for pedestrian traffic only after the repair.

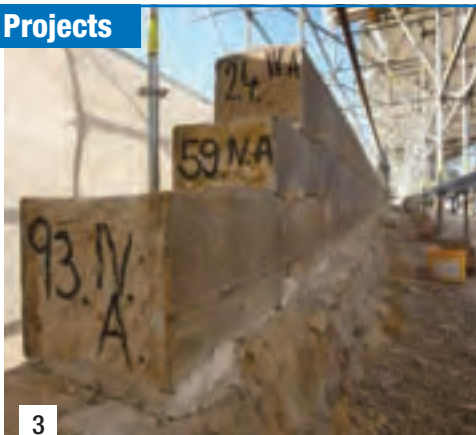
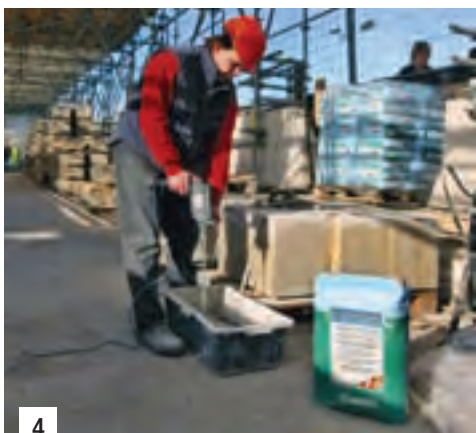
3

Photos 4 e 5. After careful analysis MAPE-ANTIQUE LC, cement-free, Eco-Pozzolan-based binder was used to repair the sandstone blocks.

The second aspect was to find the substitution of the original historical mortar for walling and grouting of the sandstone masonry above water level (only with random flooding during spring thaw). Cement-free, hydraulic binder MAPE-ANTIQUÉ LC for light-coloured dehumidifying lime and Eco-Pozzolan based mortars, was used in this case.

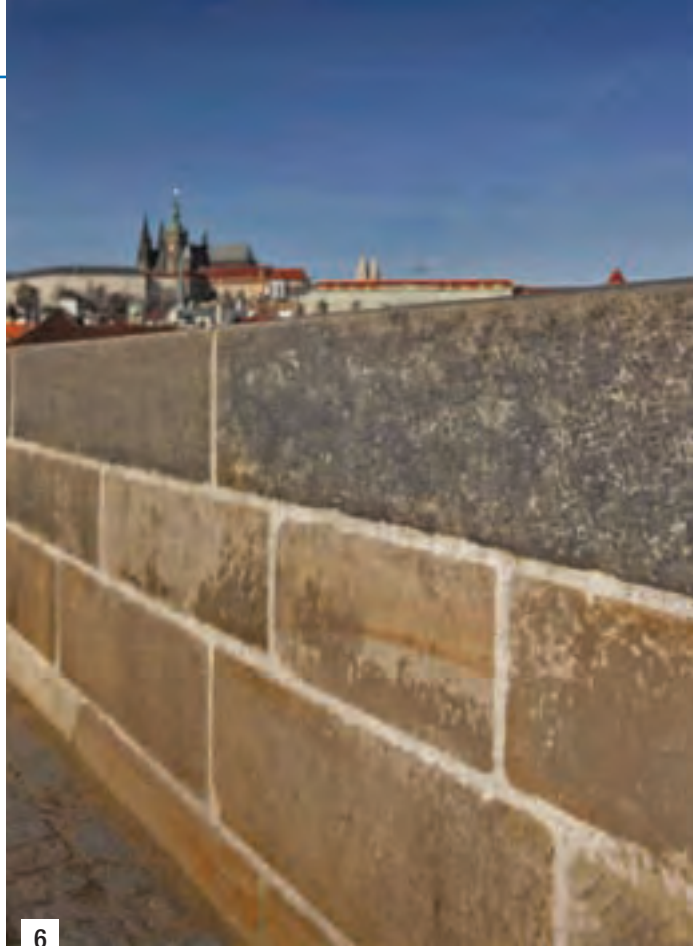
6

Photo 6. A detail view of the bridge after completion of the repairs.
