# The FNB Stadium (Soccer City) in Johannesburg

The biggest sport facility in South Africa was renovated and extended with Mapei products

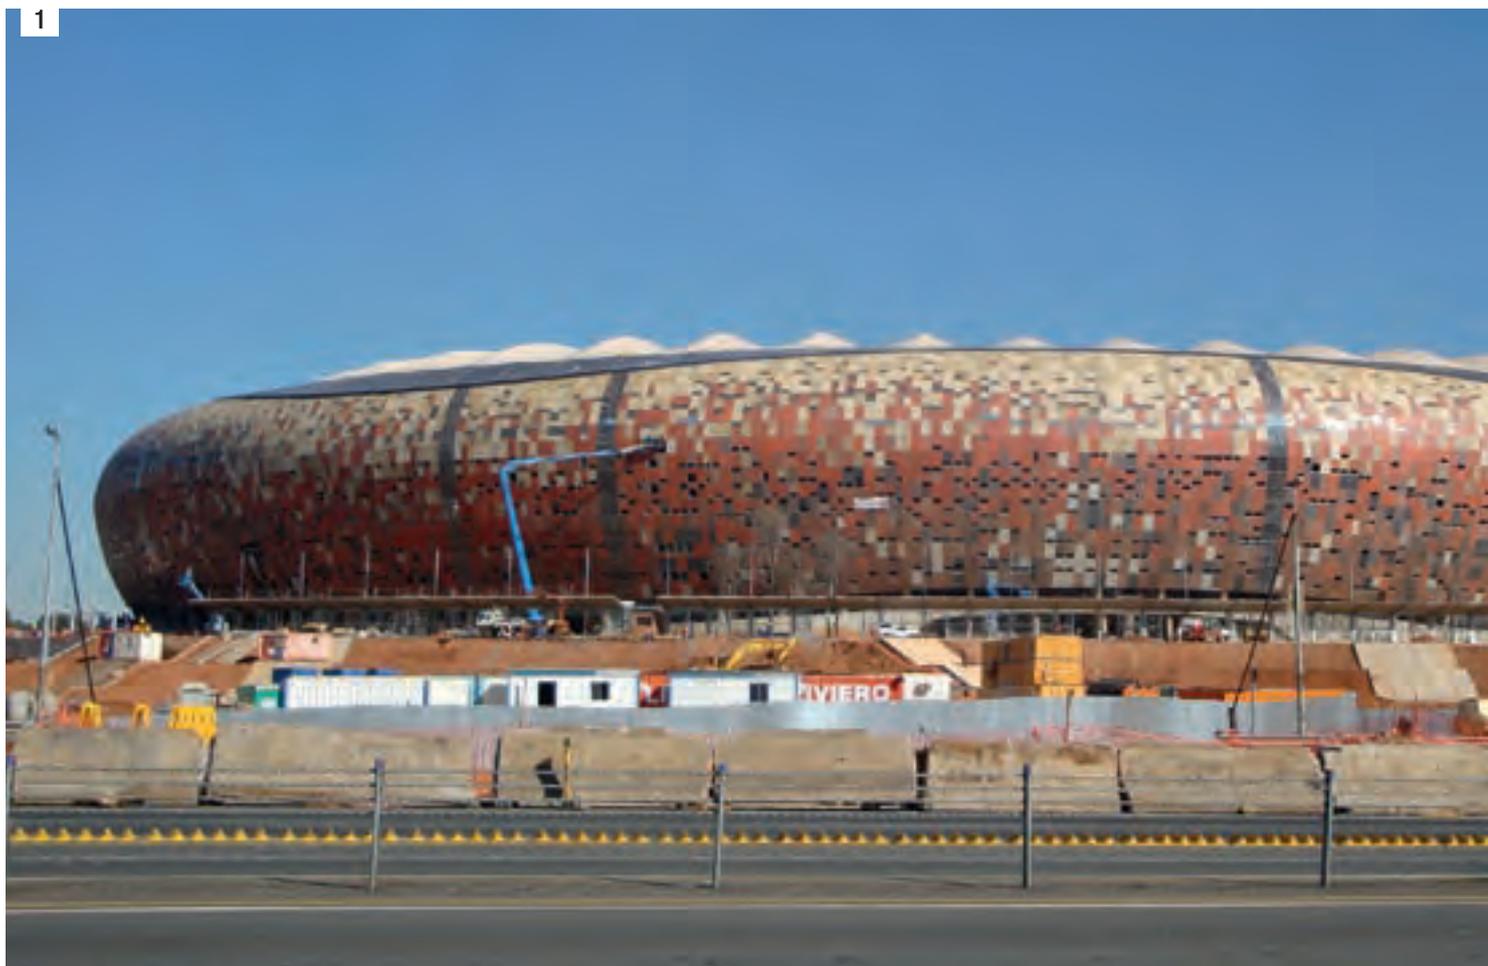
1

**Photo 1.** An external view of the Soccer City (FNB Stadium) with its characteristic “calabash” form, the multi-purpose pot typical of the African continent.

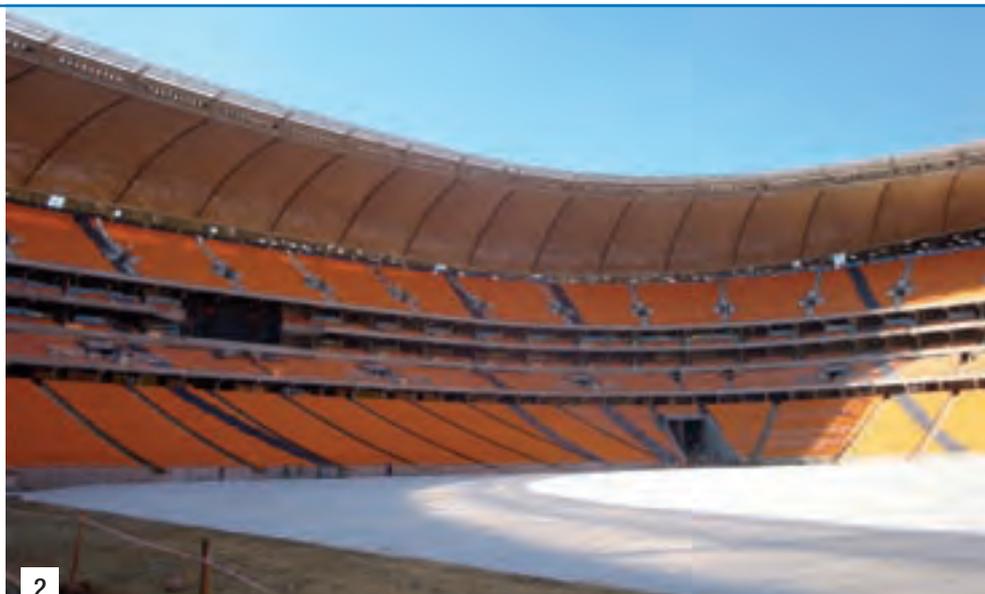
2

**Photo 2.** An internal view of the stadium with its new covered stand.

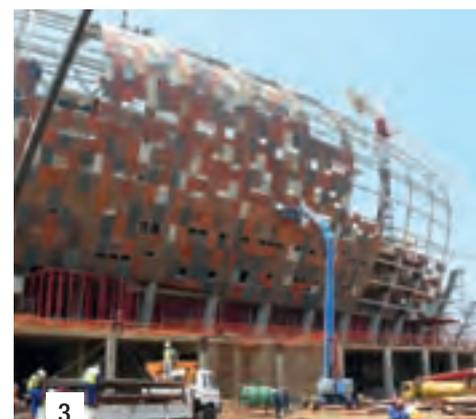
3

**Photo 3.** A phase of the installation of the covering on the external structure. The "shell" is characterised by a sinuous mosaic of cement with reinforced glass fibre panels in a range of eight different colours and two different textures.

The characteristic of the stadium is the shell around the stand and playing field area, the idea of the designer being to create a structure which was similar in form and colour to a "calabash", the multi-purpose pot typical of the African continent. The structure is composed of reinforced concrete profiles which support the two levels of terraces and the gallery, connected together by steps. The external "shell" is characterised by a sinuous mosaic of cement with reinforced glass fibre panels in a range of eight different colours and two different textures. These are

interspersed at irregular intervals by glass cut outs. A truss-supported roof surrounds the whole stadium.

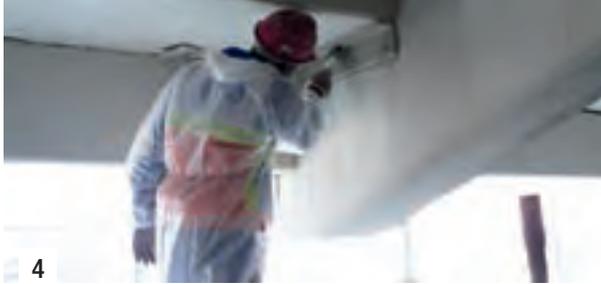
4

**Photo 4.** The adhesives ADESILEX PG1 and ADESILEX PG2 were used to bond and seal the steel brackets.

Karrena Africa, a specialised contracting company, has been responsible for a considerable portion of the repair and enhancement work. Mapei products contributed to the works in and around the suites of the old stadium which over the years were subject to weather and water erosion. Areas which required strengthening were repaired with steel brackets using Mapei's ADESILEX PG1 and ADESILEX PG2 thixotropic epoxy adhesives for structural bonding. ADESILEX PG1 provides exceptional mechanical strength and

bonding capacity and hardens into a shrinkage-free compounds within a few hours. On the other hand, ADESILEX PG2 features extended workability which makes it especially recommended for applications at temperatures above +20°C.

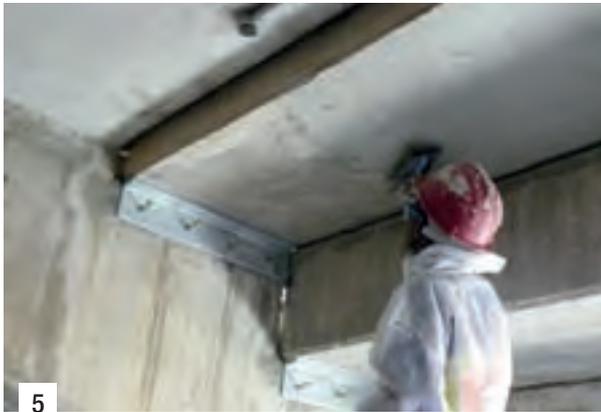
5

**Photo 5.** MAPEGROUT FAST-SET fibre-reinforced mortar was used to repair the concrete surfaces.

Concrete sections where corrosion and deterioration occurred were scoured out and cleaned with high pressure water. If any reinforcing steel was exposed as a result of this process, it was treated with MAPEFER 1K, a one-component anti-corrosion cementitious mortar applied with a brush. Thereafter MAPEGROUT FAST-SET (RAPIDO) shrinkage-compensated fibre-reinforced mortar was applied in

layers ranging from 25 mm to 30 mm. Some damaged areas also required the use of MAPEGROUT HI-FLOW (COLABILE) shrinkage-compensated fibre-reinforced grout.

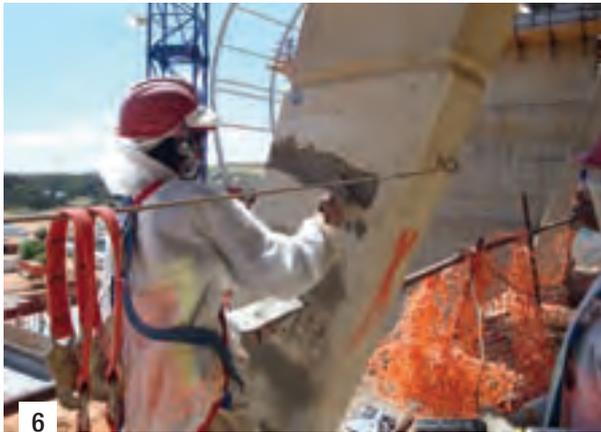
6

**Photo 6.** PLANITOP 100 mortar was applied to fill blow holes in the damaged concrete.

Blow holes in concrete surfaces were filled with PLANITOP 100 light grey and fine skimming mortar, which was applied in layers up to 3 mm. Some of the vertical and horizontal joints were sealed with MAPEFLEX PU45 one component, thixotropic, rapid-hardening polyurethane sealant and adhesive with high modulus of elasticity.
